State of Alaska
Department of Fish and Game
Sportfish Division

Nomination Form
Anadromous Waters Catalog

Anadromous Waters Catalog Number of Waterway 115-32-10250-2977

115-32-10250-2977 Route Correction*Stream:* 115-32-10250-2977*Watershed:* Chilkat-Inlet Frontal Lynn Canal*USGS Quadrangle:* Skagway B-3*MTRS:* CO28S056E*Date Surveyed:* July 30, 2012*Findings:* We caught rearing coho past the documented upper extent of anadromy for this stream.*Recommendations:* Add rearing coho to the AWC and extend the upper extent of anadromy for this stream.*Nomination form submitted:* Yes*Nomination status:**Notes:***Table 1: 115-32-10250-2977 Route Correction Survey Data**

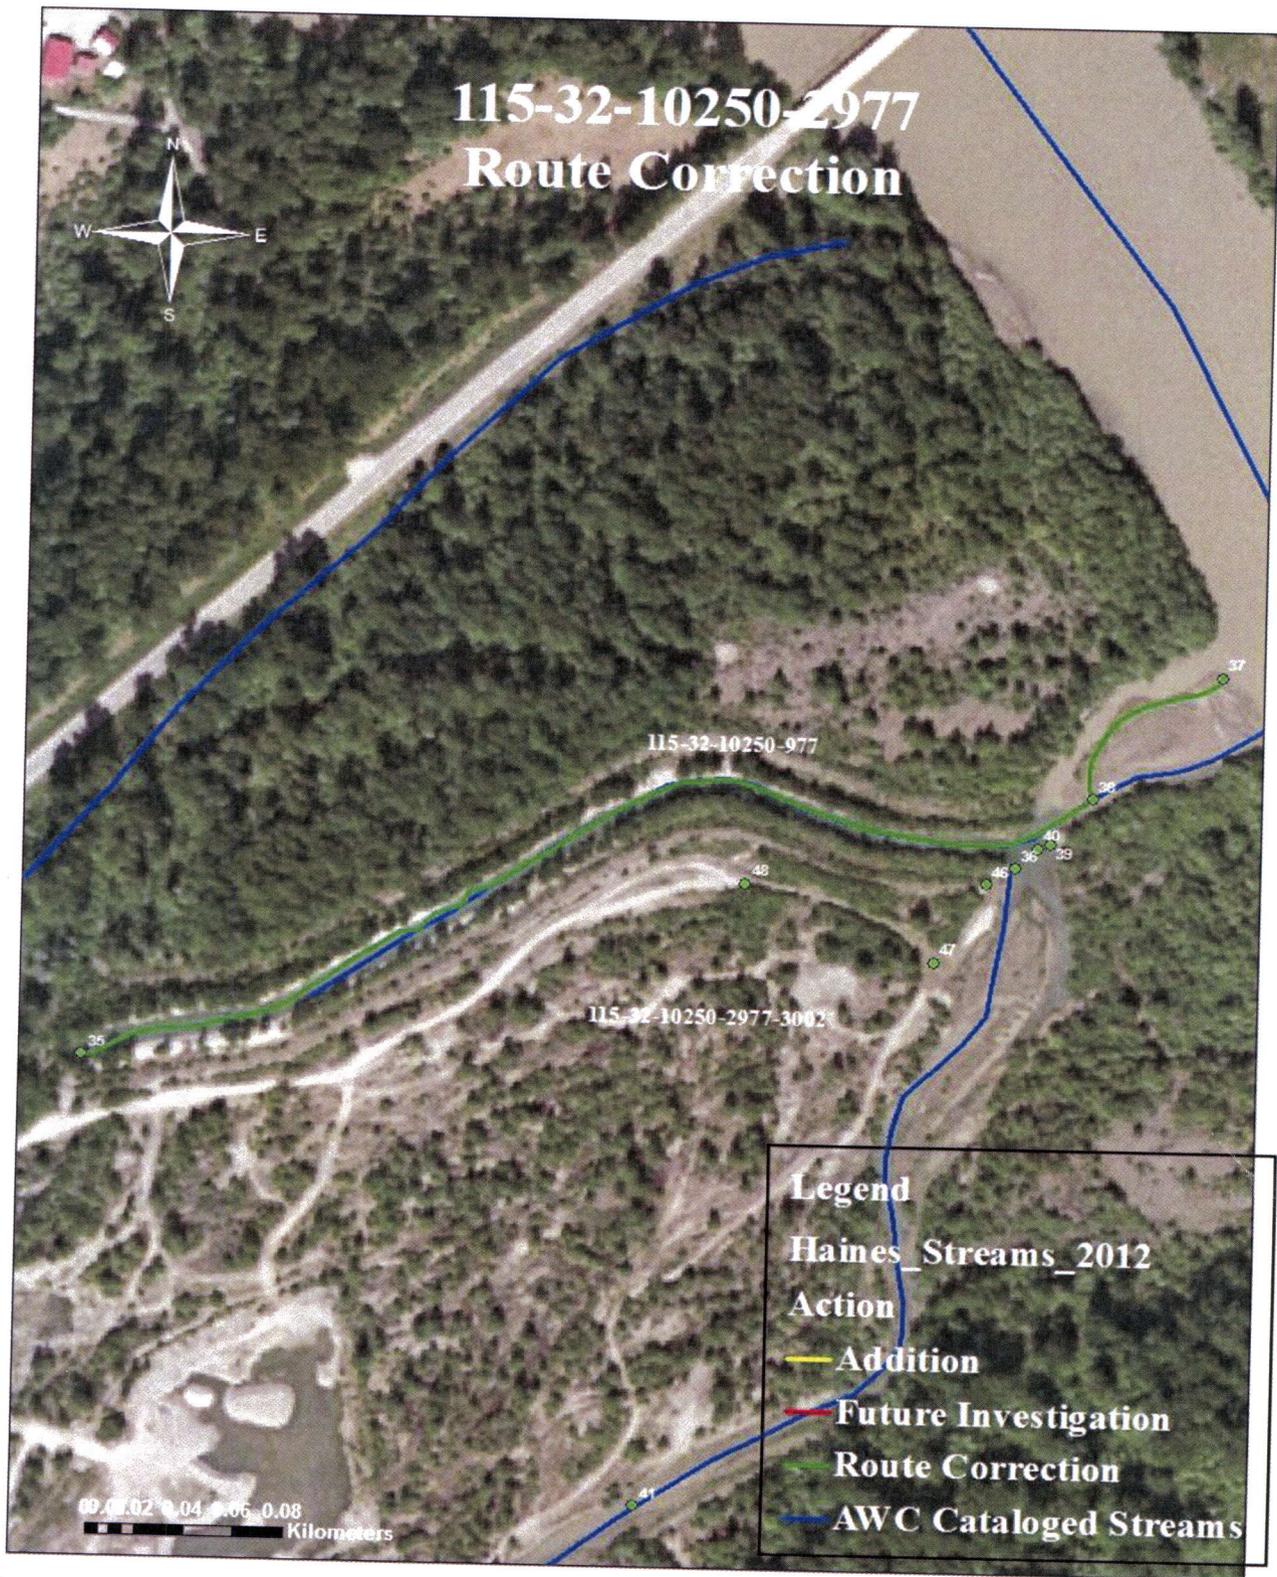
Figure 1: Map of 115-32-10250-2977 Route Correction

Waypoints	Latitude	Longitude	Notes	Sample Effort	Sample Results
35	59.411821	-135.939887	Top of spawning channel, almost chest deep at the head here and whole way is covered in algae. Track and shocking. Electrofished at settings 350 V, 30 Hz, 25 % duty cycle, got 2 coho about 45 mm and both bounced back.	electrofishing	2 CO ~ 45 mm
36	59.411884	-135.93314	This is where the spawning channel enters back log of water from Chilkat River and body of water where the tributary enters. This back log could also be considered a part of the spawning channel even though it has a silty bottom.		
37	59.412453	-135.931435	Where spawning channel back log enters into the Chilkat River. River backing up a lot of water.

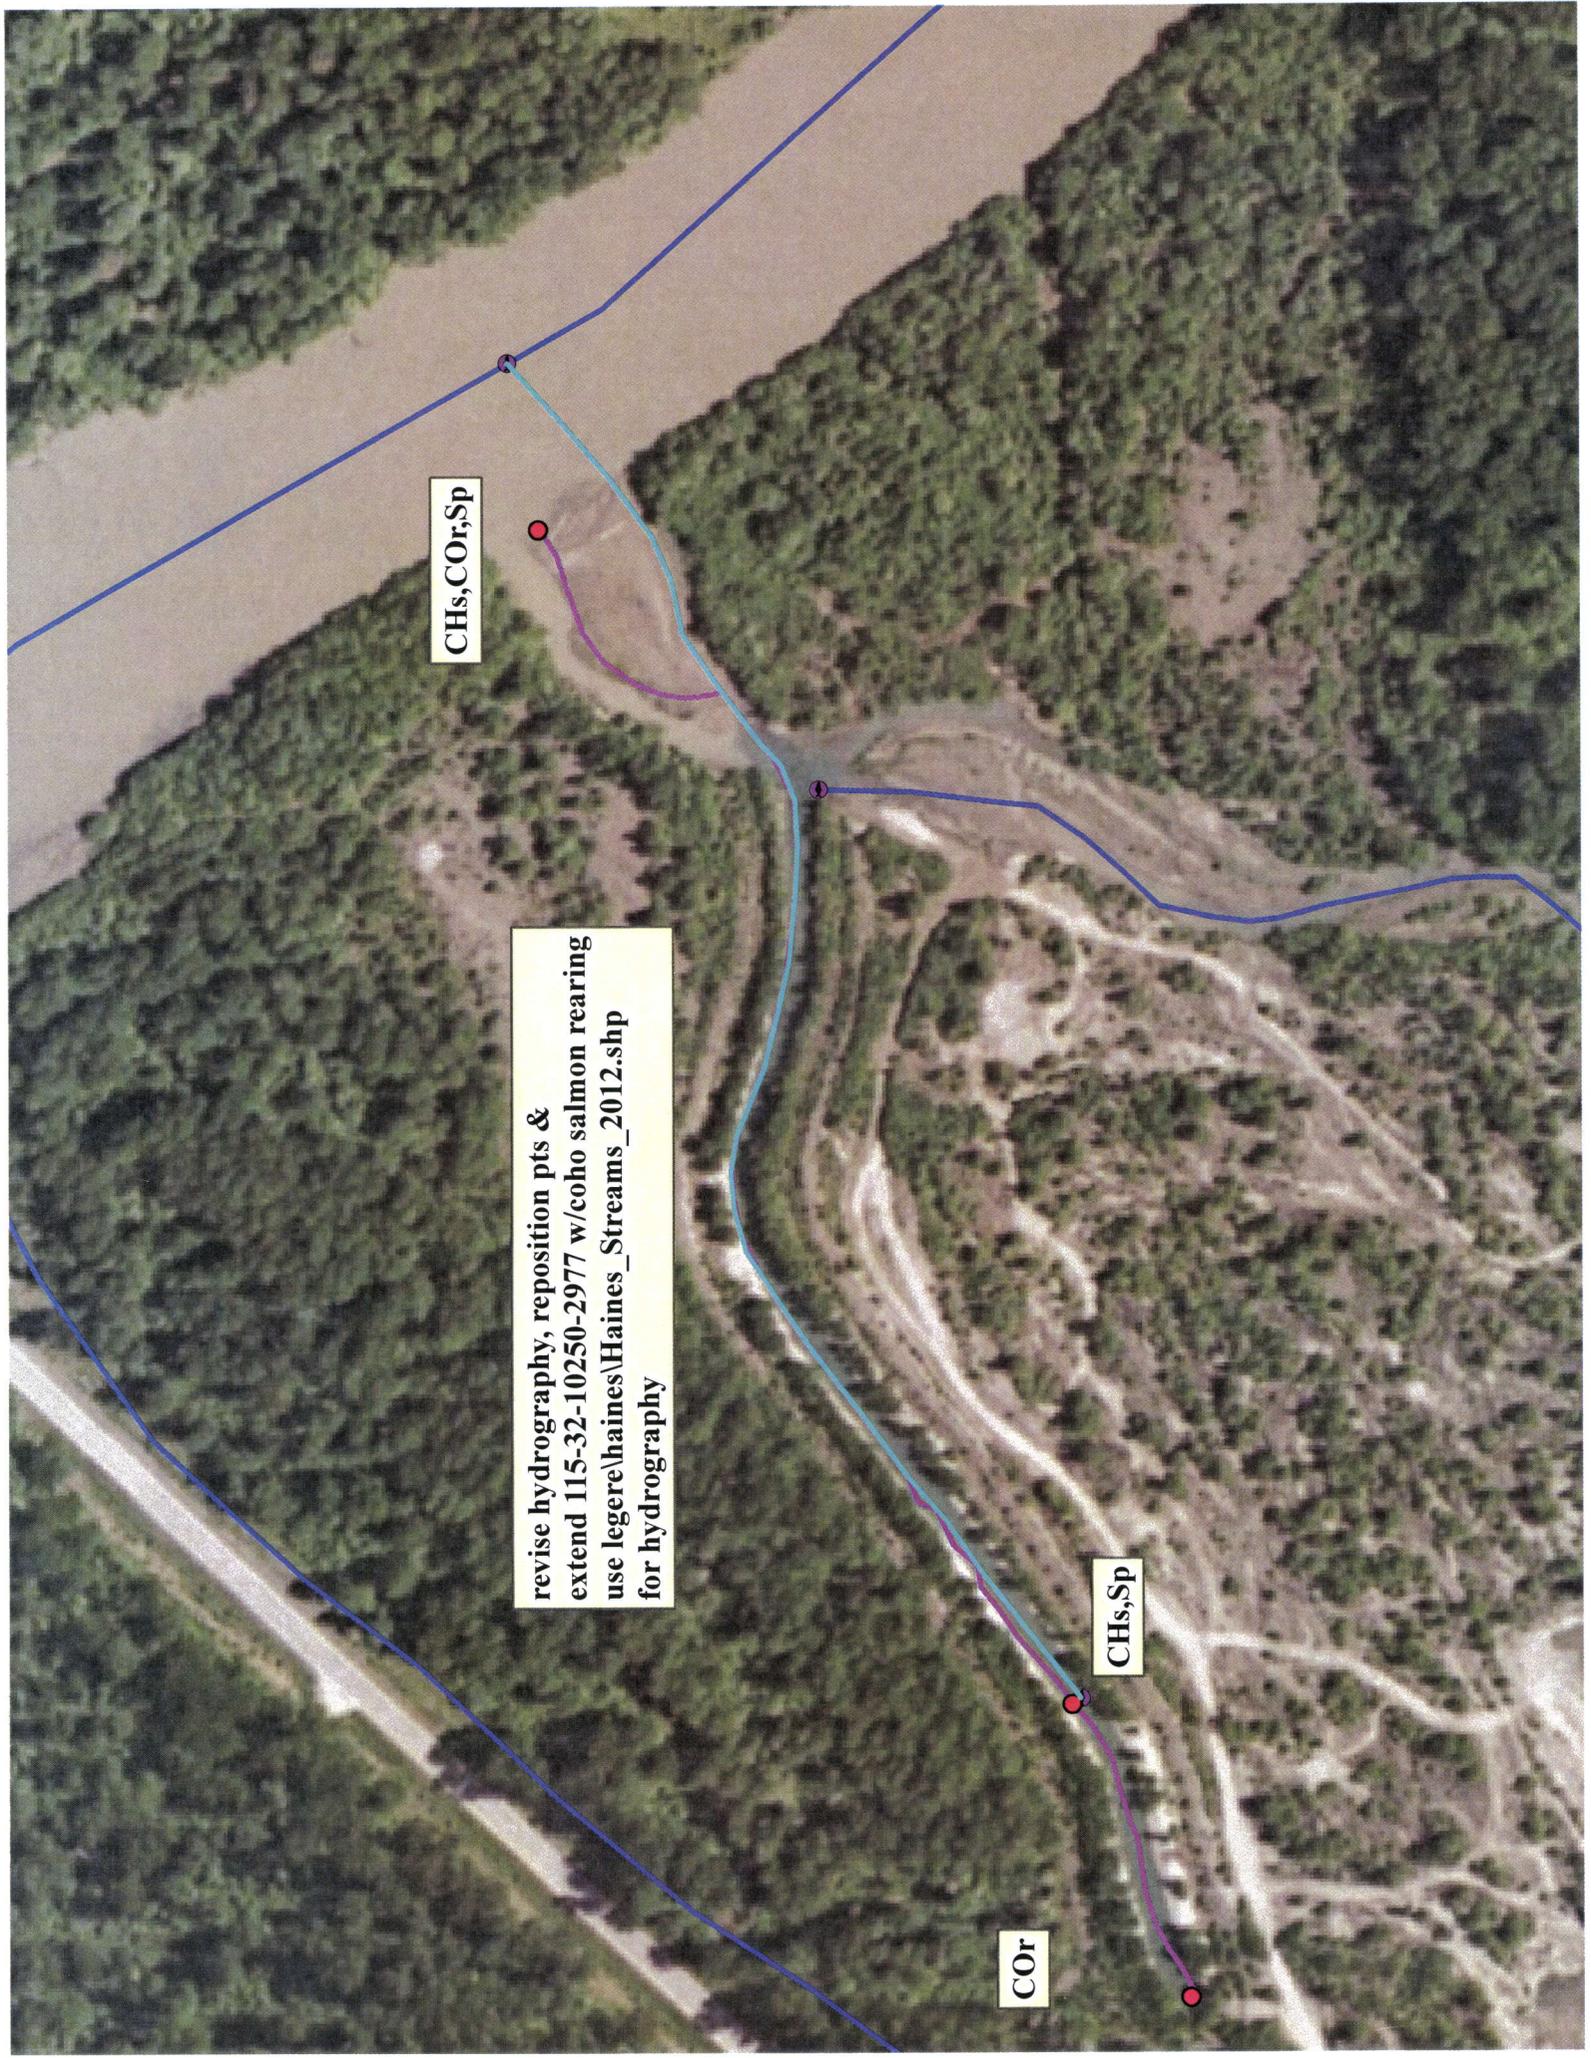
CHs, COr, Sp

revise hydrography, reposition pts &
extend 115-32-10250-2977 w/coho salmon rearing
use legere/haines/Haines_Streams_2012.shp
for hydrography

CHs, Sp

COr
