State of Alaska  
Department of Fish and Game  
Sportfish Division

Nomination Form  
Anadromous Waters Catalog

Region Southeastern USGS Quad(s) Skagway B-3 NW  
 Anadromous Waters Catalog Number of Waterway 115-32-10250-2081  
 Name of Waterway Muskrat Creek  USGS Name  Local Name  
 Addition  Deletion  Correction  Backup Information

**Muskrat Creek (115-32-10250-2081) Route Correction***Stream:* Muskrat Creek (115-32-10250-2081)*Watershed:* Chilkat-Inlet Frontal Lynn Canal*USGS Quadrangle:* Skagway B-3*MTRS:* CO28S056E30*Date Surveyed:* August 9-11, 2012*Findings:* Over the course of three days we tracked and surveyed Muskrat Creek (115-32-10250-2081) and its associated tributaries. We had several visual observations of spawning sockeye salmon in the lower-mid portions of the creek. We caught juvenile coho salmon above the current AWC upper extent. The headwater of Muskrat Creek is a small seep from ground close to the Haines Highway.*Recommendations:* Correct the stream route, add spawning sockeye, and extend the upper extent for coho in the AWC for Muskrat Creek.*Nomination form submitted:* Yes*Nomination status:**Notes:***Table 1: Muskrat Creek (115-32-10250-2081) Route Corr

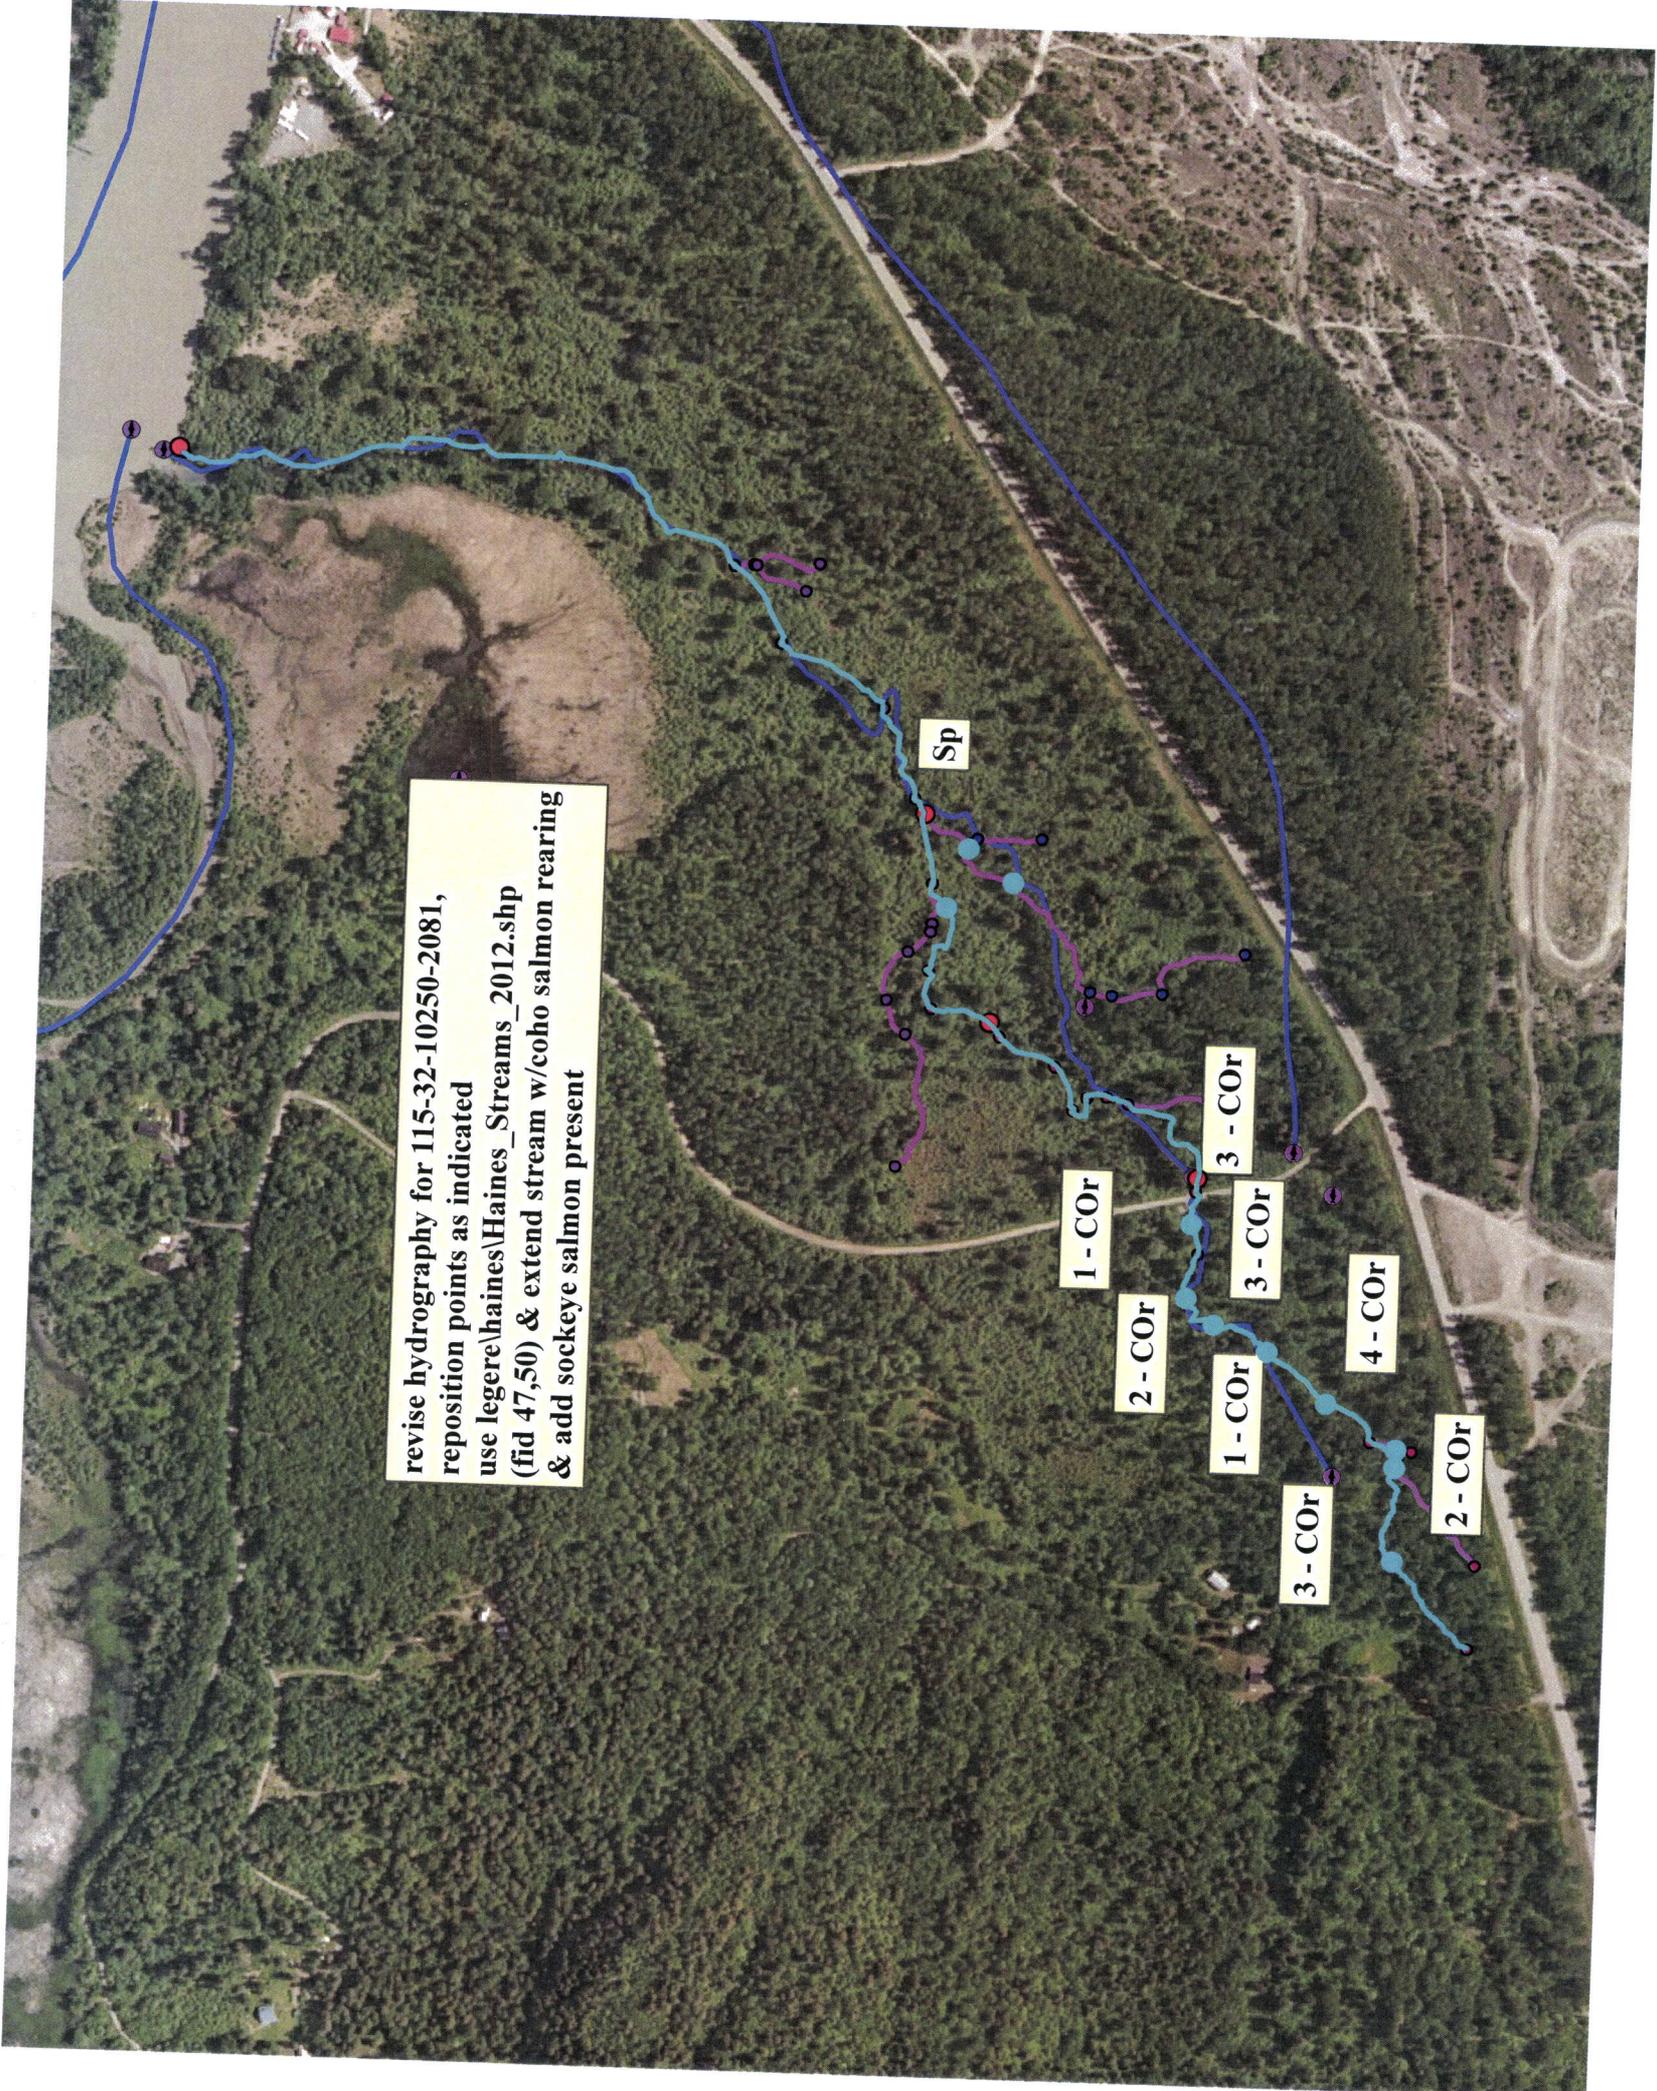
revise hydrography for 115-32-10250-2081,  
reposition points as indicated  
use legere\haines\Haines\_Streams\_2012.shp  
(fid 47,50) & extend stream w/coho salmon rearing  
& add sockeye salmon present

Sp

1 - COr

2 - COr

3 - COr

4 - COr
