Nomination Form
Anadromous Waters Catalog

Anadromous Waters Catalog Number of Waterway 108-40-10600

108-40-10600 ROUTE CORRECTION

Stream: 108-40-10600 (cataloged for COP,Pp,DVp)

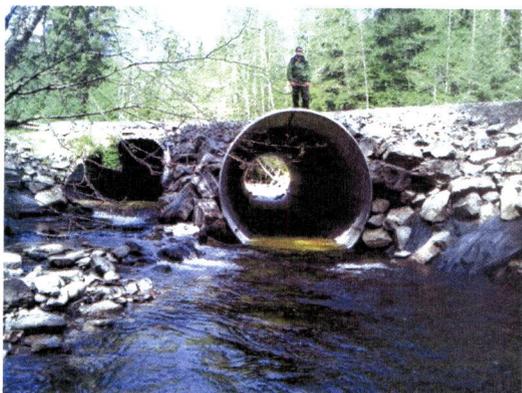
Findings: We surveyed stream 108-40-10600 and associated tributaries over the course of two days (Table 1). There are two large culverts under the Mitkof Highway which appear to be recently installed (Figure 1). The stream channel was shifted (Figure 2) and there were large buildups of debris in the outside curves of the creek which is evidence of a recent landslide in the creek. We stopped tracking the creek because the gradient increased and the substrate was large boulders making falls (Figure 3). There was no jumping or holding pools for fish.

Figure 1: Rick Hoffman standing on the outlet of the culverts.

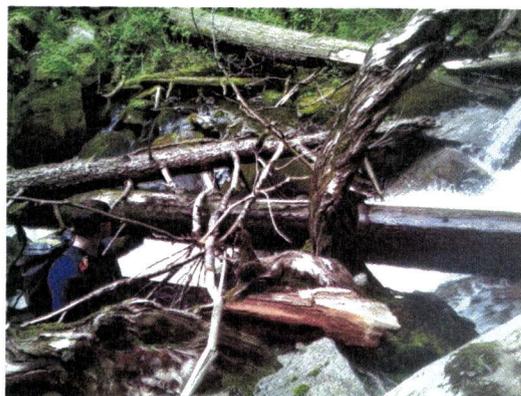
361	56.5594	-132.6459	Large rock and wood build-up, possible limit fish use upstream.		
362	56.5608	-132.6461	Calling it the top of the mainstem. Major gradient change with large boulders making falls. Right now possible velocity barrier and even more so at high water. No pools in falls for jumping.

Figure 3: Rick Hoffman in front of potential velocity barrier.

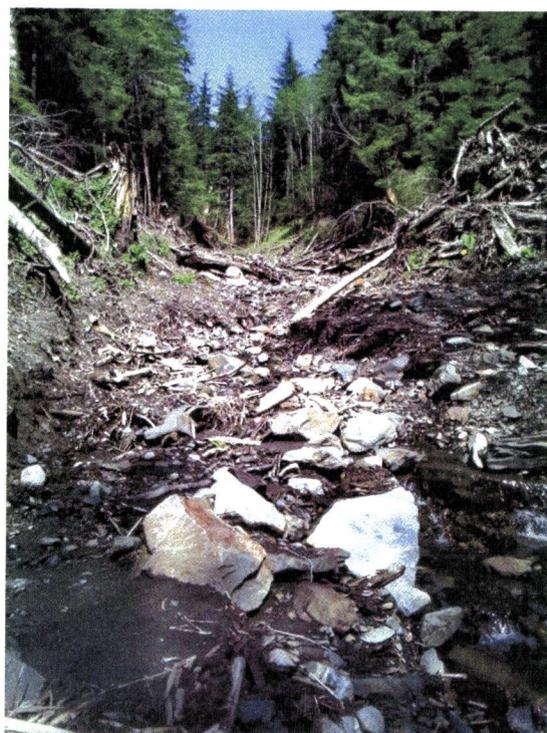
Figure 2: Old tributary channel that had been rerouted after landslide.

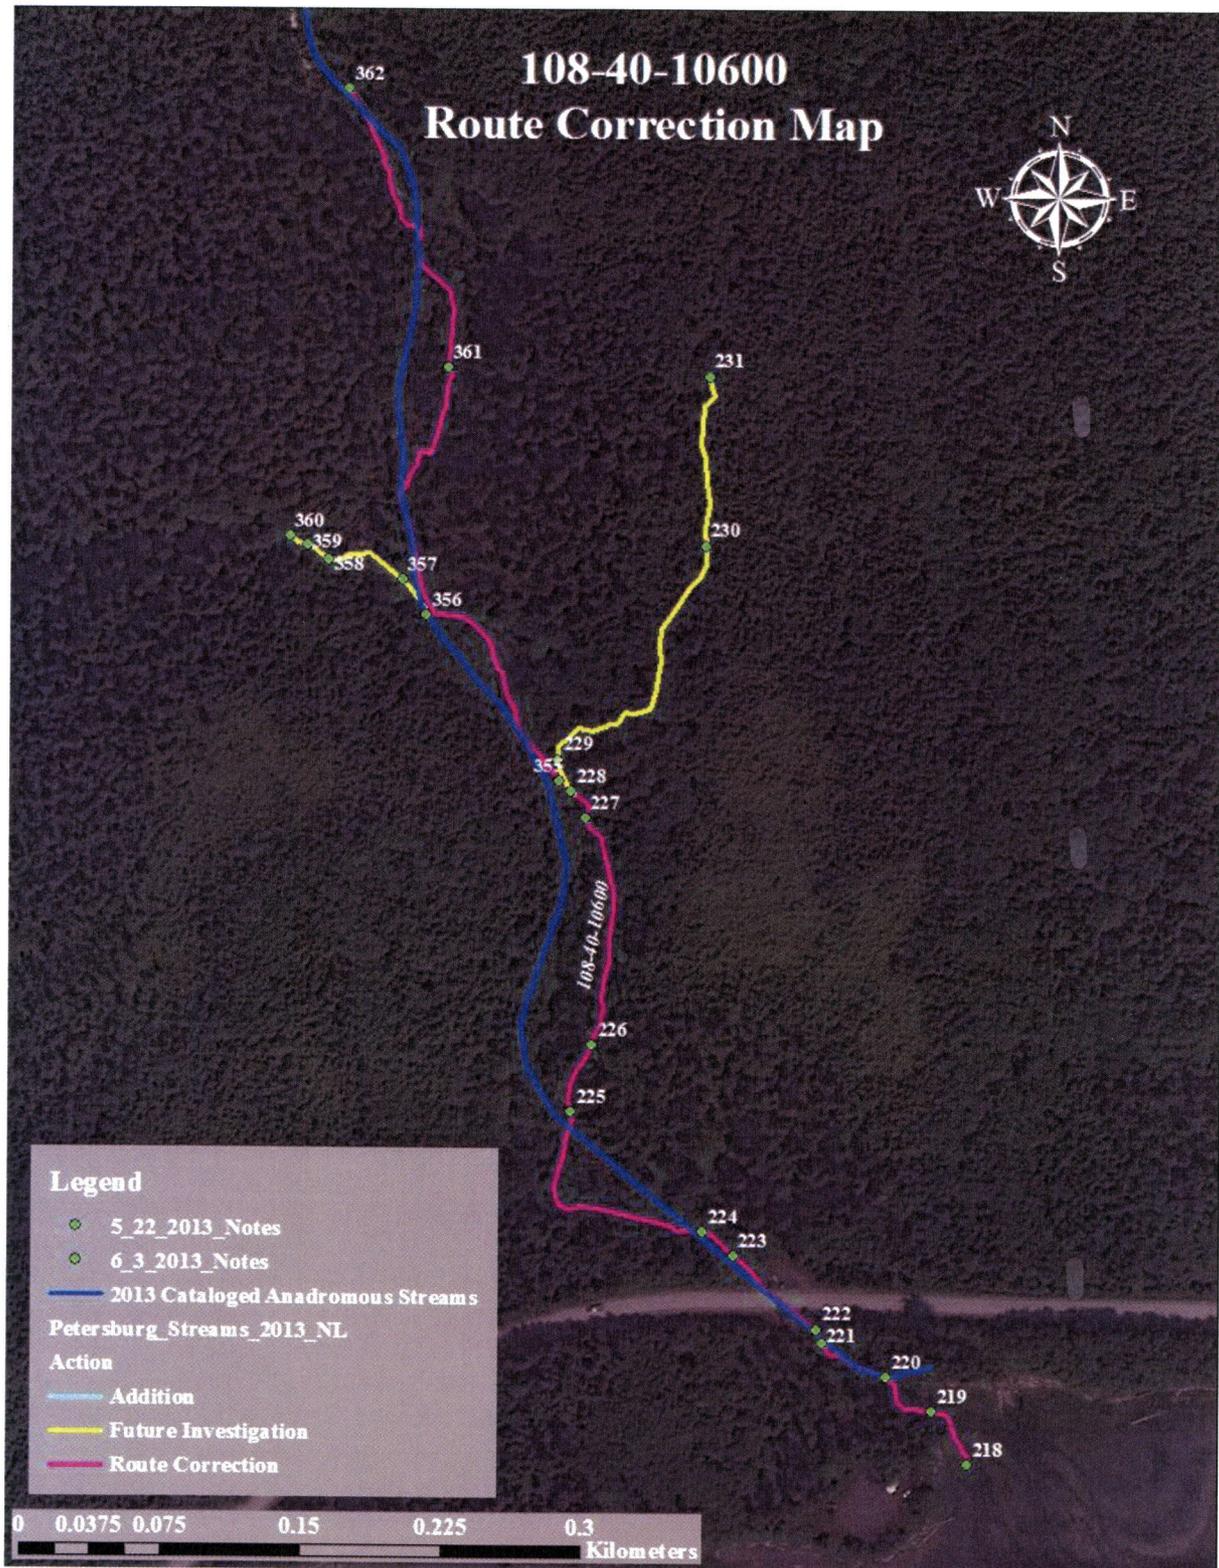
Figure 1: 108-40-10060 route correction map.

Recommendations: Update the route for stream 108-40-10600 in the Anadromous Waters Catalog.
