Fish Survey  
Nomination Form  
Anadromous Waters Catalog

Name of Waterway: Lee's Cabin Creek

Station: SEA13MIT30

Date Observed: 07/17/2013

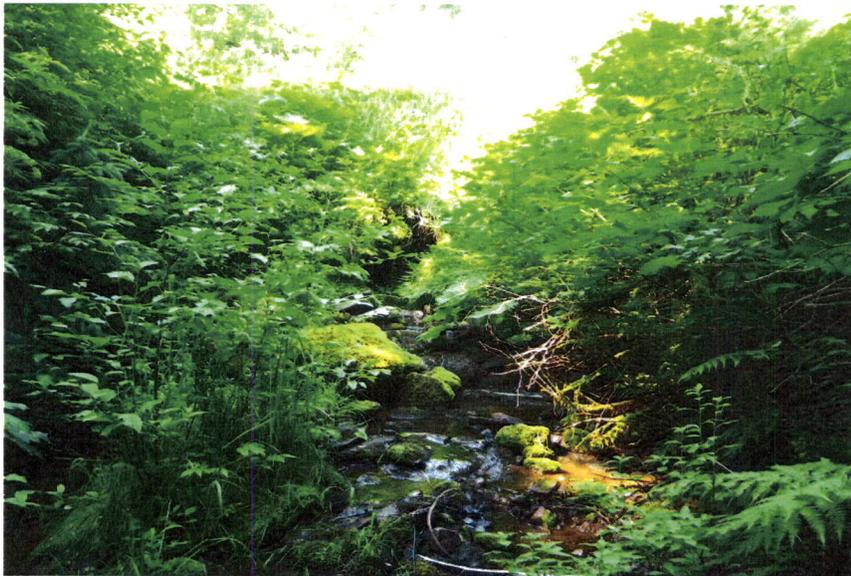
IMG7593.jpg  
Outlet

**Station Comments:** Between milepost 17 and 18 FID 860. Coho, dolly varden, and cutthroat observed and trapped. Habitat is apparently quite productive, and looks like possible spawning habitat for adults in addition to being a rearing stream. There is a small outfall at the outlet, currently a cascade with pocket pools due to low flow. Large rocks in channel are mossy.
