Nomination Form
Anadromous Waters Catalog

Name of Waterway Thayer Creek USGS Name Local Name
 Addition Deletion Correction Backup Information

THAYER CREEK

Table 1.-Thayer Creek survey data.

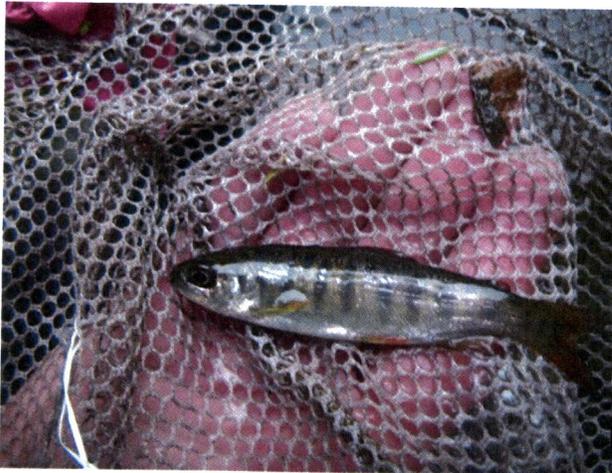
Figure 1.—Coho salmon caught below waterfall in Thayer Creek.

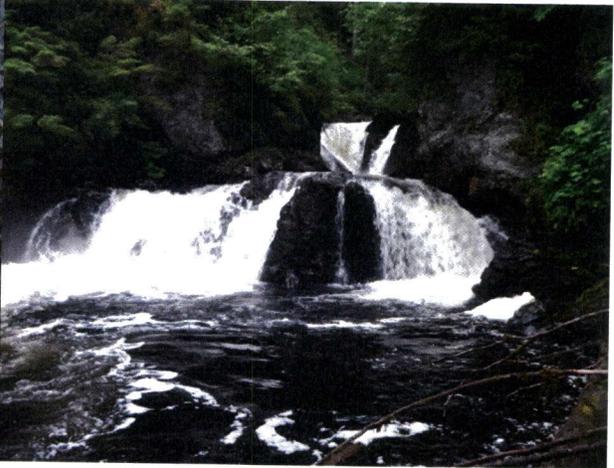
Findings: The lower section of Thayer Creek is gravel and cobble substrate. We had visual observations of several adult pink and one chum salmon in the stream. There is a series of water falls approximately 1250' upstream from the mouth of the creek that we determined are anadromous fish passage barriers. We caught four rearing coho salmon downstream of the waterfalls and saw several pink and one pair of sockeye salmon swimming in the plunge pool below the falls. Upstream of the waterfall the creek flows through a bedrock gorge for approximately one mile then opens up to a low gradient stream with gravel and cobble substrate. We surveyed a tributary in this area and caught resident cutthroat trout and Dolly Varden char.

Figure 2.—First 12' waterfall with 20' deep plunge pool.

Recommendations: Correct the anadromous section of Thayer Creek in the AWC to represent the actual extent of anadromy. Add rearing coho salmon and sockeye salmon presence to the AWC.

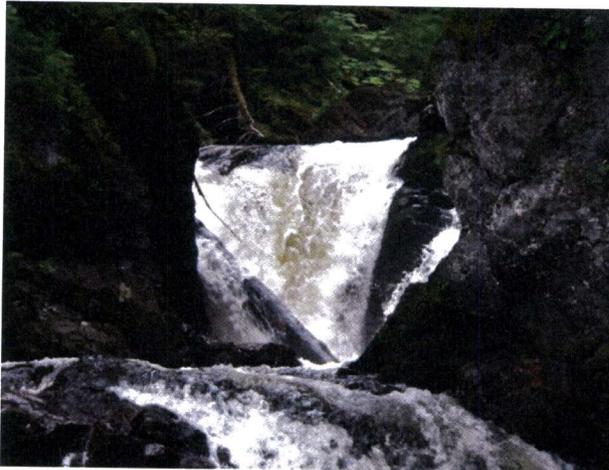
Figure 3.—Second 14' waterfall with no plunge pool.

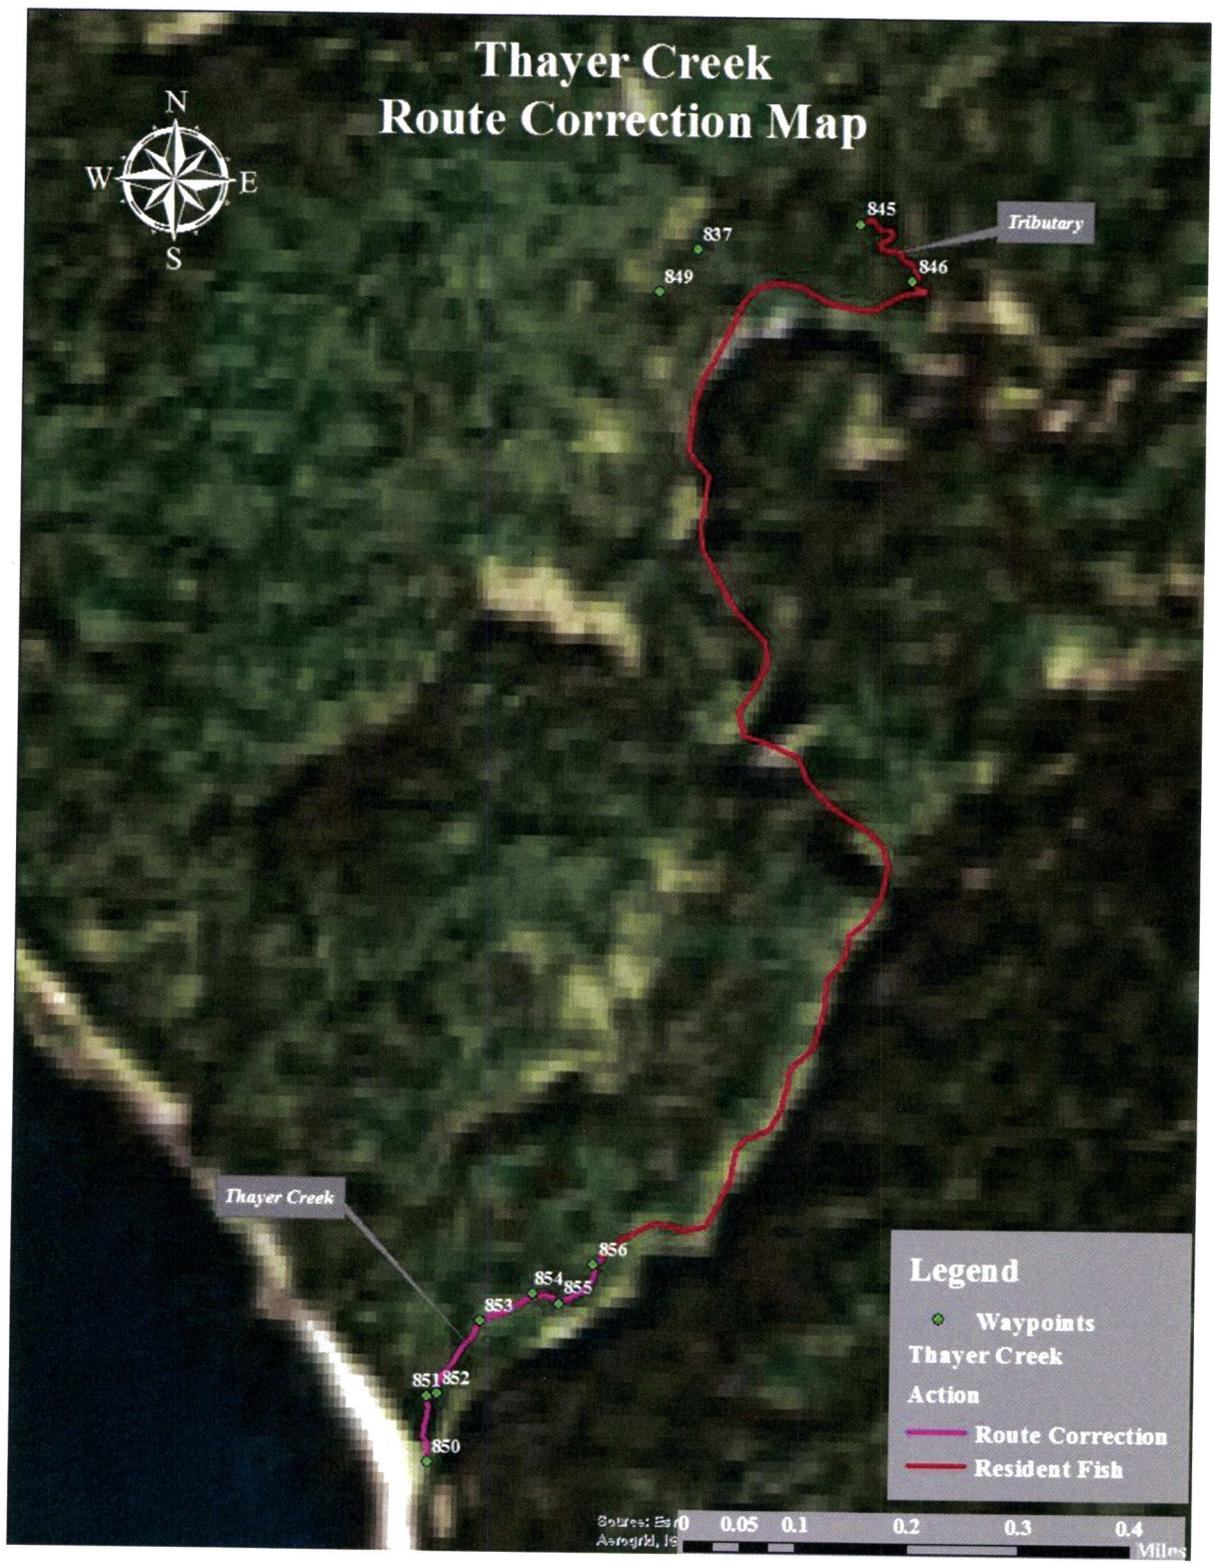
Figure 5.— Thayer Creek route correction map.

shorten 112-17-10500, add coho salmon rearing & sockeye salmon present, update hydrography using \noms\legere\14-584\Thayer Creek\Thayer Creek.shp
