State of Alaska
Department of Fish and Game
Division of Sport Fish

Fish Survey
Nomination Form
Anadromous Waters Catalog

Anadromous Waters Catalog Number of Waterway: 106-30-10670-2004-3021

Site Information Survey: SEA14COR13 Date Observed: 08/15/2014 Legal Desc.: C068S081E20 Latitude Longitude Datum
Site: 10103365 55.96367 -132.91302 WGS8

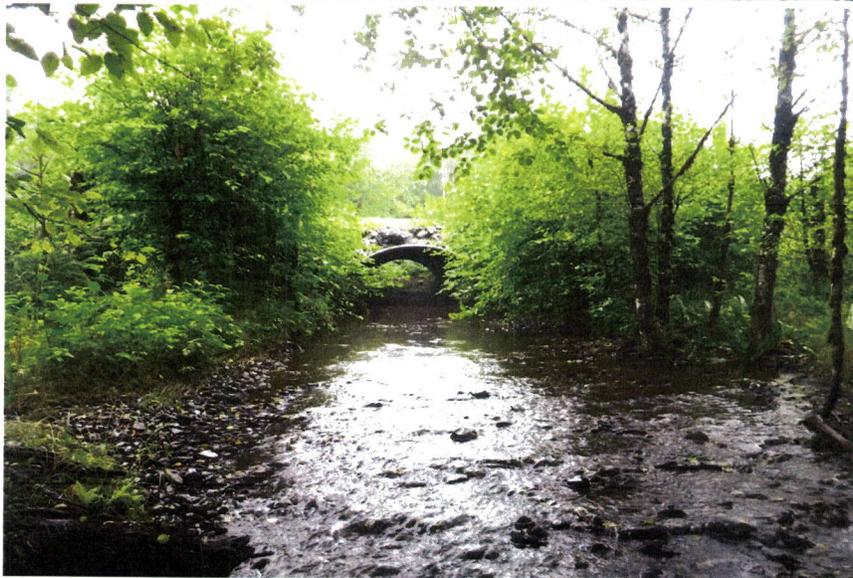
IMG1469.JPG
outlet

Station Comments FID 474. Mitered length 107.5, 99.3 without miter. Total length is a guess due to buried to miters.

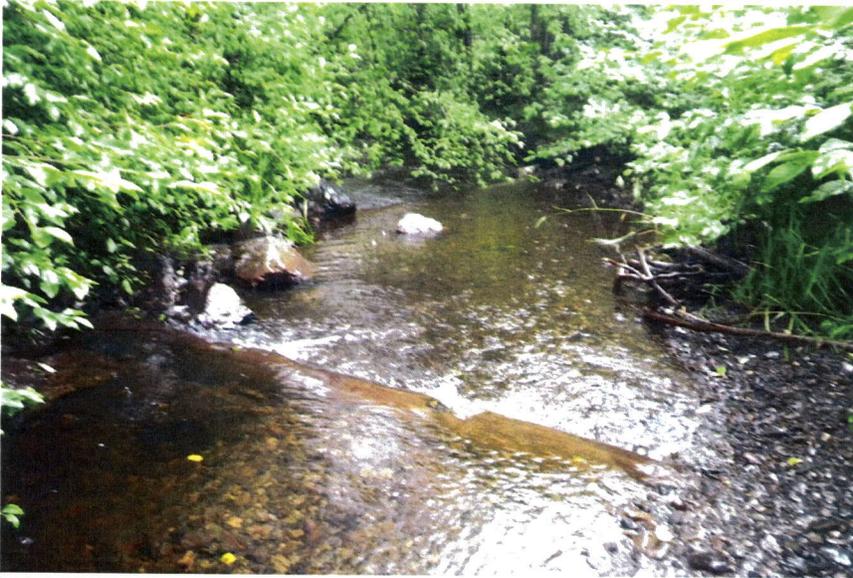
IMGP1475.JPG
downstream grade control log

Additional Comments: This information was collected as part of the ADF&G Fish Passage Project. This nomination supports the addition for presence of dolly varden char in AWC Stream # 106-30-10670-2004-3021. Up and downstream are both aggraded with little channel variability. Stream banks were logged 40-50 years ago and wood was removed from the stream. Unusually uniform ordinary high water width may indicate that heavy machinery was run in stream and logs were very likely flumed down it. Artificial log step pools downstream.
