State of Alaska
Department of Fish and Game
Sportfish Division

Nomination Form
Anadromous Waters Catalog

Region Southeastern USGS Quad(s) JUNEAU B-5
 Anadromous Waters Catalog Number of Waterway 114-80-10400
 Name of Waterway North Creek USGS Name Local Name
 Addition Deletion Correction Backup Information

SUBJECT: Excursion Inlet Hydro
Trip Report
8/13/2012

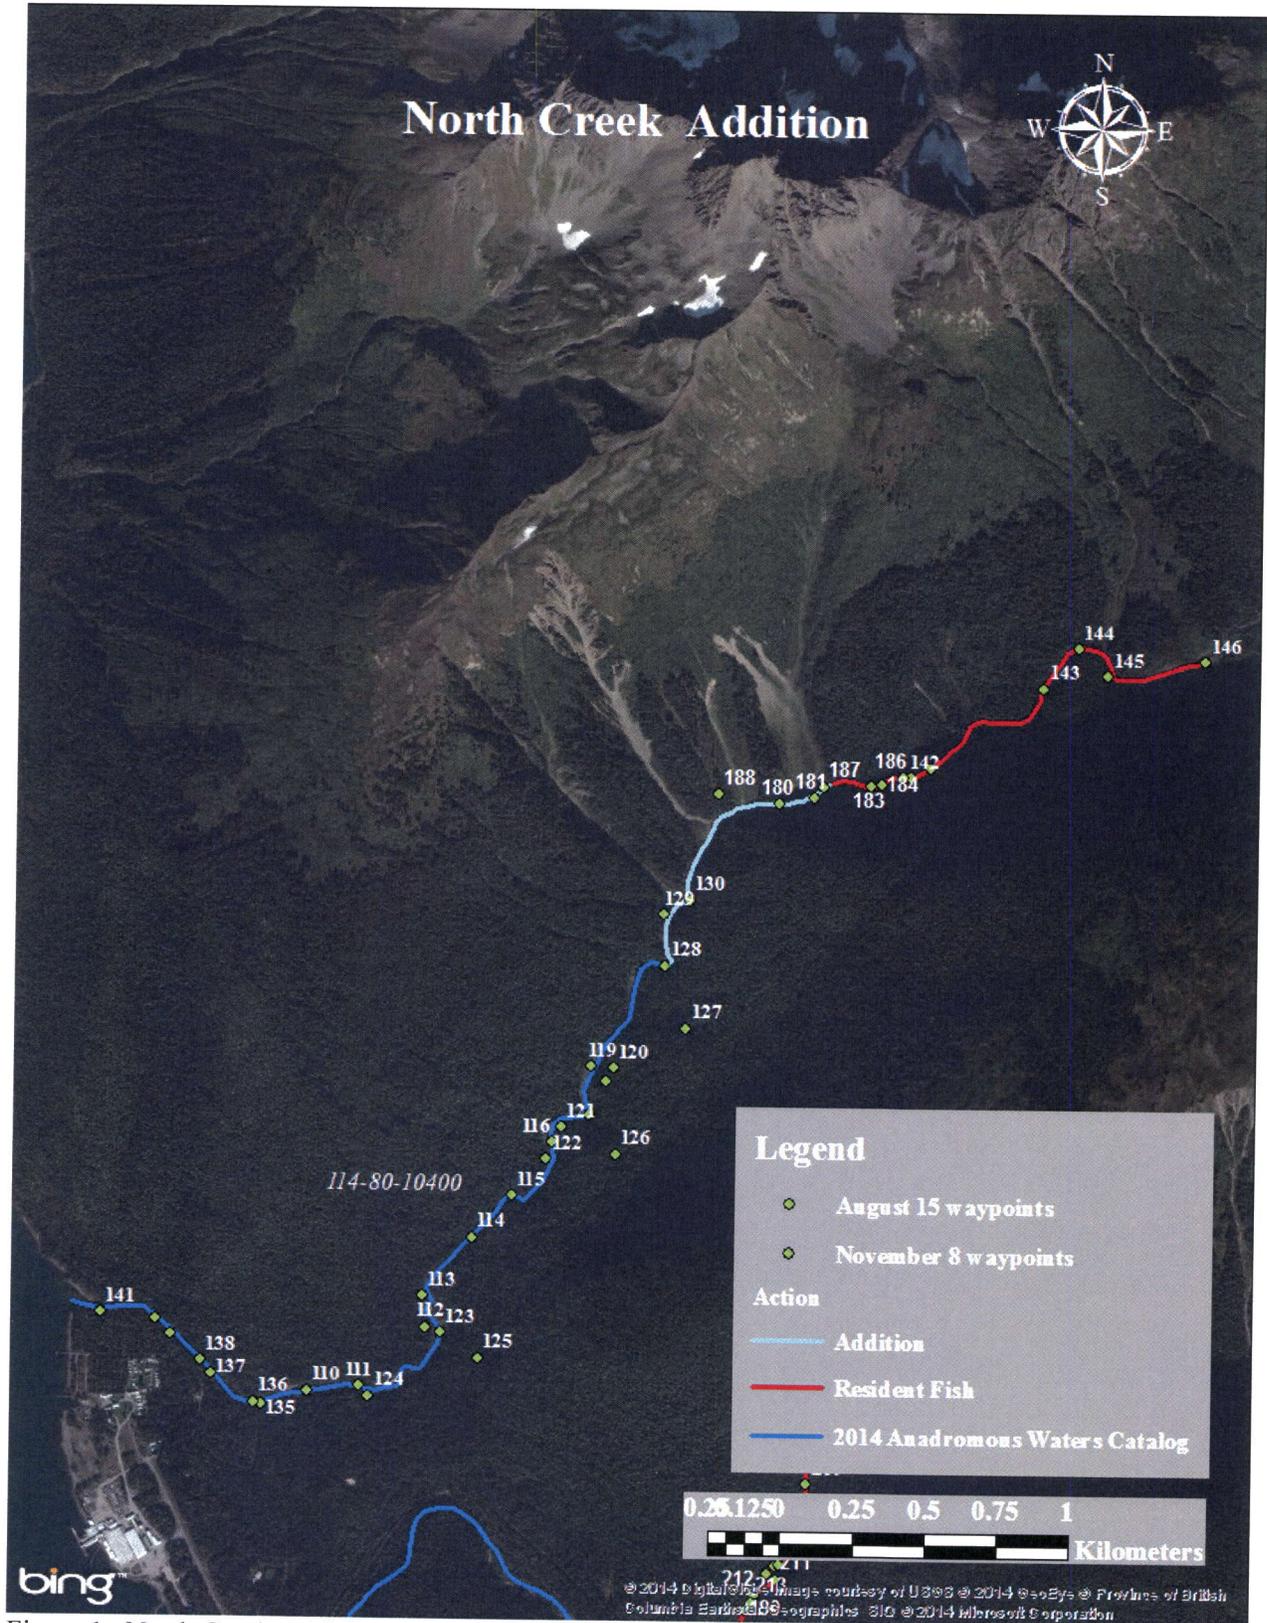
Figure 1.—North Creek Addition.

Water body name: North Creek
Water body number: 114-80-10400
Watershed: North Creek
Findings: Rearing coho.

185	58.4411	-135.3973	directly below falls.		
186	58.4408	-135.3985	7% gradient, 21.5 m. 2 Coho - 30 mm, 10 DV electrofished in calm side channel. Good habitat between	EF	2 DV
187	58.4404	-135.4037	here and snow bridge. Side channel, good rearing habitat.	EF	2 CO, 10 DV
188	58.4400	-135.4099

Recommendations: I found a mistake in my 2012 nomination and did not report the furthest upstream coho capture documented on November 7, 2012. I recommend extending the upper extent to waypoint 187 where 2 rearing CO were captured.

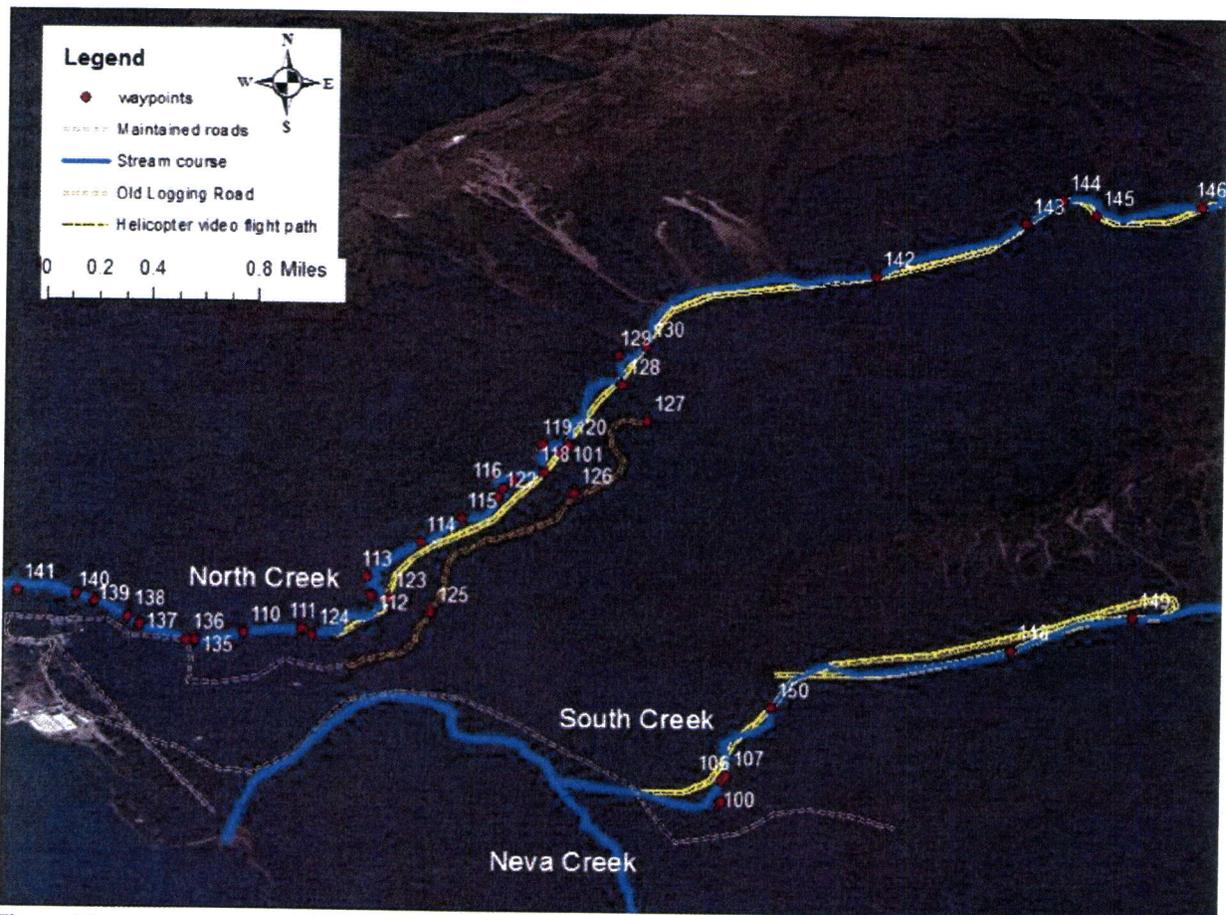
Figure 1 Map showing surveyed reaches of North and South Creeks. Waypoint numbers correspond to those on Table 1

Our South Creek foot survey spanned about 1.7 miles upstream from tidewater. In this reach, South Creek is characterized by clear, fast moving water, flowing through a steep canyon over an average gradient of 1 to 3%. A dike was used to reroute the last ¼ mile of South Creek around the town site in the 1940s. During our survey we estimated several thousand pink salmon to be present in this stretch of river; however, none were sighted upstream of the bridge at stream mile 1.3 (Figs 1&2), where gradient and channelization increase. The confluence of Neva Creek, a productive sockeye, coho and trout system, with South Creek is located at stream mile 1.1, just below the bridge (Figs 1&2). High flows and the steep canyon walls limited our foot survey to ¼ of a mile above the bridge. We electroshocked (375 volts, 30Hz, 15% duty cycle; see Table 1 and Figs 1-3 for data on all fish captures) one side channel near the top of the survey (Figs 1&3; Table 1; waypoint 106) and caught 4 Dolly Varden. There did not appear to be a barrier where the current upper extent of anadromy is recorded in ADF&G's Anadromous Waters Catalog (Figs 1&3; Table 1; waypoint 100).

Our North Creek foot survey spanned about 2.3 miles upstream from tidewater (Figs 1&2; Table 1; waypoint 130). In this reach, North Creek is characterized by clear, fast moving water, flowing through a canyon over an average gradient of 1 to 3%. Flow was 1 to 2 feet below Ordinary High Water, but was still too high to easily wade upstream and cross in most locations, making for slow progress. North Creek is currently cataloged for pink salmon presence up to about stream mile 1.7 (Figs 1&2; Table 1; waypoint 101); however, there is no barrier at this location and coho juveniles were captured upstream of here (Figs 1-3; Table 1; waypoint 128).

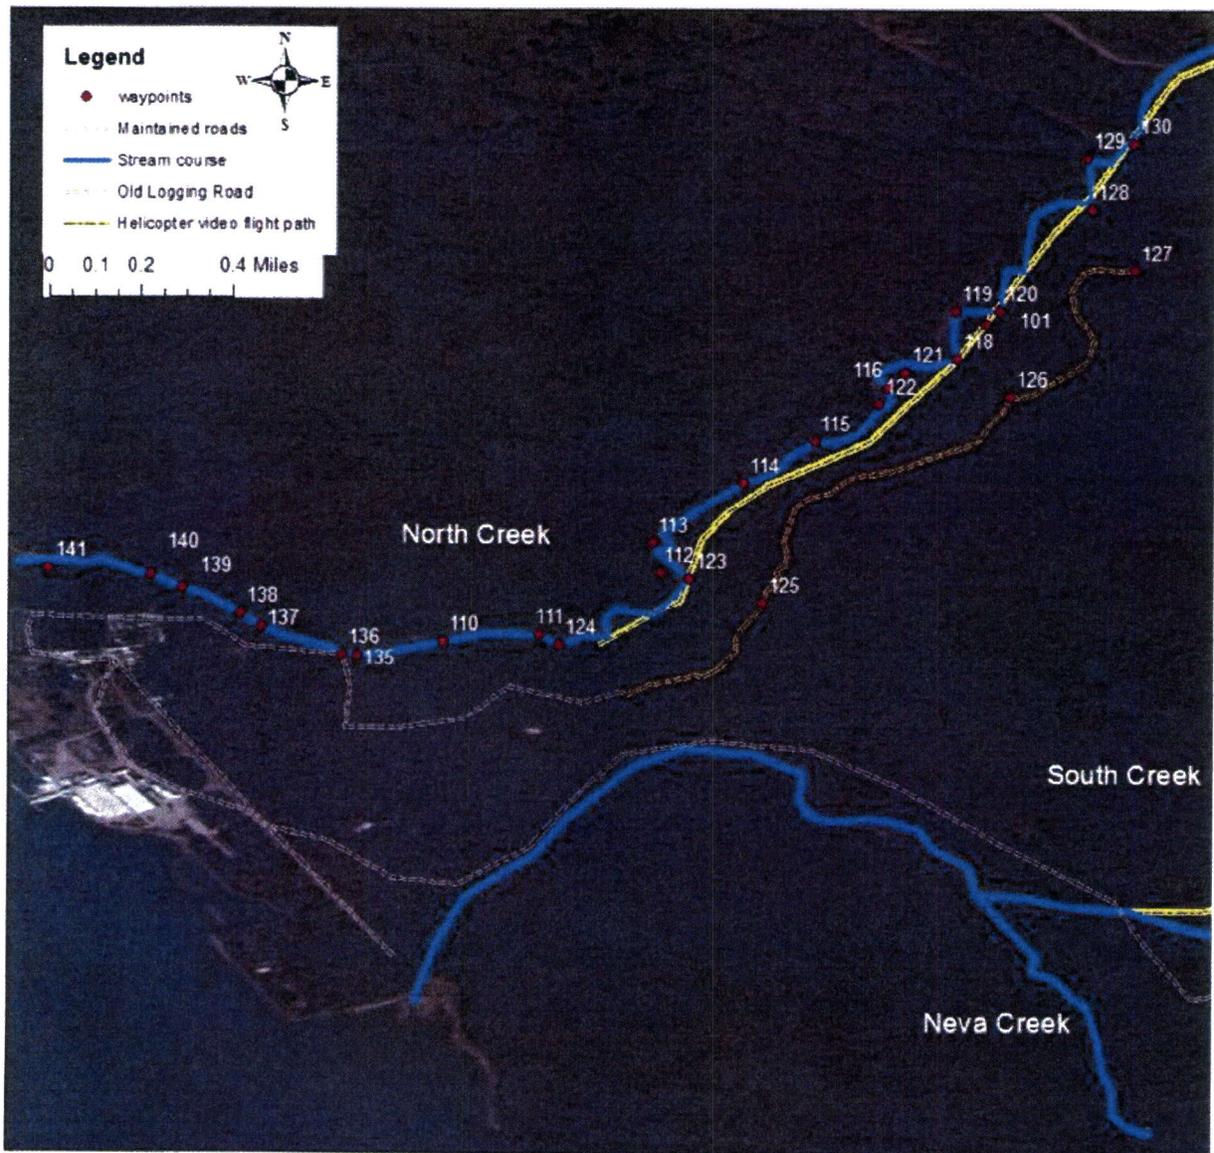
Figure 2 Lower North and South Creeks. Waypoint numbers correspond to those on Table 1.

Similar to South Creek, North Creek was rerouted around the town site with a dike by the US Army Corps of Engineers in the 1940s. Additionally, a low head dam was built upstream to create a reservoir used as part of a fire suppression system for the POW camp present where the canary now sits (Figs 1&2; Table 1; Waypoint 112). From this point down, the stream is relatively straight and side channel habitat was recorded over about 20% of the segment, including one 0.1 mile long stretch where about 40 adult pink salmon were sighted (Figs 1&2; Table 1; waypoint 139). No other adult salmon were sighted in North Creek, and locals confirm that few salmon are seen in North Creek. Upstream of this segment to the top of our foot survey, side channels (typically containing ~3 CFS of flow) were present over about 10% of the area and from that point up, gradient and channelization increased as seen in fly-over video and topographical maps.

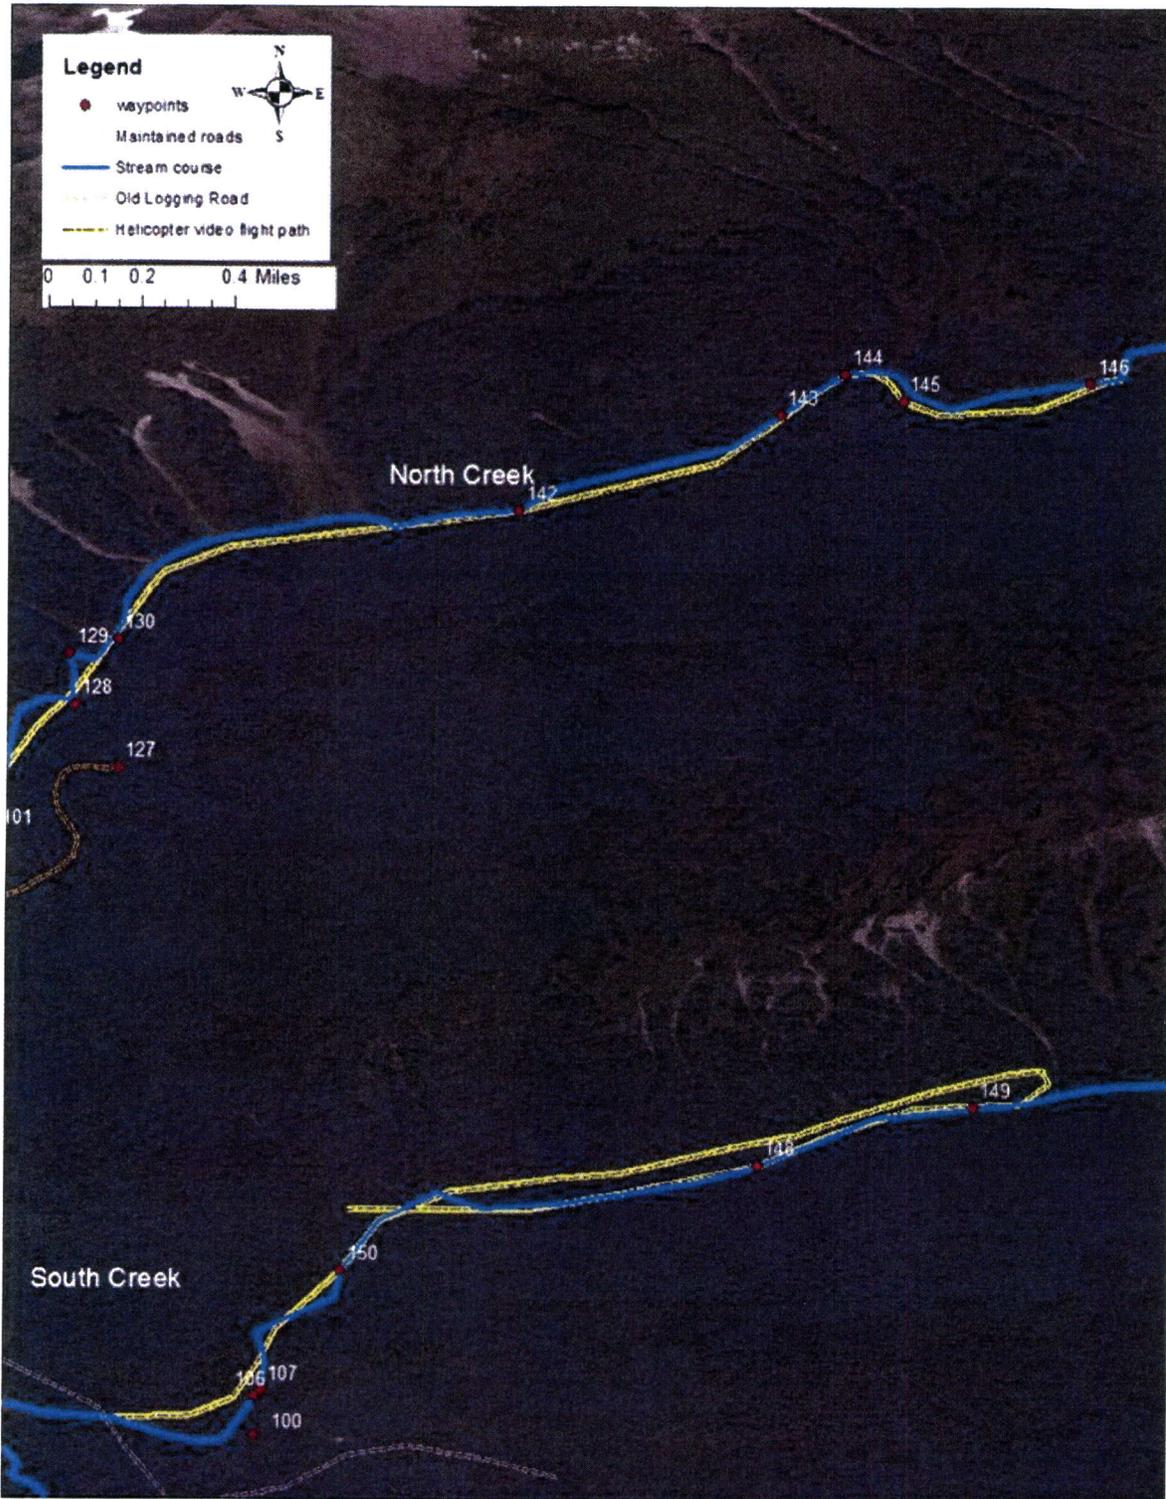
Figure 3 Upper North and South Creeks. Waypoint numbers correspond to those on Table 1.

and/or the two falls I marked during the fly-over may be a barrier to anadromous fish migration (Figs 1&3; Table 1; waypoints 148, 149), and requires additional investigation.

During the fly-over I was able to land upstream of our survey (river mile 4) and electroshock two large side channel systems (600' total length). Shocking at 450 Volts, 30Hz, and a 15% duty cycle, I captured at least 50 Dolly Varden ranging from 30 to 140mm fork length, but no coho. During the fly-over I marked four structures downstream of this site that require additional investigation as they may be barriers to upstream fish passage (Figs 1&3; Table 1; waypoints 142-145).

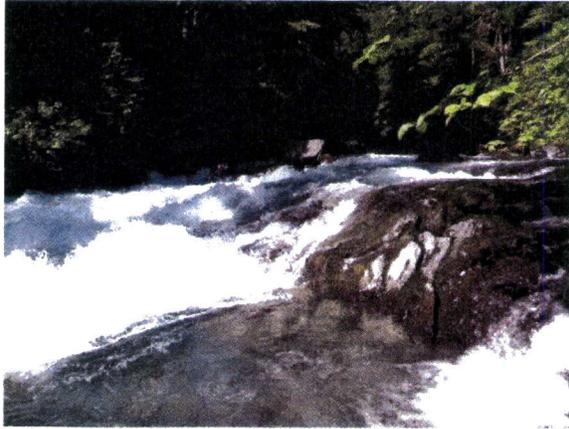
Waypoint	Notes	Fish caught	Pictures located in Appendix A
South Creek			
100	ADF&G <i>Anadromous Waters Catalog</i> top of anadromous fish presence		
106		4 Dolly Varden (DV) 30-90mm	
107	3-4' falls not a total barrier		1121
148	Potential Barrier <i>South Creek Fly-over</i>		S Creek 1

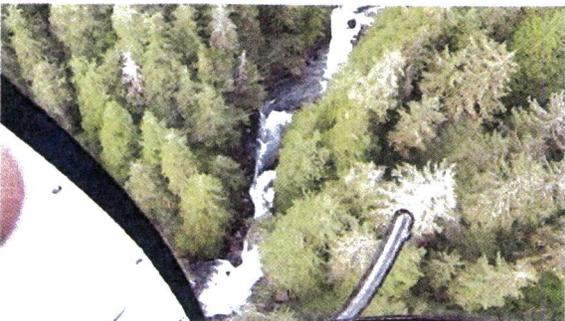
video minute 0:18		
149	Potential Barrier <i>South Creek Fly-over</i> video minute 0:54		S Creek 2
North Creek			
101	ADF&G <i>Anadromous Waters Catalog</i> top of anadromous fish presence		
110		Minnow trap Several coho (CO) juveniles	
111		1 CO, 2 DV	
112	Large Log jam, site of previous low head dam. 2-3% gradient up to here,		1125
113	Side Channel (SC)	9 DV 30-60mm, 2 CO 40, 80mm	1127
114	Some incised banks beginning		
115	2% gradient here, Lunch spot	2 CO, 6 DV	1131
116	2.5% gradient over 200'	2 CO	1132, 1133
118	SC with about 3 Cubic Feet per Second (CFS) of flow	CO numerous	1135
119	Long SC with ~ 30 CFS		1136
120	Top of survey day 1	8" DV hook and line	1138
121	Small tributary		1141
122	Small SC		
123	Good SC and rearing		1143
124	Old dam site and penstock support		1145
125	Old logging road start		
126	Remnant building		
127	High gradient trib. that was followed to stream		
128	SC Top of anadromous fish capture	2 CO, 4 DV	1148

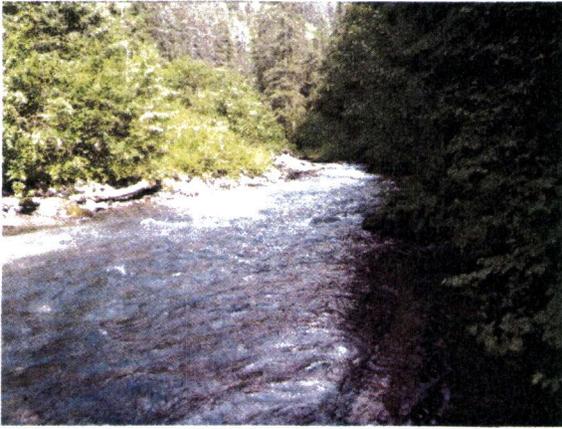
129	Bottom of slide at left		1150
130	Top of survey, no barrier present. Typical substrate along survey reach pictured		1152, 1153
135	XIP winter water intake site		
136	SC		
137	Concrete footing, excellent rearing habitat here		1173
138	Start of 0.1 mile SC	~40 adult pinks, some digging redds	1175
139	SC		1176
140	Crossing cable and SC		1177
141	Tidewater falls, below mean		1178

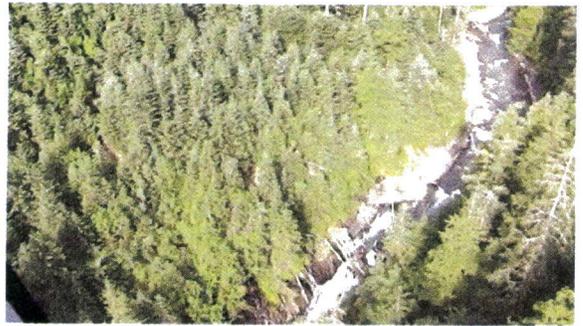
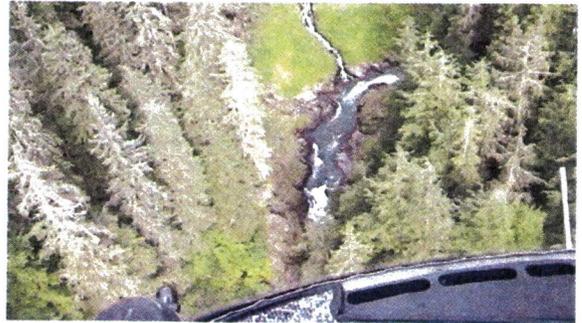
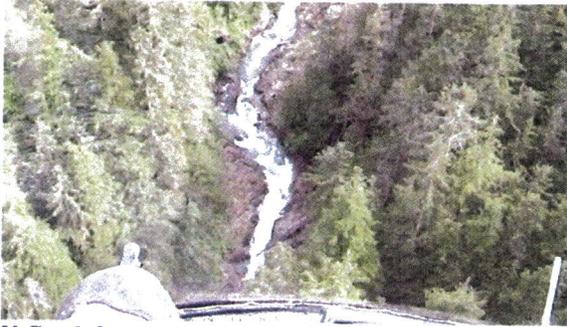
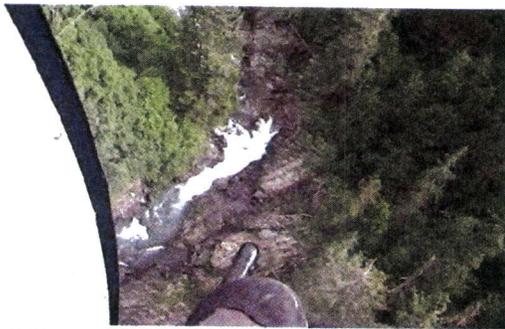
142	Potential Barrier <i>North Creek Fly-over</i> video minute 1:38		N Creek 1
143	Potential Barrier <i>North Creek Fly-over</i> video minute 2:11		N Creek 2
144	Potential Barrier <i>North Creek Fly-over</i> video minute 2:21		N Creek 3
145	Potential Barrier <i>North Creek Fly-over</i> video minute 2:30		N Creek 4
146	Landing site and SCs <i>North Creek Fly-over</i> video minute 2:58		N Creek 5
