Nomination Form
Anadromous Waters Catalog

Anadromous Waters Catalog Number of Waterway 251-82-10050-2026-3020

Name of Waterway Unnamed Stream USGS Name Local Name
 Addition Deletion Correction Backup Information

SUBJECT: AKSSF AWC Survey: Afognak Island
July 2012

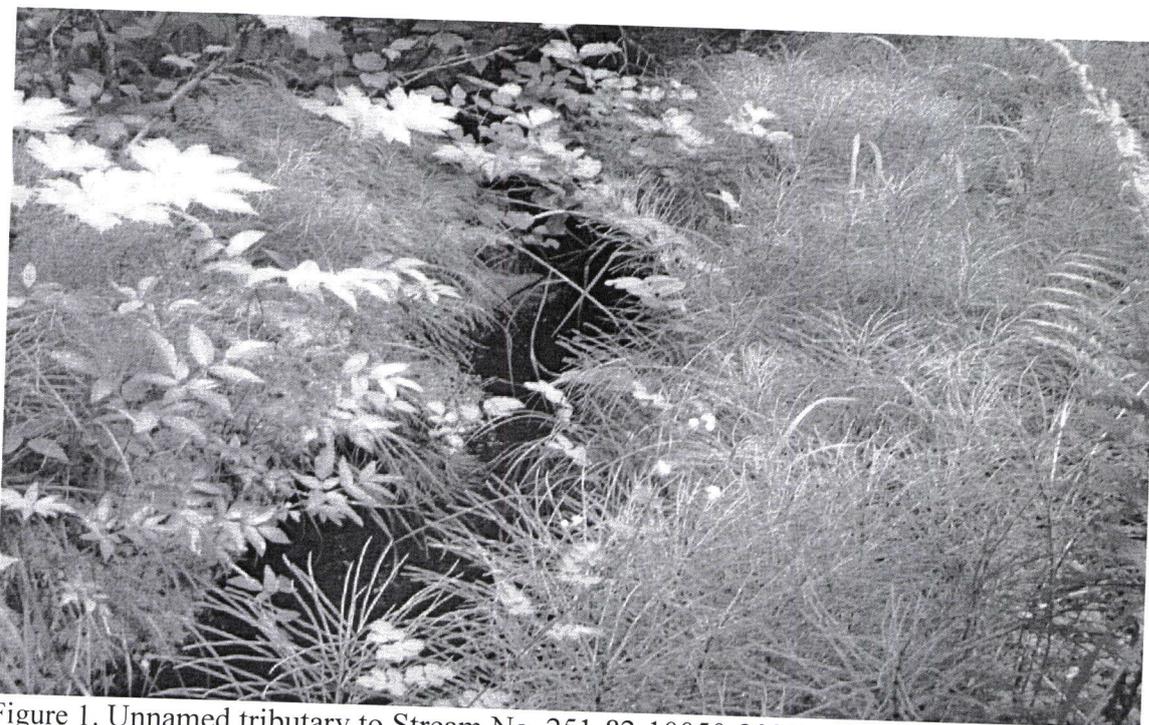
Figure 1. Unnamed tributary to Stream No. 251-82-10050-2026.

On July 9, 2012, Mr. Coulter, Mr. Bales and I drove from the Evergreen Camp to the 710 Road mile post (MP) 0.2. We located an unnamed tributary to Stream No. 251-82-10050-2026 that flows into Portage River (Figure 1). At about 2:00 p.m., we walked down the stream below the road using an electrofisher to sample the stream. I used a hand held Garmin Global Positioning System (GPS) unit to map the stream course of the sampled 1,000 foot reach. The stream is located at Section 18, Township 22 South, Range 19 West, Seward Meridian. Sampling below the road captured 6 juvenile coho salmon (25 to 75 mm fork length (FL)) and 10 Dolly Varden (25 to 95 mm FL). The unnamed stream will be nominated to the Anadromous Waters Catalog.

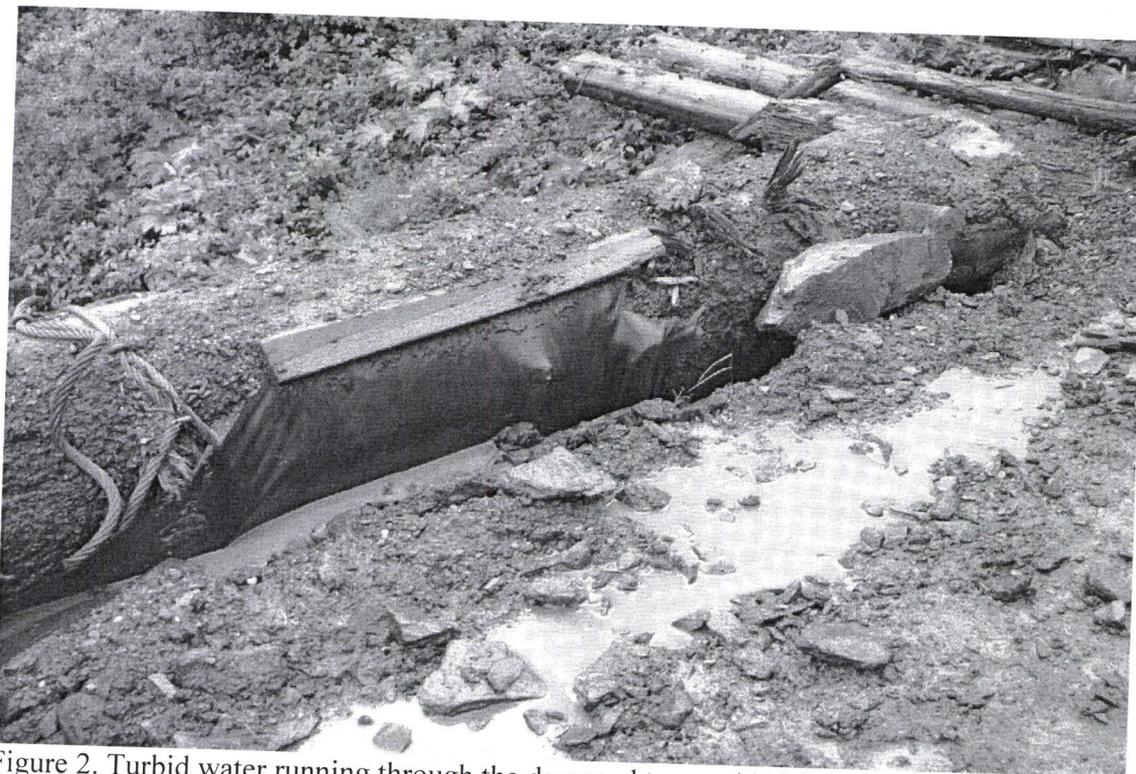
While returning to camp on the 1100 road, we stopped at a log bridge at MP 6.5. The bridge is upstream of the specified reach of Stream No. 252-33-10010-2006. We observed turbid water running down the road and flowing through damaged tyrap sediment barrier along the bridge bull rails into the creek (Figures 2 and 3). I requested that the operator responsible for maintaining the road (Evergreen Timber) remove the damaged tyrap and replace it with material that will not allow sediment to flow into the creek.

Figure 2. Turbid water running through the damaged typar. 1100 Road MP 6.5.

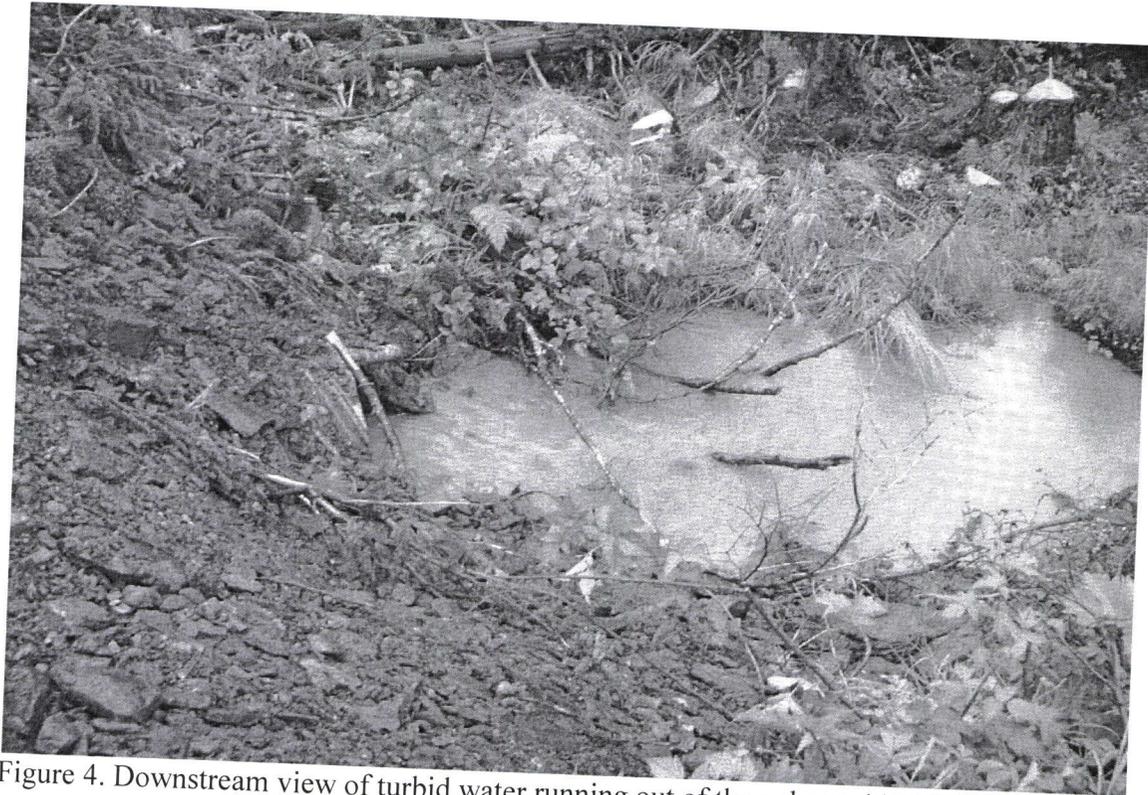
We drove the 1100 road to MP 6.0. A culvert is located in an unnamed stream upstream of the specified reach of Stream No. 252-33-10010-2004-3020. The stream flows into Lilly Lake. We observed turbid water running off the road into the creek (Figures 4 and 5). During my May 2012 site visit, I observed turbid water from this location in the specified portion of the waterbody originating from this location. I observed a log was recently placed on the side of the

road and unscreened fill was placed on both sides of the road above the culvert. Turbid water was running under the log into the creek. A small sediment basin was installed on the downstream side of the road adjacent to the creek. Turbid water was flowing out of the basin into the creek. The Division of Forestry and Department of Environmental Conservation visited this site in June 2012. They recommended best management practices should be used to address the turbidity in the stream. Turbid water entering a specified waterbody is a violation of Alaska Statute (AS) 16.05.871. The road is being maintained by Evergreen Timber. The ADF&G requested Evergreen Timber take immediate action to address the turbidity. If the turbidity source is not remedied within 30 days, the ADF&G may pursue legal action to correct the violation of AS 16.05.871.

Figure 4. Downstream view of turbid water running out of the culvert. 1100 Road MP 6.0.

On the morning of July 10, 2012, Mr. Harris, Mr. Bybee, Mr. Bales, and I drove to the 1100 Road MP 6.0 to discuss a solution to the turbidity. We agreed that there were two options available. The first option is to install a cross drainage culvert under both sides of the road about 75 to 100 feet from the creek and install larger sediment basins below the culverts. The second option is to move the road downstream about 100 feet and install a log bridge. This option will straighten the road and allow sediment to be managed with less maintenance.

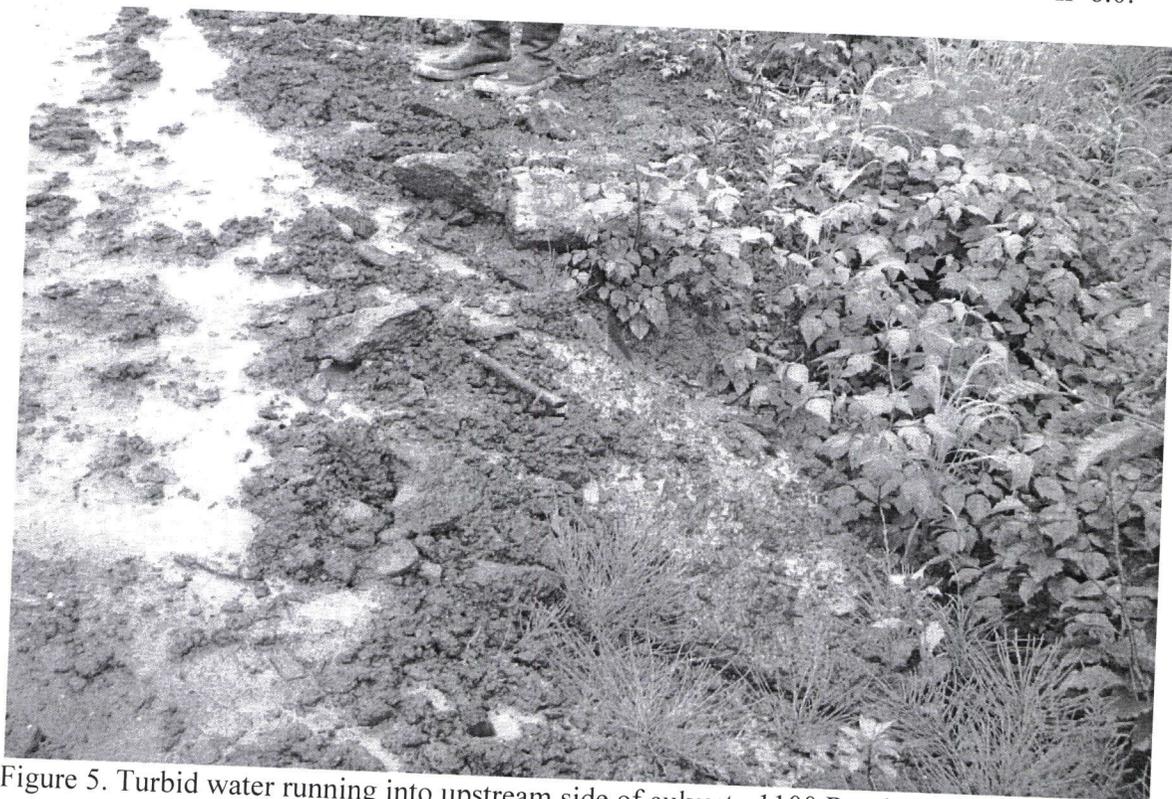
Figure 5. Turbid water running into upstream side of culvert. 1100 Road MP 6.0.

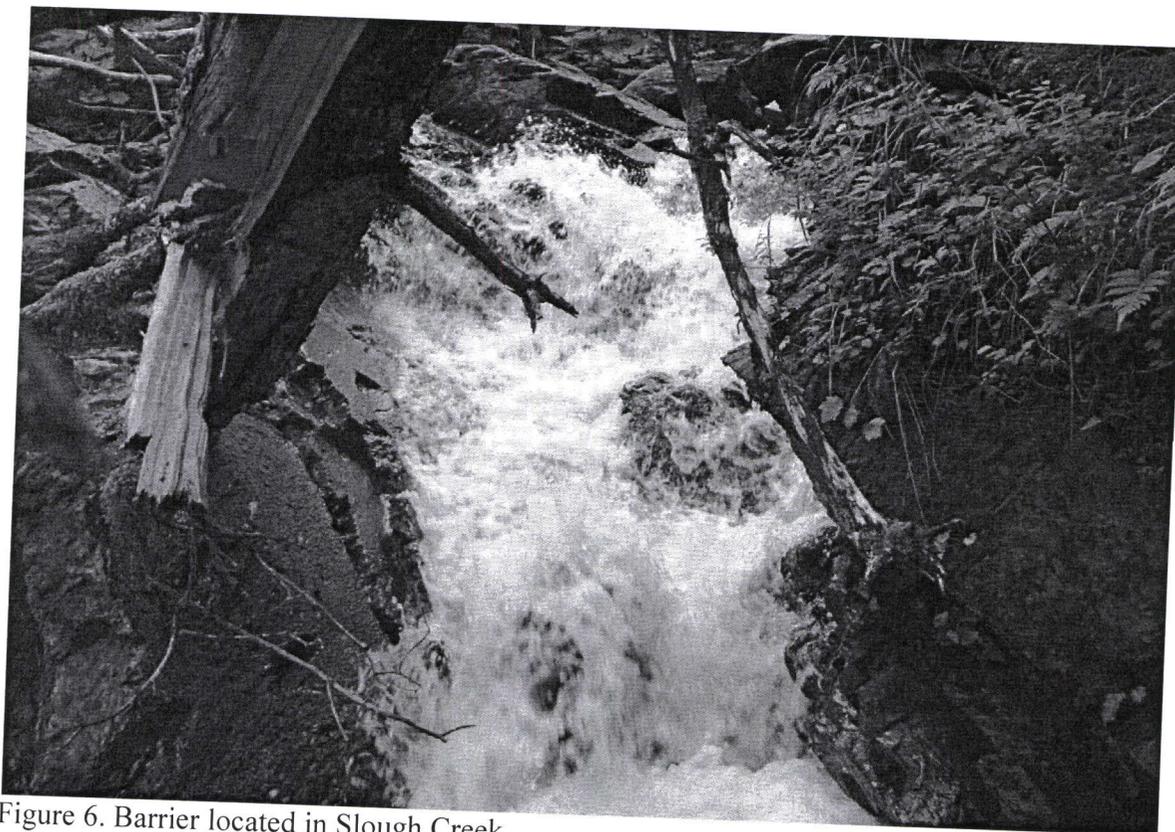
ANC is planning to harvest units in the Discoverer Bay watershed. Mr. Bybee, Mr. Bales, and I located Stream No. 251-82-10057-2005. The stream location is incorrectly depicted in the Anadromous Waters Catalog. The stream flows under the 1100 Road through a perched 42-inch diameter culvert. The stream enters Slough Creek (Stream No. 251-82-10057) about 670 feet below the 1100 Road. I walked the specified stream reach using a hand held Garmin GPS unit to identify the correct location. The stream is located at Section 34, Township 21 South, Range 19 West, Seward Meridian. We walked up Slough Creek about 2,500 linear feet to a 10-foot high barrier (Figure 6). The barrier location is not identified in the Anadromous Waters Catalog. We walked downstream to Stream No. 251-82-10057-2009. The stream location is incorrectly depicted in the Anadromous Waters Catalog. I used a hand held Garmin GPS unit to identify the correct location. The corrected stream locations and the barrier location will be nominated for updates to the Anadromous Waters Catalog.

Figure 6. Barrier located in Slough Creek.

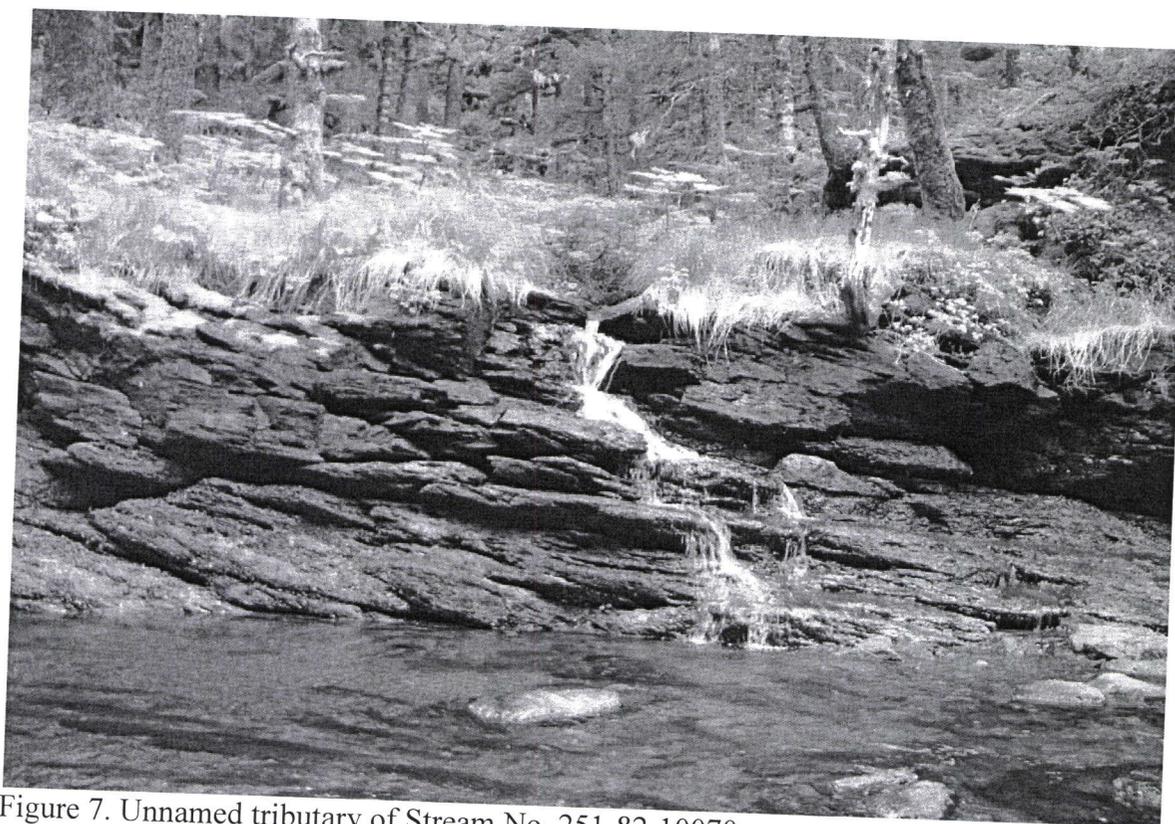
On the morning of July 11, we returned to Stream No. 251-82-10070. We sampled an unnamed tributary below the 1100 Road. An 8-foot high barrier is located about 80 feet from Stream No. 251-82-10070. We sampled about 600 feet above the barrier. We captured 7 Dolly Varden. No length measurements were taken for the Dolly Varden. No salmon were captured or observed.

Figure 7. Unnamed tributary of Stream No. 251-82-10070.
