Nomination Form
Anadromous Waters Catalog

Region Southwest USGS Quad(s) Afognak B-2
 Anadromous Waters Catalog Number of Waterway 251-82-10057
 Name of Waterway Slough Creek USGS Name Local Name
 Addition Deletion Correction Backup Information

SUBJECT: AKSSF AWC Survey: Afognak Island
July 2012

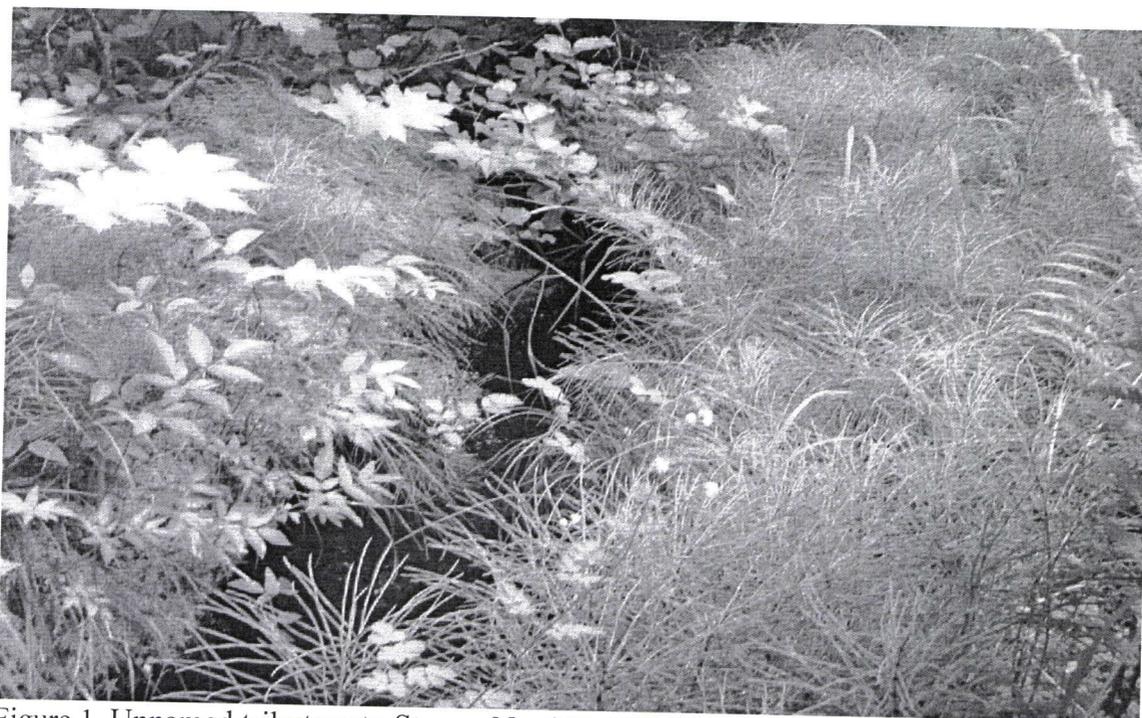
On July 9, 2012, Mr. Coulter, Mr. Bales and I drove from the Evergreen Camp to the 710 Road mile post (MP) 0.2. We located an unnamed tributary to Stream No. 251-82-10050-2026 that flows into Portage River (Figure 1). At about 2:00 p.m., we walked down the stream below the road using an electrofisher to sample the stream. I used a hand held Garmin Global Positioning System (GPS) unit to map the stream course of the sampled 1,000 foot reach. The stream is located at Section 18, Township 22 South, Range 19 West, Seward Meridian. Sampling below the road captured 6 juvenile coho salmon (25 to 75 mm fork length (FL)) and 10 Dolly Varden (25 to 95 mm FL). The unnamed stream will be nominated to the Anadromous Waters Catalog.

Figure 1. Unnamed tributary to Stream No. 251-82-10050-2026.

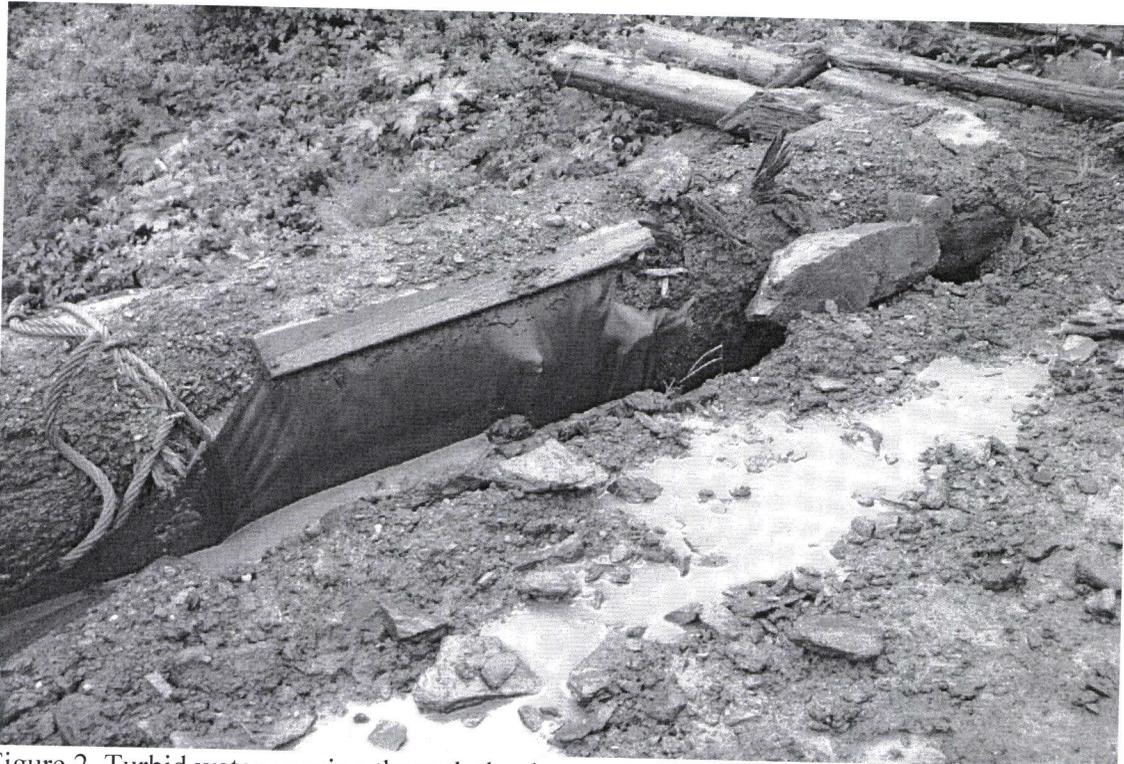
While returning to camp on the 1100 road, we stopped at a log bridge at MP 6.5. The bridge is upstream of the specified reach of Stream No. 252-33-10010-2006. We observed turbid water running down the road and flowing through damaged typar sediment barrier along the bridge bull rails into the creek (Figures 2 and 3). I requested that the operator responsible for maintaining the road (Evergreen Timber) remove the damaged typar and replace it with material that will not allow sediment to flow into the creek.

Figure 2. Turbid water running through the damaged tyrod. 1100 Road MP 6.5.

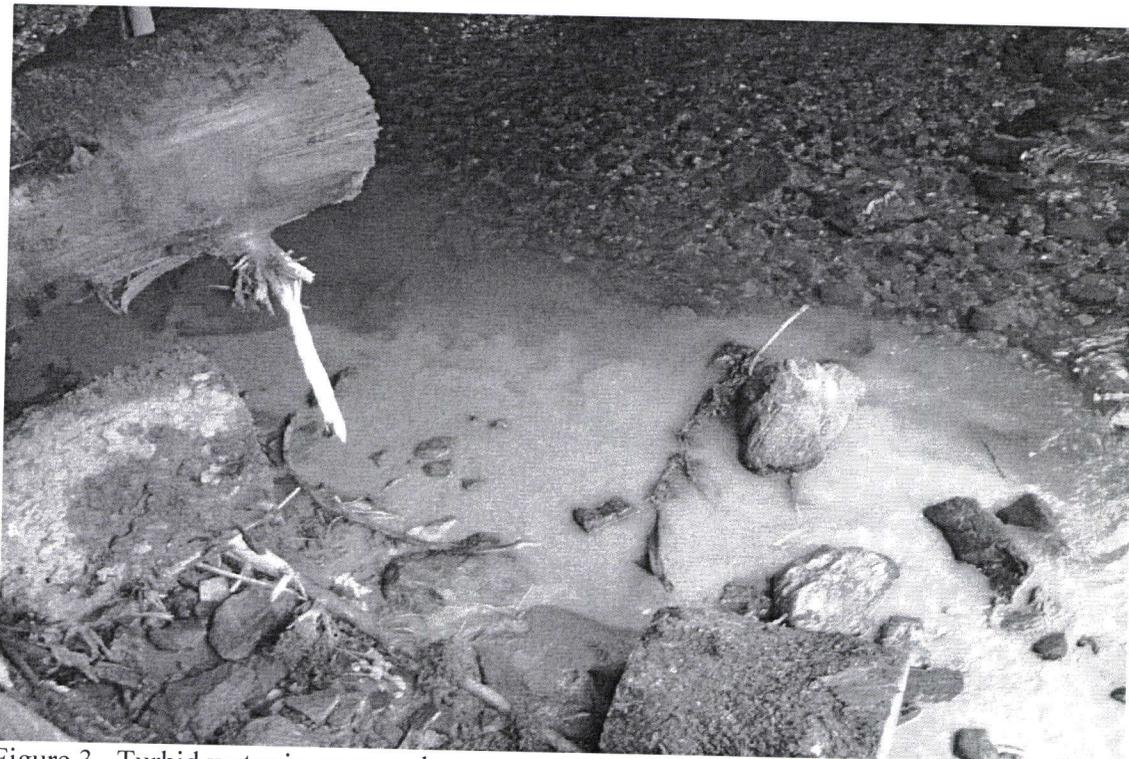
Figure 3. Turbid water in unnamed stream. 1100 Road MP 6.5.

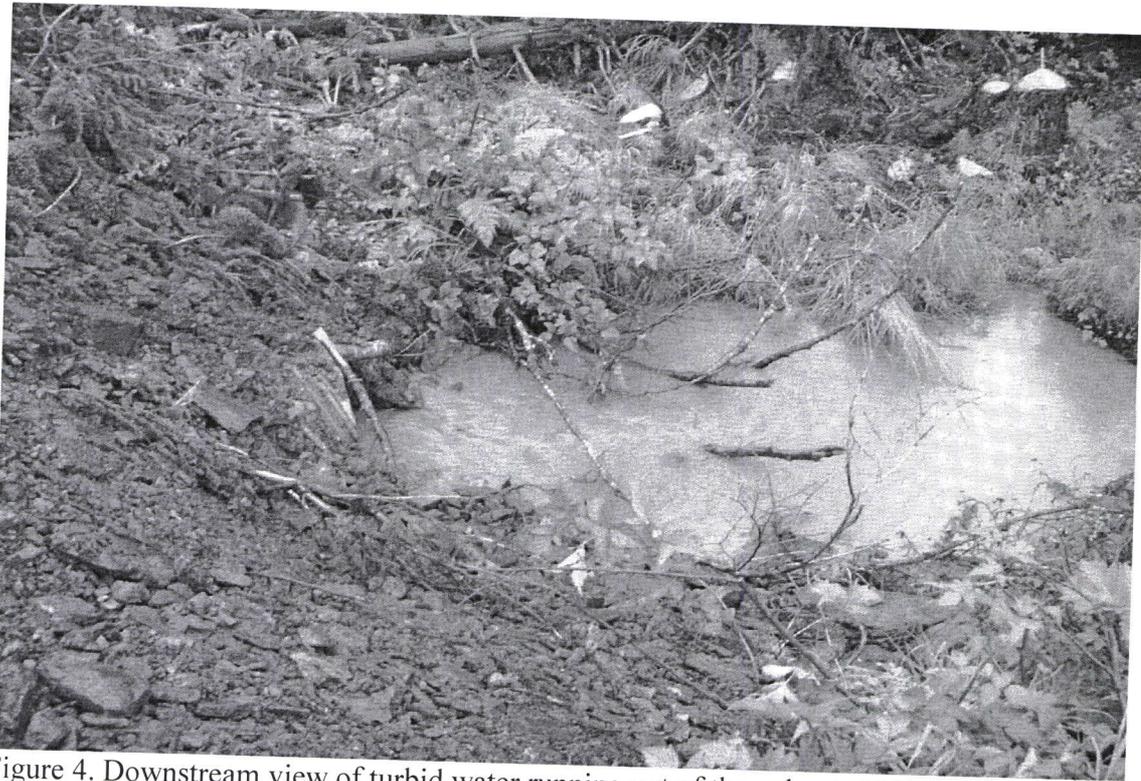
We drove the 1100 road to MP 6.0. A culvert is located in an unnamed stream upstream of the specified reach of Stream No. 252-33-10010-2004-3020. The stream flows into Lilly Lake. We observed turbid water running off the road into the creek (Figures 4 and 5). During my May 2012 site visit, I observed turbid water from this location in the specified portion of the waterbody originating from this location. I observed a log was recently placed on the side of the

road and unscreened fill was placed on both sides of the road above the culvert. Turbid water was running under the log into the creek. A small sediment basin was installed on the downstream side of the road adjacent to the creek. Turbid water was flowing out of the basin into the creek. The Division of Forestry and Department of Environmental Conservation visited this site in June 2012. They recommended best management practices should be used to address the turbidity in the stream. Turbid water entering a specified waterbody is a violation of Alaska Statute (AS) 16.05.871. The road is being maintained by Evergreen Timber. The ADF&G requested Evergreen Timber take immediate action to address the turbidity. If the turbidity source is not remedied within 30 days, the ADF&G may pursue legal action to correct the violation of AS 16.05.871.

Figure 4. Downstream view of turbid water running out of the culvert. 1100 Road MP 6.0.

On the morning of July 10, 2012, Mr. Harris, Mr. Bybee, Mr. Bales, and I drove to the 1100 Road MP 6.0 to discuss a solution to the turbidity. We agreed that there were two options available. The first option is to install a cross drainage culvert under both sides of the road about 75 to 100 feet from the creek and install larger sediment basins below the culverts. The second option is to move the road downstream about 100 feet and install a log bridge. This option will straighten the road and allow sediment to be managed with less maintenance.

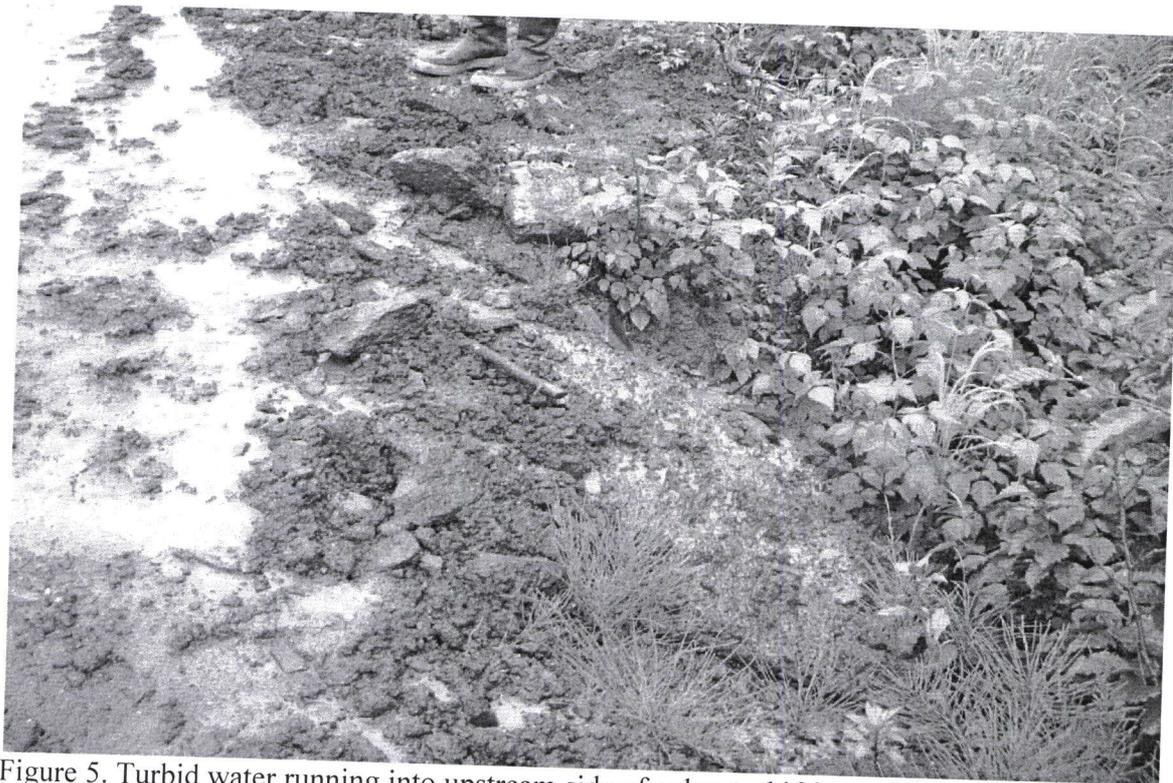
Figure 5. Turbid water running into upstream side of culvert. 1100 Road MP 6.0.

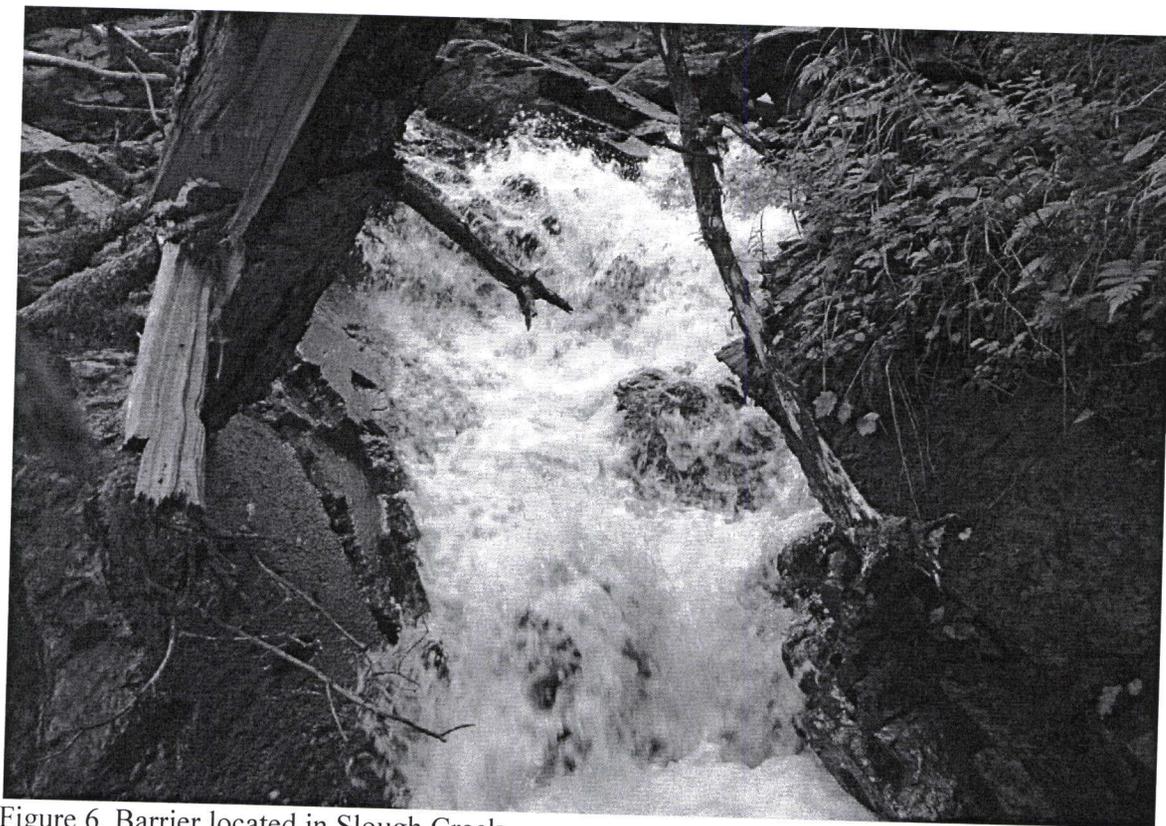
ANC is planning to harvest units in the Discoverer Bay watershed. Mr. Bybee, Mr. Bales, and I located Stream No. 251-82-10057-2005. The stream location is incorrectly depicted in the Anadromous Waters Catalog. The stream flows under the 1100 Road through a perched 42-inch diameter culvert. The stream enters Slough Creek (Stream No. 251-82-10057) about 670 feet below the 1100 Road. I walked the specified stream reach using a hand held Garmin GPS unit to identify the correct location. The stream is located at Section 34, Township 21 South, Range 19 West, Seward Meridian. We walked up Slough Creek about 2,500 linear feet to a 10-foot high barrier (Figure 6). The barrier location is not identified in the Anadromous Waters Catalog. We walked downstream to Stream No. 251-82-10057-2009. The stream location is incorrectly depicted in the Anadromous Waters Catalog. I used a hand held Garmin GPS unit to identify the correct location. The corrected stream locations and the barrier location will be nominated for updates to the Anadromous Waters Catalog.

Figure 6. Barrier located in Slough Creek.

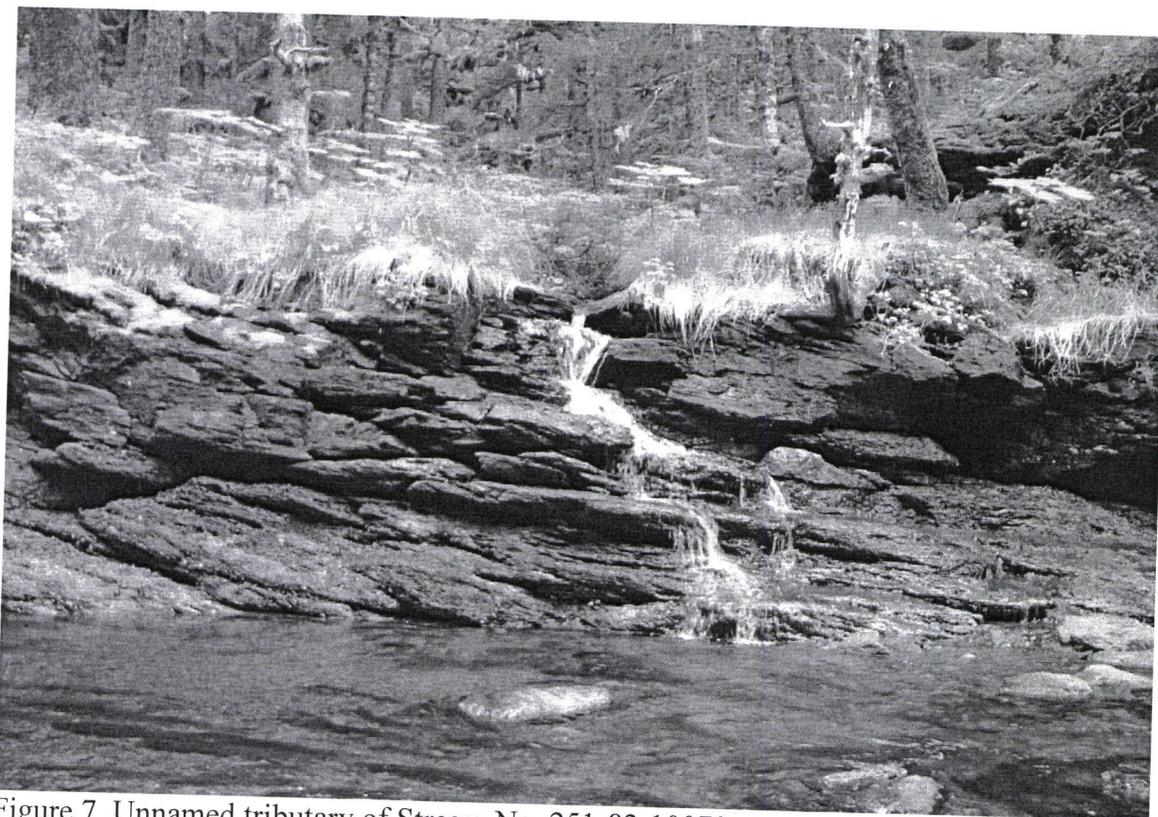
On the morning of July 11, we returned to Stream No. 251-82-10070. We sampled an unnamed tributary below the 1100 Road. An 8-foot high barrier is located about 80 feet from Stream No 251-82-10070. We sampled about 600 feet above the barrier. We captured 7 Dolly Varden. No length measurements were taken for the Dolly Varden. No salmon were captured or observed.

Figure 7. Unnamed tributary of Stream No. 251-82-10070.

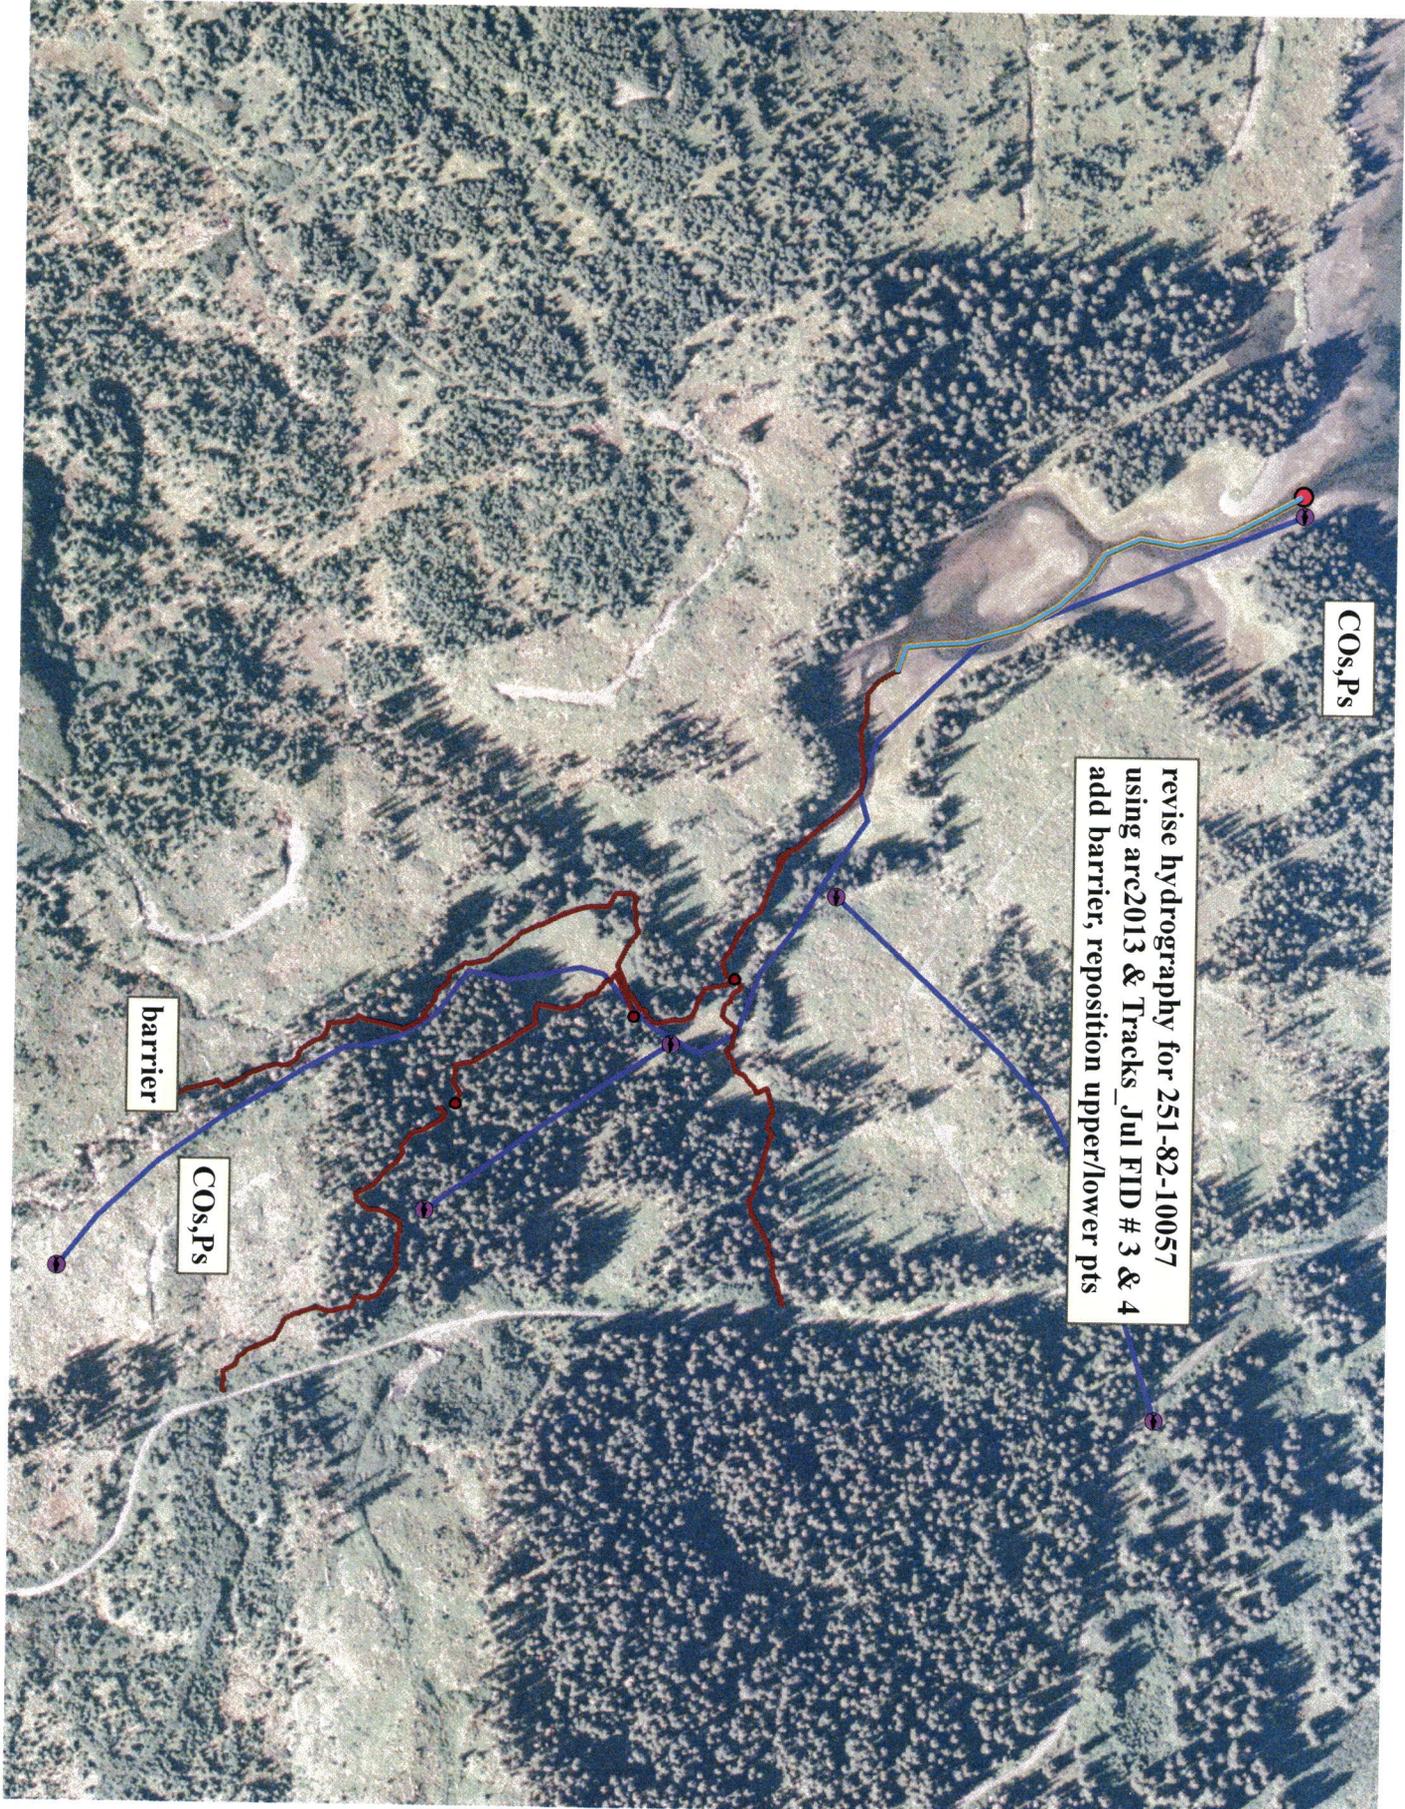
revise hydrography for 251-82-10057
using arc2013 & Tracks_Jul FID # 3 & 4
add barrier, reposition upper/lower pts

barrier
