State of Alaska
Department of Fish and Game
Division of Sport Fish

Nomination Form
Anadromous Waters Catalog

Region Southwest USGS Quad(s) Afognak A-2
 Anadromous Waters Catalog Number of Waterway 252-32-10010-2028
 Name of Waterway Unnamed Tributary Little Afognak Lake USGS Name Local Name
 Addition Deletion Correction Backup Information

SUBJECT: AKSSF AWC Survey: Afognak Island
October 2012

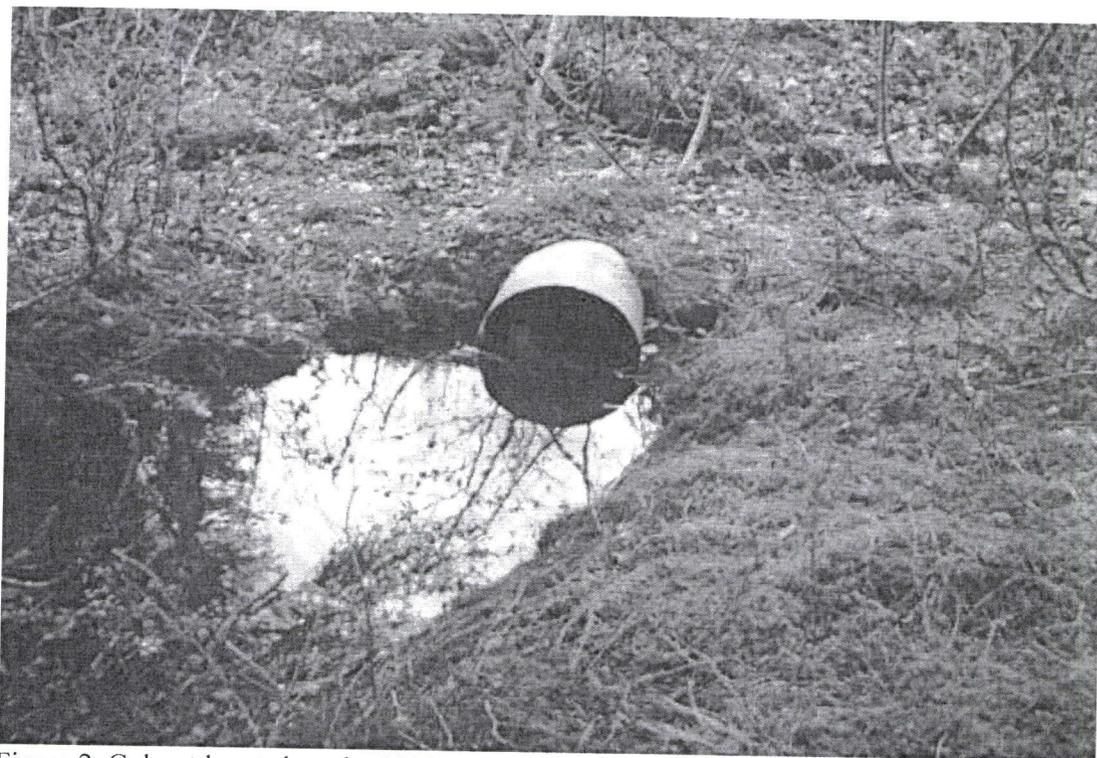
We drove to MP 9.9. I sampled about 800 linear feet above the specified reach of Stream No. 251-40-10030-2040 to the 1110 Road. I did not capture or observe any fish. At the road, I observed a 24-inch diameter culvert (Figure 2). The culvert may be a barrier to fish passage. I sampled about 300 linear feet above the road. I captured one Dolly Varden. No length

Figure 2. Culvert located on the 1110 Road MP 9.9.

measurement was taken for the Dolly Varden. Stream No. 251-40-10030-2040 will be re-sampled in 2013. The purpose of the new survey will be to correct the geographic stream location and sample for juvenile salmon during the summer.

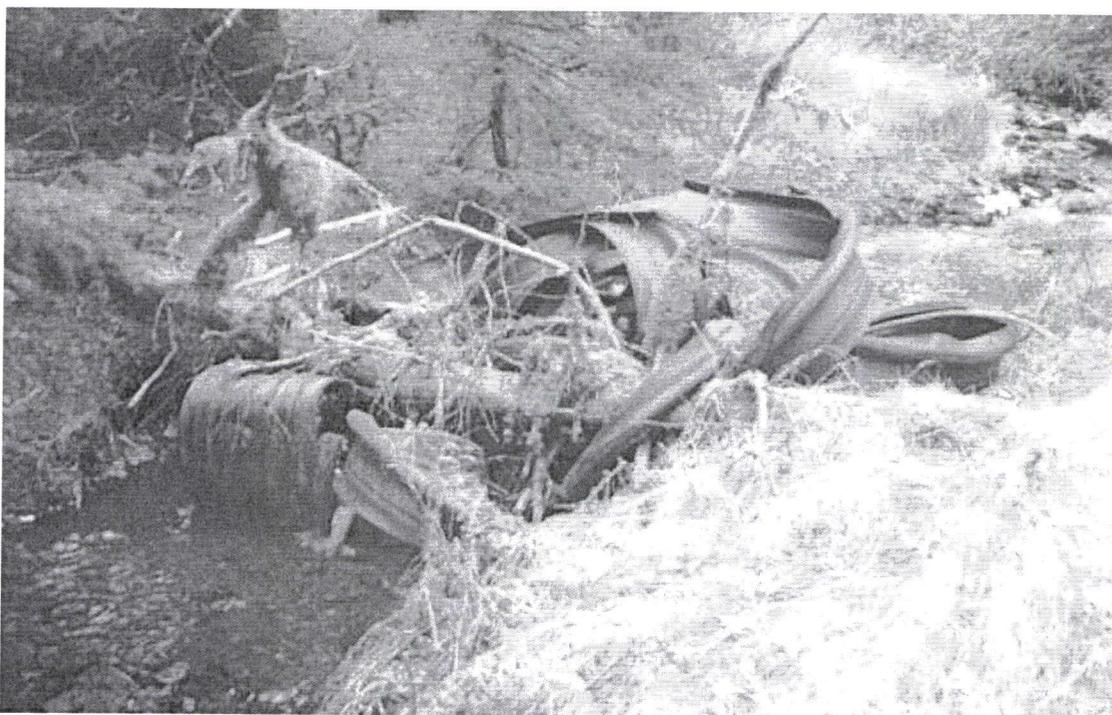
We drove to MP 9.7. I sampled about 400 linear feet above the specified reach of Stream No. 251-40-10030 to the 1110 Road. I captured one juvenile coho salmon. No length measurement was taken for the coho salmon. About 100 feet below the 1110 road, I observed a failed plastic culvert buried in the streambed and blocking fish passage (Figure 3). The culvert may be a complete barrier to fish passage. I sampled about 200 linear feet above the road. I captured 10 Dolly Varden. No length measurements were taken for the Dolly Varden. Stream No. 251-40-10030 will be re-sampled in 2013. The purpose of the new survey will be to correct the geographic stream location and sample for juvenile salmon during the summer. By November 1, 2012, the failed culvert was removed from the stream.

Figure 3. Failed culvert located below the 1110 Road MP 9.7.

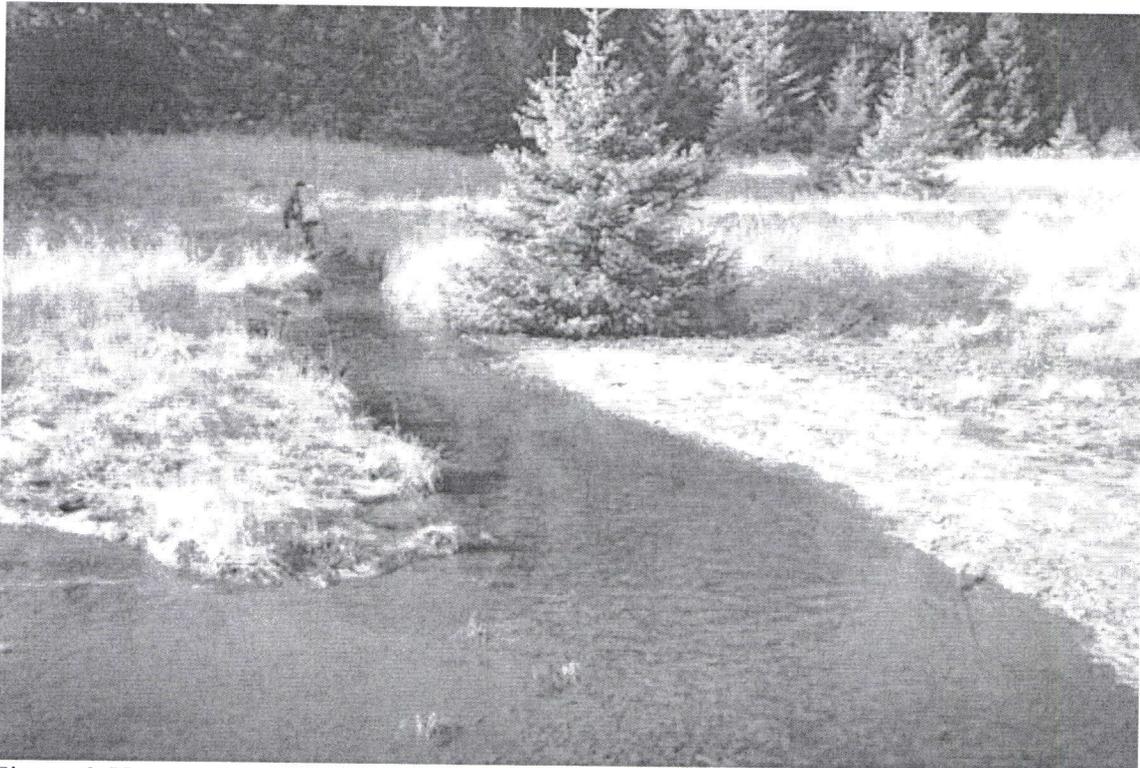
At MP 2.8, we located a 24-inch diameter culvert. I walked to Paramanof Lake and sampled an unnamed stream that flows into the lake about 1,500 linear feet below the road (Figure 6). I captured 8 juvenile coho salmon (45 to 70 mm FL) and 10 Dolly Varden (30 to 175 mm FL). The unnamed stream will be nominated to the Anadromous Waters Catalog. The ADF&G recommends that the culvert be removed and a log stringer bridge installed.

Figure 6. Unnamed stream above Paramanof Lake below the 1125 Road MP 2.8.

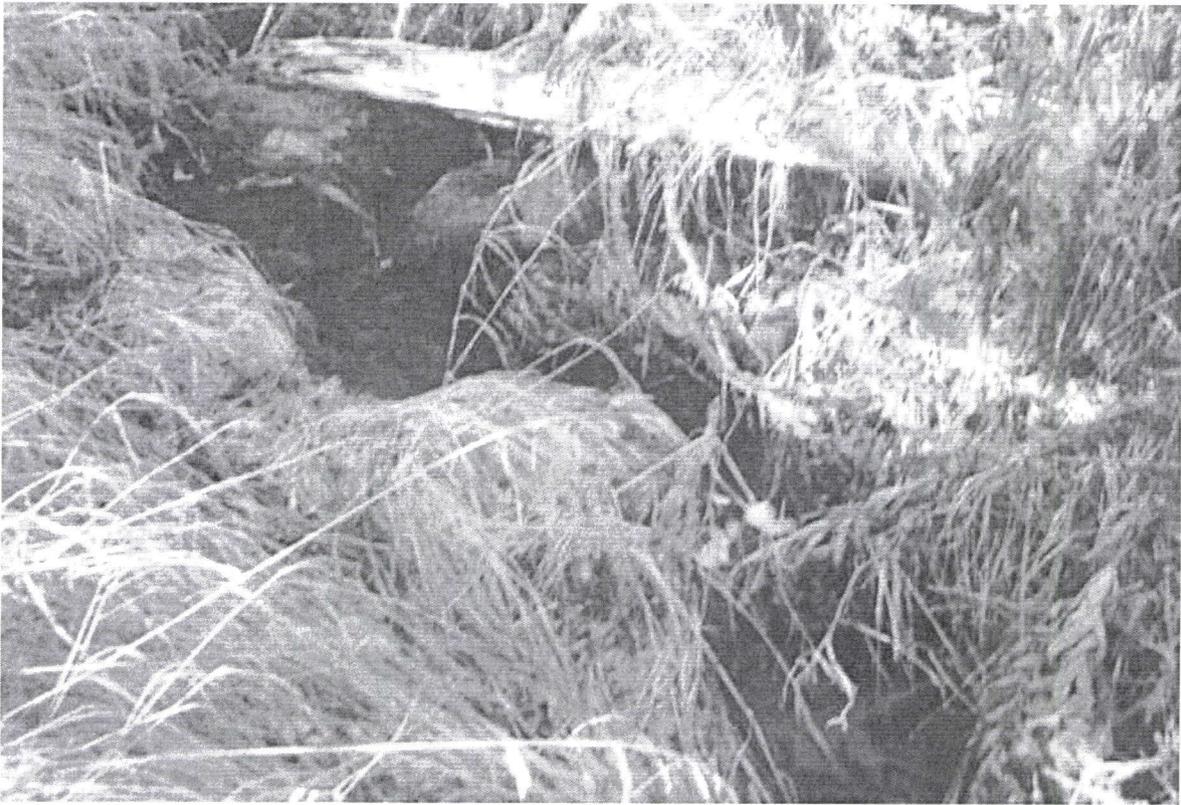
At MP 3.2, we located a 24-inch diameter culvert. An unnamed stream about 3-feet wide flows through the culvert (Figure 7). The stream enters Stream No. 251-40-10030 about 1,300 linear feet below the road. I sampled about 450 linear feet of the stream below the road. I captured one Dolly Varden. No length measurement was taken for the Dolly Varden. The stream will be re-sampled in 2013. The ADF&G has no recommendation for the culvert until additional sampling is completed in 2013.

Figure 7. Unnamed stream below the 1125 Road MP 3.2.

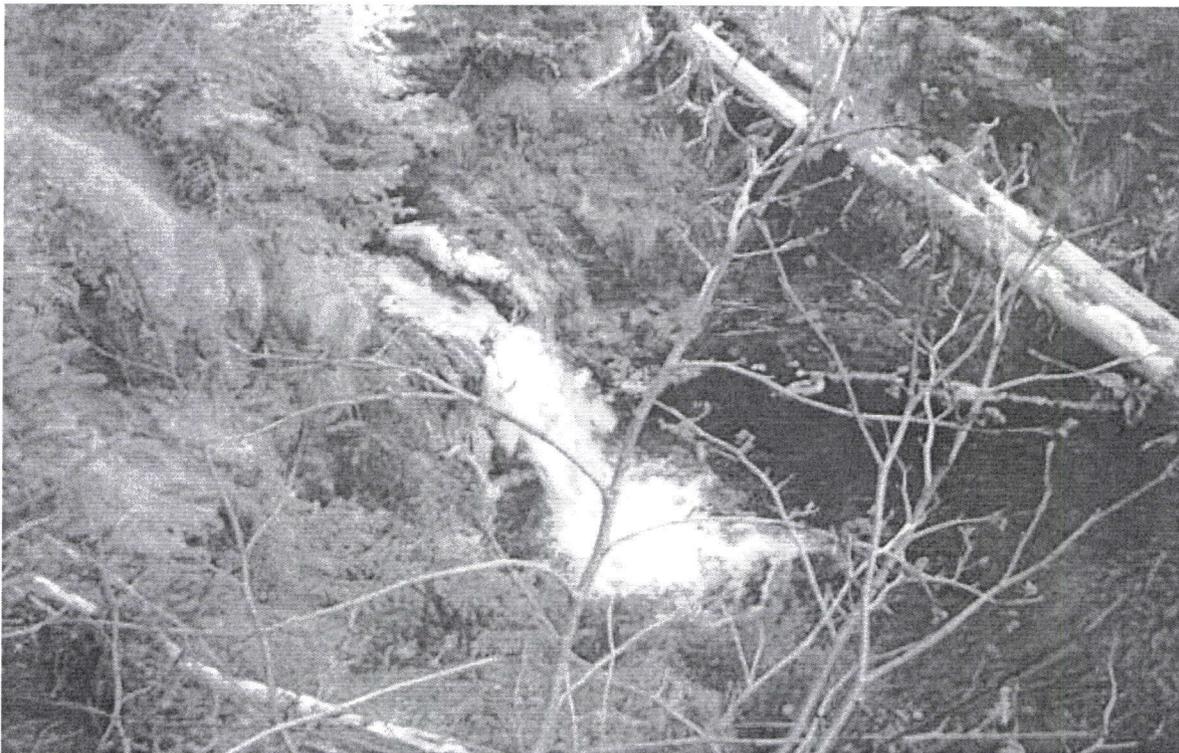
At MP 3.4, we located a 72-inch diameter culvert above the specified reach of Stream No. 251-40-10030-2014. We located a 12-foot high barrier about 200 feet below the road (Figure 8). The barrier location will be updated to the Anadromous Waters Catalog. The ADF&G recommends no action to be taken with the culvert.

Figure 8. Barrier below the 1125 Road MP 3.4.
