Nomination Form
Anadromous Waters Catalog

Region Southwest USGS Quad(s) Afognak A-3
 Anadromous Waters Catalog Number of Waterway 251-40-10030-2020-3018
 Name of Waterway Unnamed Tributary Paramanof Lake USGS Name Local Name
 Addition Deletion Correction Backup Information

SUBJECT: AKSSF AWC Survey: Afognak Island
October 2012

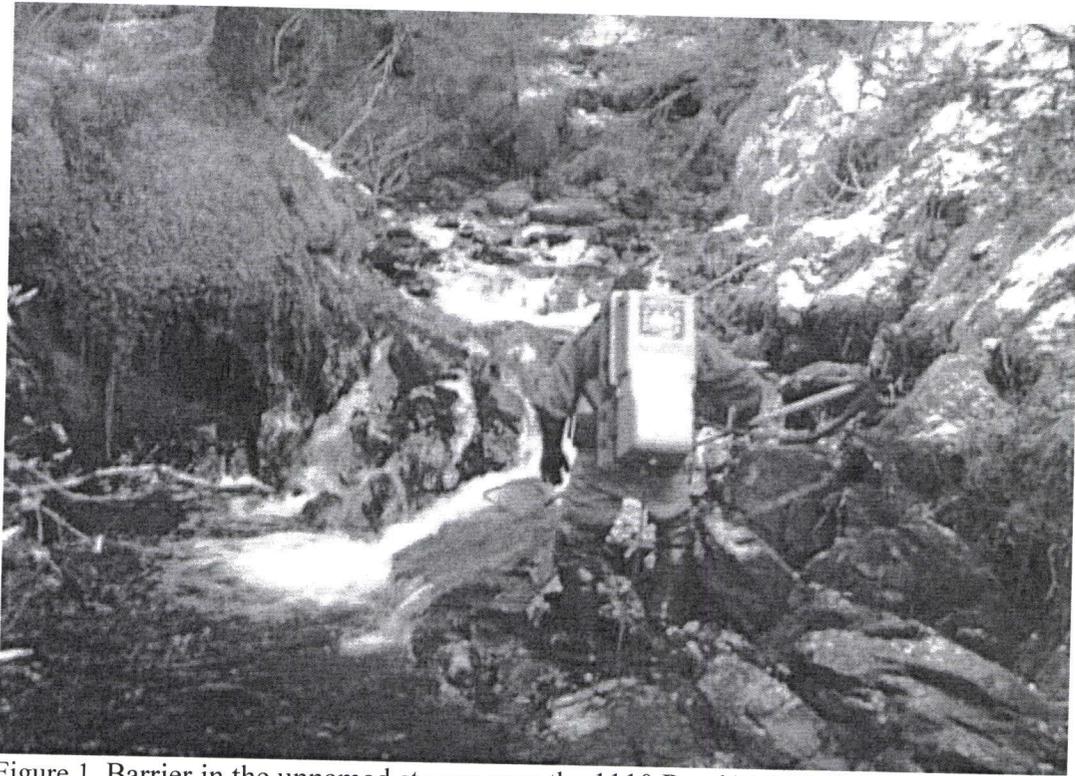
Mr. Blanche and I drove to MP 13.6. I used an electrofisher to sample above the specified reach of Stream No. 252-34-10005-2069. About fifty feet above the road, I captured two juvenile coho salmon (70 mm Fork Length (FL)). I located a 5-foot high barrier about 500 linear feet above the road (Figure 1). I sampled an additional 2,000 linear feet of the stream to the MP 14 stream crossing. I captured 13 Dolly Varden (70 to 110 mm FL). No additional coho salmon were captured above the barrier. The additional stream reach will be updated to the Anadromous Waters Catalog.

Figure 1. Barrier in the unnamed stream near the 1110 Road MP 13.6.

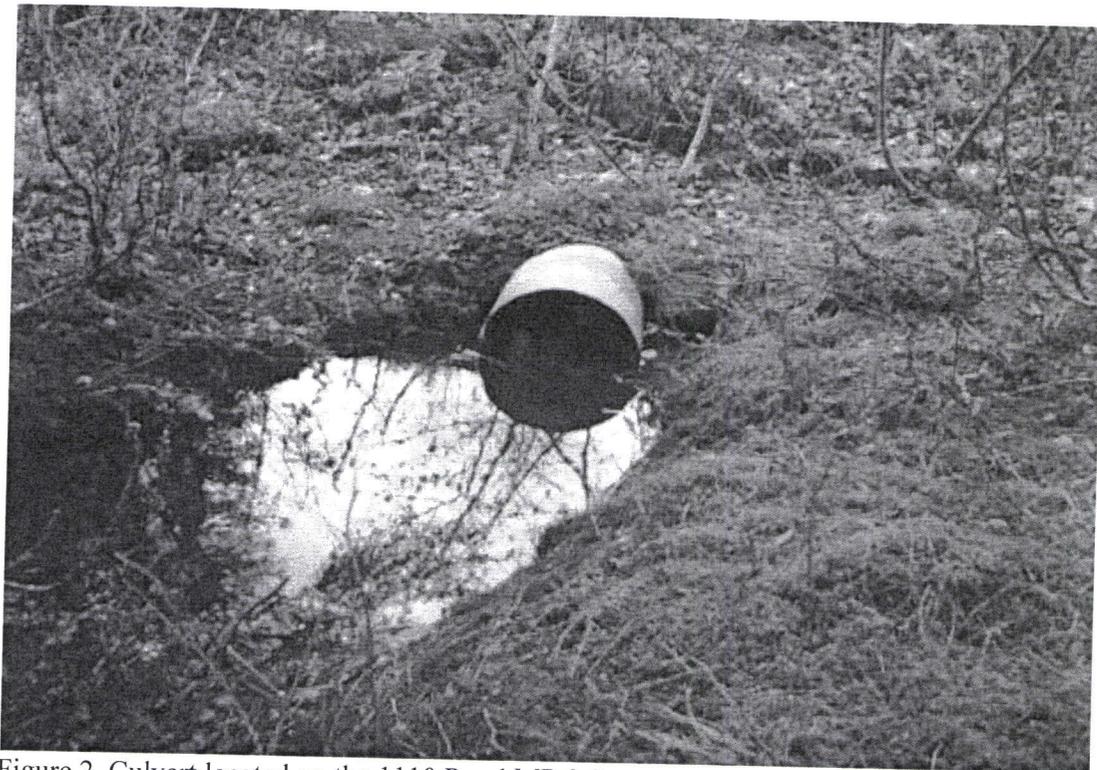
We drove to MP 9.9. I sampled about 800 linear feet above the specified reach of Stream No. 251-40-10030-2040 to the 1110 Road. I did not capture or observe any fish. At the road, I observed a 24-inch diameter culvert (Figure 2). The culvert may be a barrier to fish passage. I sampled about 300 linear feet above the road. I captured one Dolly Varden. No length

Figure 2. Culvert located on the 1110 Road MP 9.9.

measurement was taken for the Dolly Varden. Stream No. 251-40-10030-2040 will be re-sampled in 2013. The purpose of the new survey will be to correct the geographic stream location and sample for juvenile salmon during the summer.

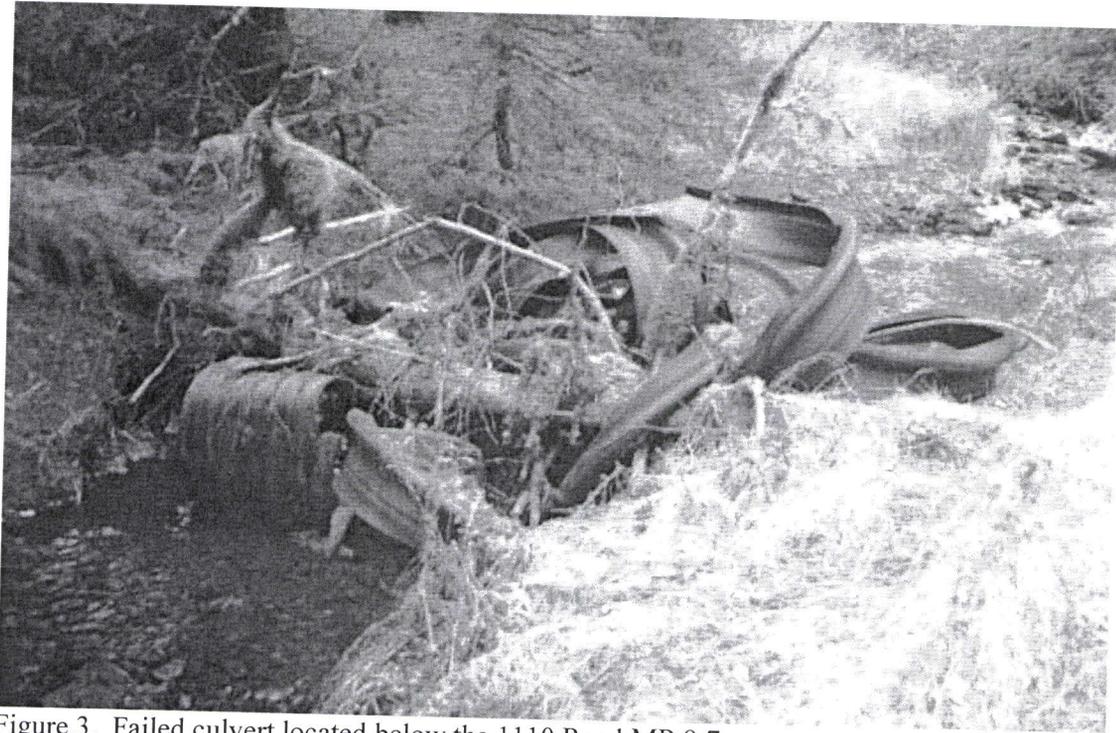
We drove to MP 9.7. I sampled about 400 linear feet above the specified reach of Stream No. 251-40-10030 to the 1110 Road. I captured one juvenile coho salmon. No length measurement was taken for the coho salmon. About 100 feet below the 1110 road, I observed a failed plastic culvert buried in the streambed and blocking fish passage (Figure 3). The culvert may be a complete barrier to fish passage. I sampled about 200 linear feet above the road. I captured 10 Dolly Varden. No length measurements were taken for the Dolly Varden. Stream No. 251-40-10030 will be re-sampled in 2013. The purpose of the new survey will be to correct the geographic stream location and sample for juvenile salmon during the summer. By November 1, 2012, the failed culvert was removed from the stream.

Figure 3. Failed culvert located below the 1110 Road MP 9.7.

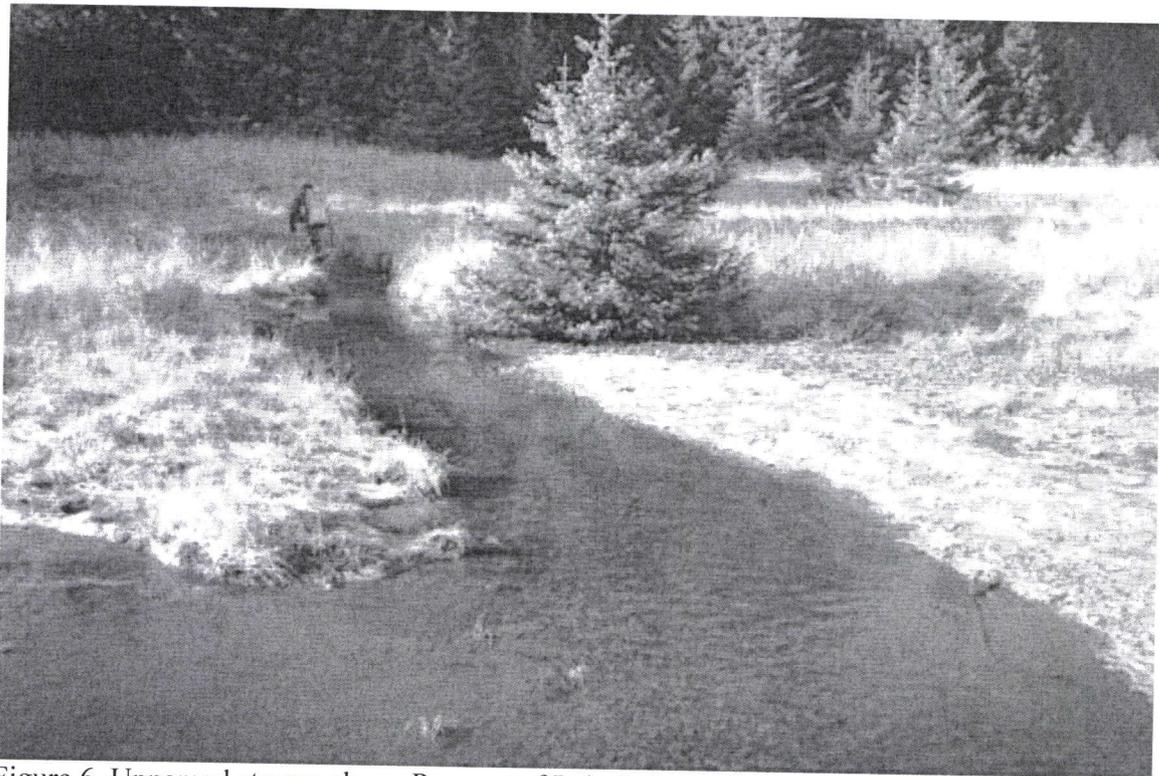
At MP 2.8, we located a 24-inch diameter culvert. I walked to Paramanof Lake and sampled an unnamed stream that flows into the lake about 1,500 linear feet below the road (Figure 6). I captured 8 juvenile coho salmon (45 to 70 mm FL) and 10 Dolly Varden (30 to 175 mm FL). The unnamed stream will be nominated to the Anadromous Waters Catalog. The ADF&G recommends that the culvert be removed and a log stringer bridge installed.

Figure 6. Unnamed stream above Paramanof Lake below the 1125 Road MP 2.8.

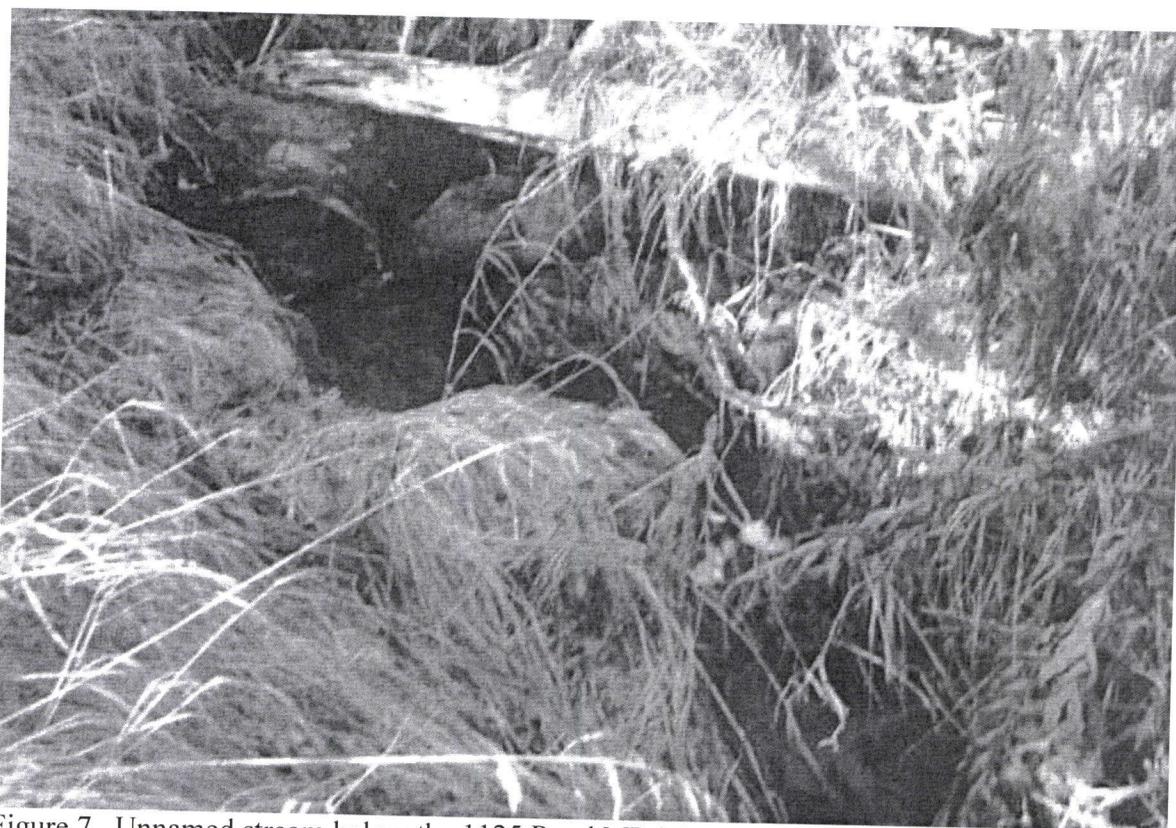
At MP 3.2, we located a 24-inch diameter culvert. An unnamed stream about 3-feet wide flows through the culvert (Figure 7). The stream enters Stream No. 251-40-10030 about 1,300 linear feet below the road. I sampled about 450 linear feet of the stream below the road. I captured one Dolly Varden. No length measurement was taken for the Dolly Varden. The stream will be re-sampled in 2013. The ADF&G has no recommendation for the culvert until additional sampling is completed in 2013.

Figure 7. Unnamed stream below the 1125 Road MP 3.2.

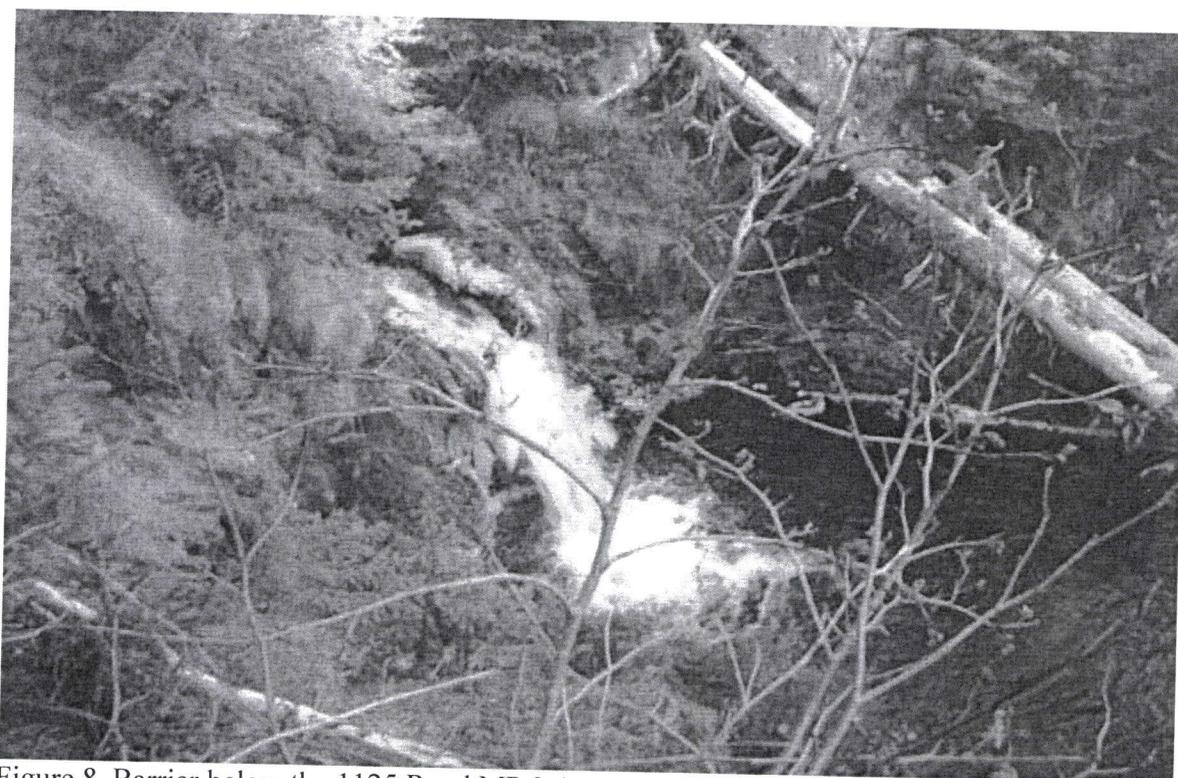
At MP 3.4, we located a 72-inch diameter culvert above the specified reach of Stream No. 251-40-10030-2014. We located a 12-foot high barrier about 200 feet below the road (Figure 8). The barrier location will be updated to the Anadromous Waters Catalog. The ADF&G recommends no action to be taken with the culvert.

Figure 8. Barrier below the 1125 Road MP 3.4.
