Nomination Form
Anadromous Waters Catalog

Region Southwest USGS Quad(s) Kodiak C-2 NE
 Anadromous Waters Catalog Number of Waterway 259-22-23-10056
 Name of Waterway Unnamed Stream USGS Name Local Name
 Addition Deletion Correction Backup Information

SUBJECT: U.S. Coast Guard Survey: Kodiak Island
September 2013

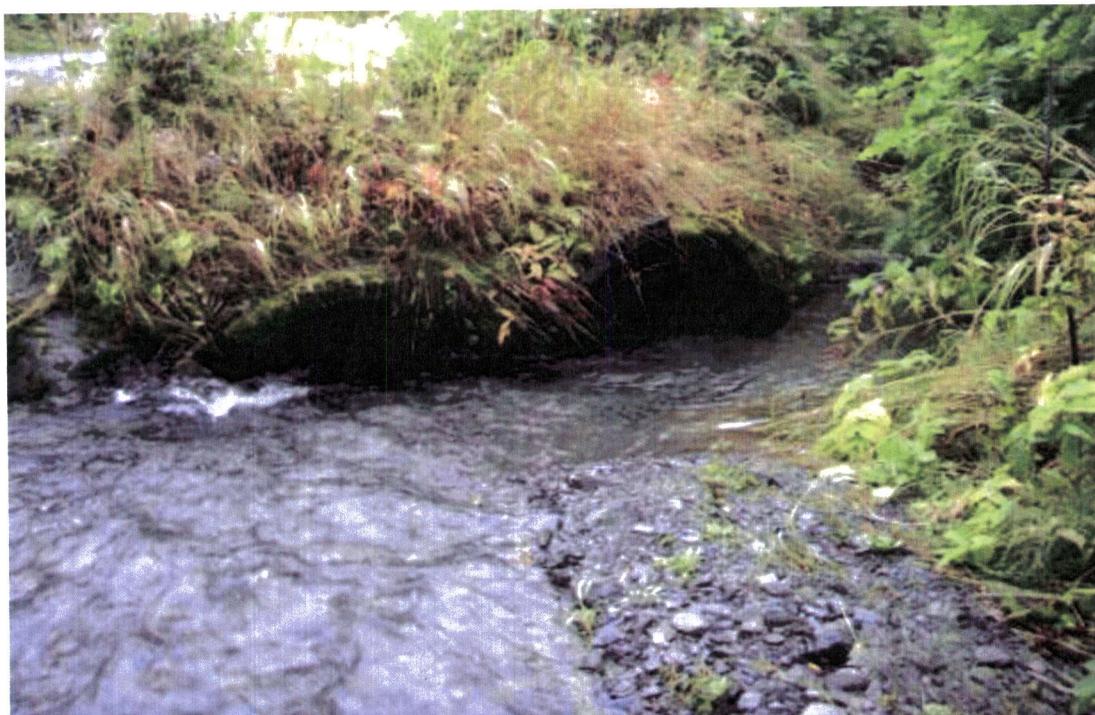
Figure 10. Twin wood stave culverts located in Battery Creek. View looking downstream.

On the morning of September 13, I drove to Battery Creek (Stream No. 259-21-10120-2011). I conducted a foot survey to determine if adult salmon were present above the specified reach of Battery Creek. I observed adult pink salmon spawning throughout the reach, up to about 3,500 linear feet above the specified reach. I set one baited minnow trap about 3,000 linear feet above the specified reach. The trap soaked about one hour and captured 4 juvenile coho salmon. While conducting the foot survey, I identified a perched 38-inch diameter culvert located in a tributary to Battery Creek. The culvert is a barrier to fish passage (Figure 9). Further upstream, I located twin wood stave 32-inch diameter culverts that may be a partial barrier to fish passage (Figure 10). The culverts are located under the U.S. Coast Guard Battery Road. The ADF&G recommends the culverts be removed and replaced with culverts designed for fish passage. The pink salmon and coho salmon will be nominated for update to the Anadromous Waters Catalog.

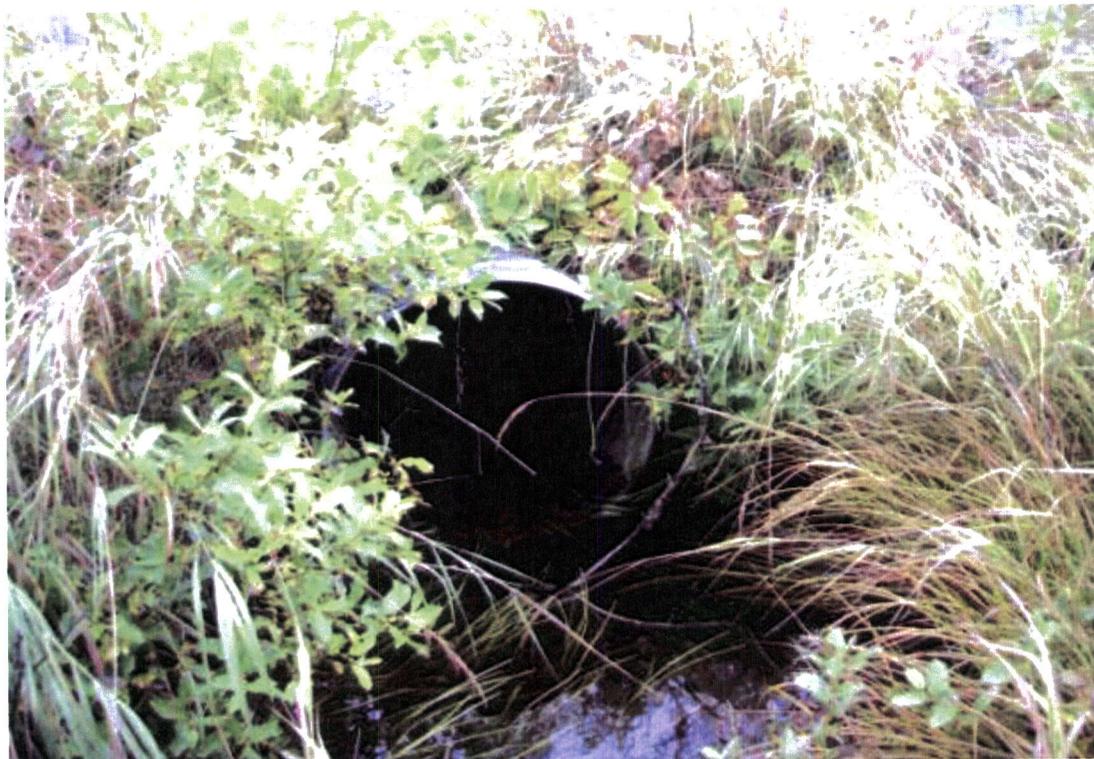
Figure 11. Culvert located in tributary to Battery Creek. View looking downstream.

I located an unnamed tributary to Battery Creek that flows under the Battery Road through a 24-inch diameter culvert (Figure 11). I set two baited minnow traps above the road. The traps soaked about one hour and captured 10 juvenile coho salmon. The culvert may be a partial barrier to fish passage. The ADF&G recommends the culvert be removed and replaced with culvert designed for fish passage. The unnamed tributary will be nominated to the Anadromous Waters Catalog.
