Nomination Form
Anadromous Waters Catalog

Name of Waterway Holiday Creek USGS Name Local Name
 Addition Deletion Correction Backup Information

SUBJECT: U.S. Coast Guard Survey: Kodiak Island
September 2013

On September 12 and 13, 2013, I joined Blyth Brown, Kodiak Soil and Water Conservation District on Kodiak Island for the purpose of sampling waters on U.S Coast Guard land to document the presence of anadromous fish. The information gathered will be used to submit official nominations for inclusion in the Anadromous Waters Catalog and its companion Atlas. A water body listed in the Anadromous Waters Catalog is afforded protection under State law at AS 16.05.871. The weather conditions were cloudy and cool.

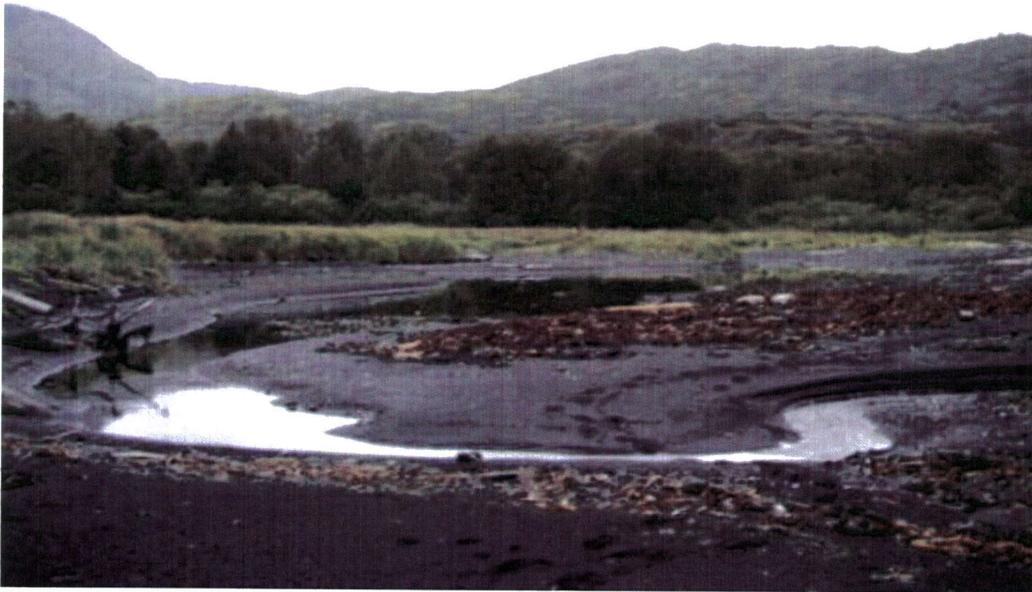
Figure 2. Holiday Creek outlet.

On the morning of September 12, we drove to "Holiday Beach" (Happy Beach, U.S. Geologic Survey Map) (Figure 1). Two streams are located near the beach. We began sampling the first stream ("Holiday Creek") where the creek enters Middle Bay (Figure 2). We used an electrofisher to sample the stream for the presence of juvenile fish (Figure 3). We captured about 10 Dolly Varden. About 500 linear feet above the stream mouth we observed about 200 adult pink salmon spawning throughout the reach. Because of the presence of adult pink salmon, we stopped using the electrofisher. About 300 linear feet below the Chiniak Highway we located a concrete box in the stream that may date from the WW II era, containing abandoned power cables (Figures 4 and 5). No adult salmon were observed above the box. The box is a barrier to fish passage. We were able to remove the accumulated woody debris and stream substrate from behind the barrier to temporarily restore fish passage. The Alaska Department of Fish and Game (ADF&G) will require the U.S. Coast Guard to remove the barrier in a timely manner. We walked up to the Chiniak Highway and located twin 5-foot diameter culverts located under the highway (ADF&G, KOD05-CR25) (Figure 6). The culverts may be a barrier to fish passage. We ended our survey at the culverts. Holiday Creek will be nominated to the Anadromous Waters Catalog.

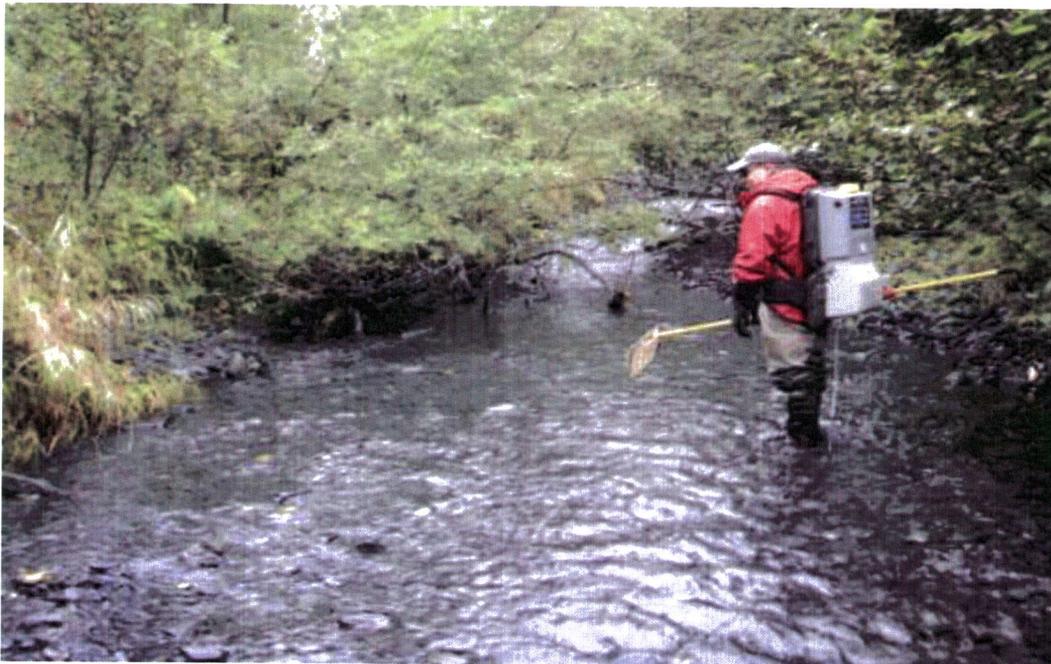
Figure 3. Will Frost, Habitat Biologist sampling Holiday Creek.

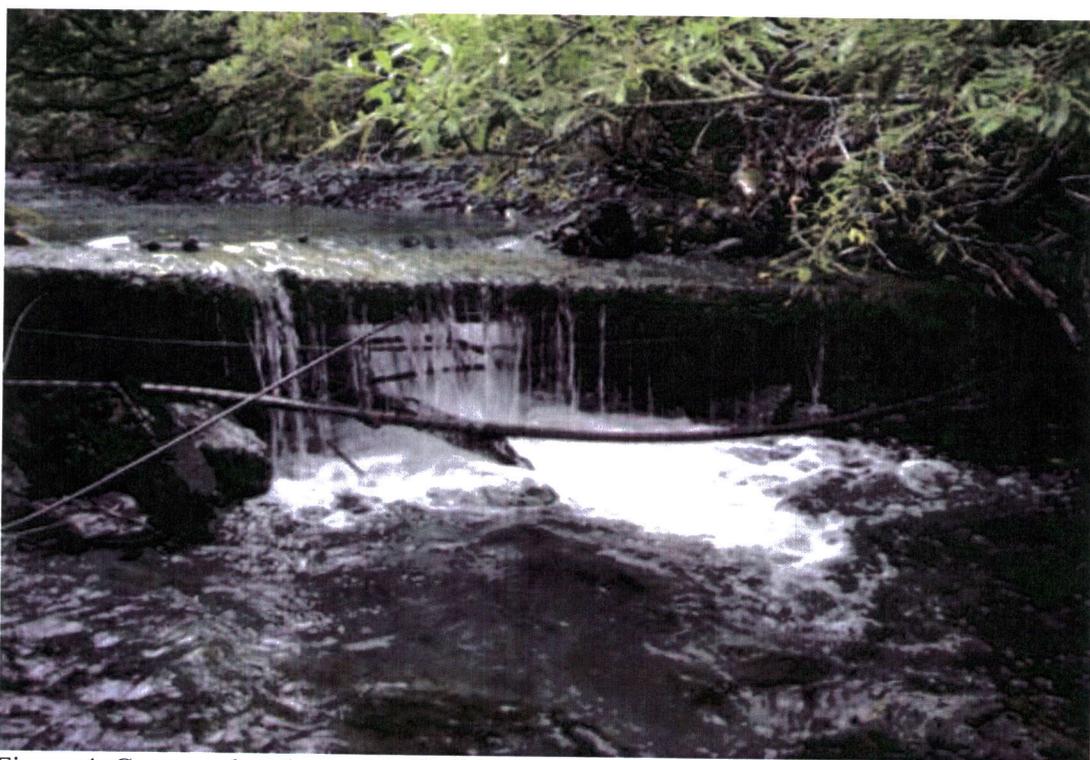
Figure 4. Concrete box located in Holiday Creek. View looking upstream.

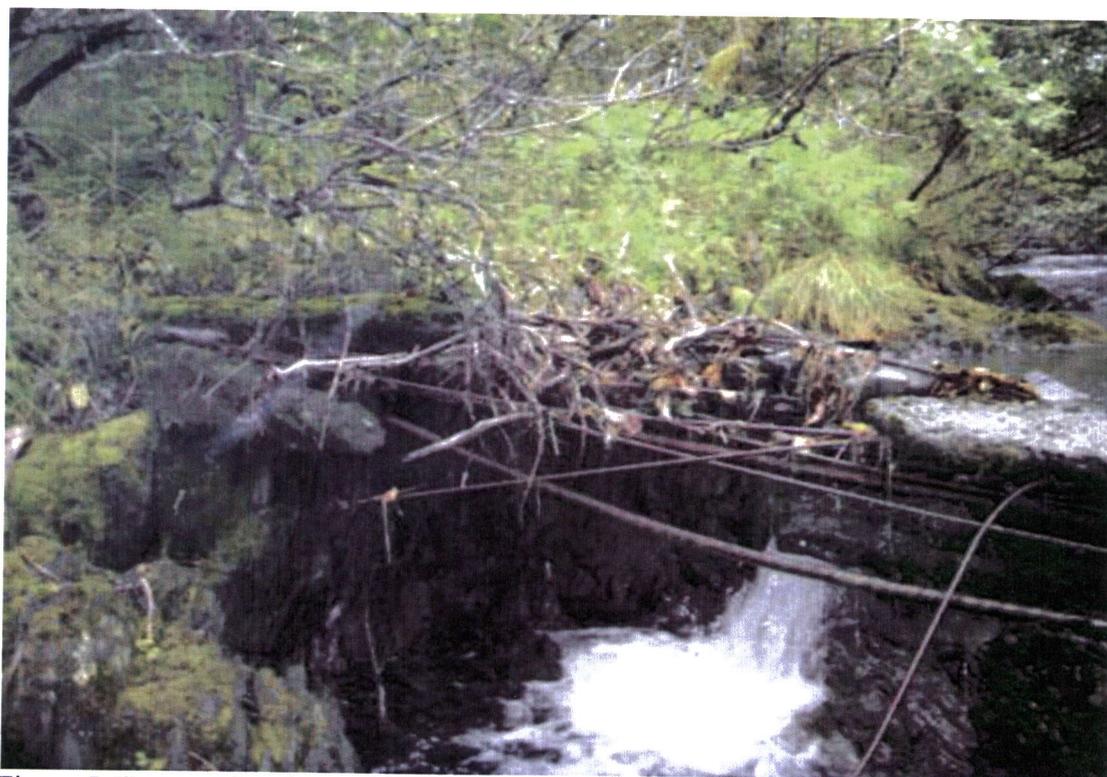
Figure 5. Concrete box located in Holiday Creek. View looking upstream.

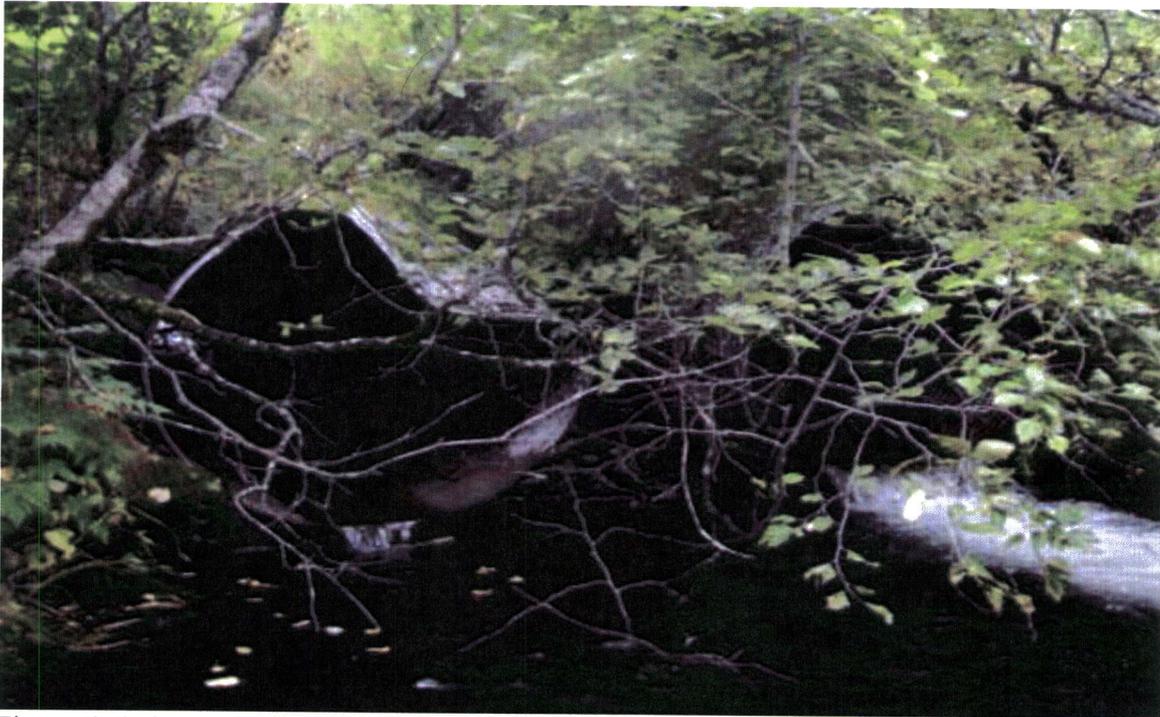
Figure 6. Culverts KOD05-CR25 located in Holiday Creek.

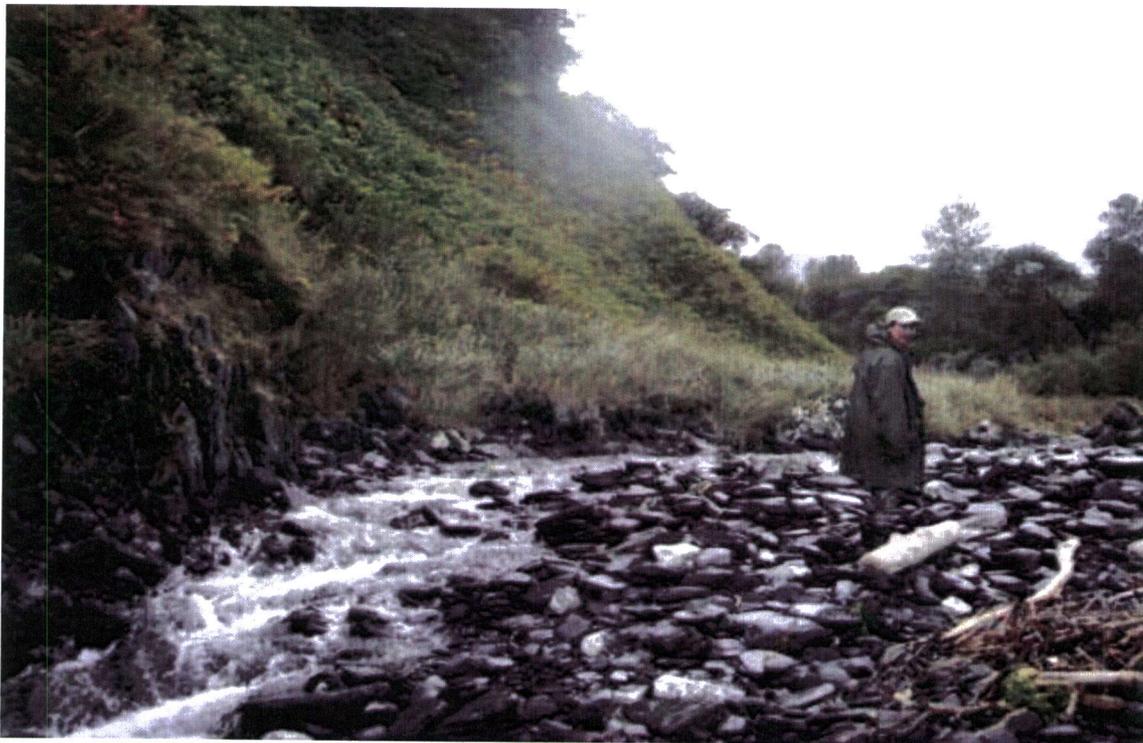
Figure 7. Blyth Brown, Kodiak Soil and Water Conservation District walking in unnamed stream.

We walked to the north end of Holiday Beach to an unnamed stream. We conducted a foot survey to determine if adult salmon were present in the stream (Figure 7). We began the survey at the beach and walked upstream to the Chiniak Highway. We observed 5 anadromous Dolly Varden in the lower reach. We estimated the length of the Dolly Varden were about 300-350 mm fork length. We observed about 15 adult pink salmon spawning throughout the stream. We ended our survey at the 9-foot diameter culvert located under the Chiniak Highway (ADF&G,

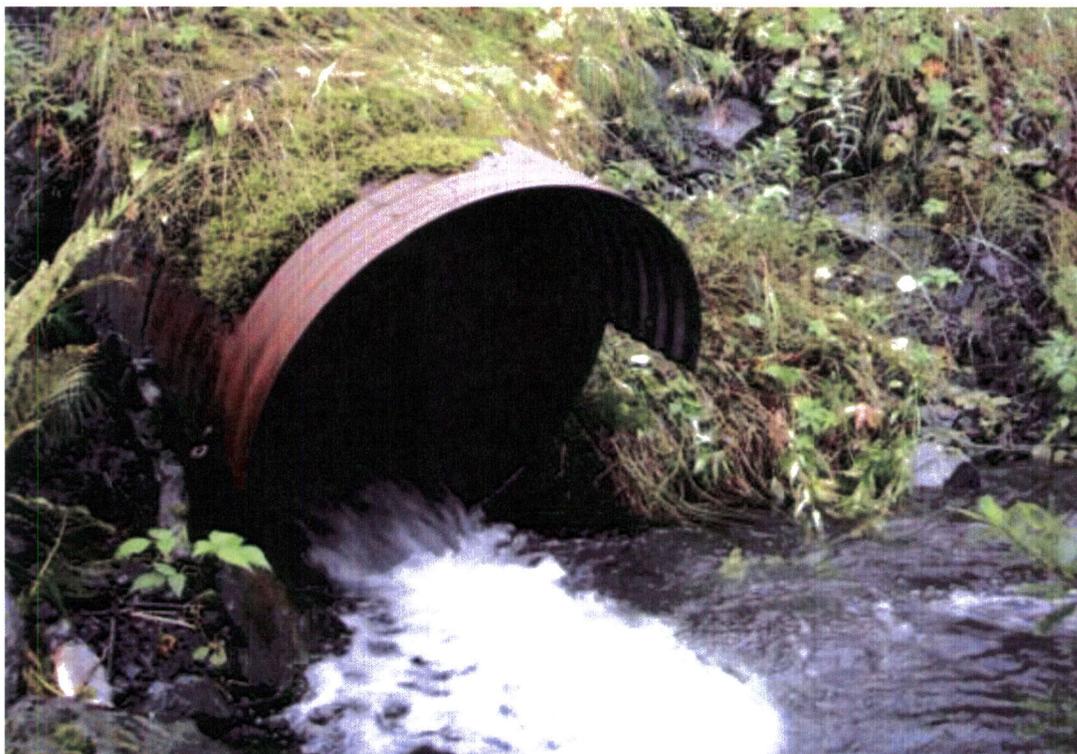
Figure 9. Culvert located in a tributary to Battery Creek. View looking upstream.

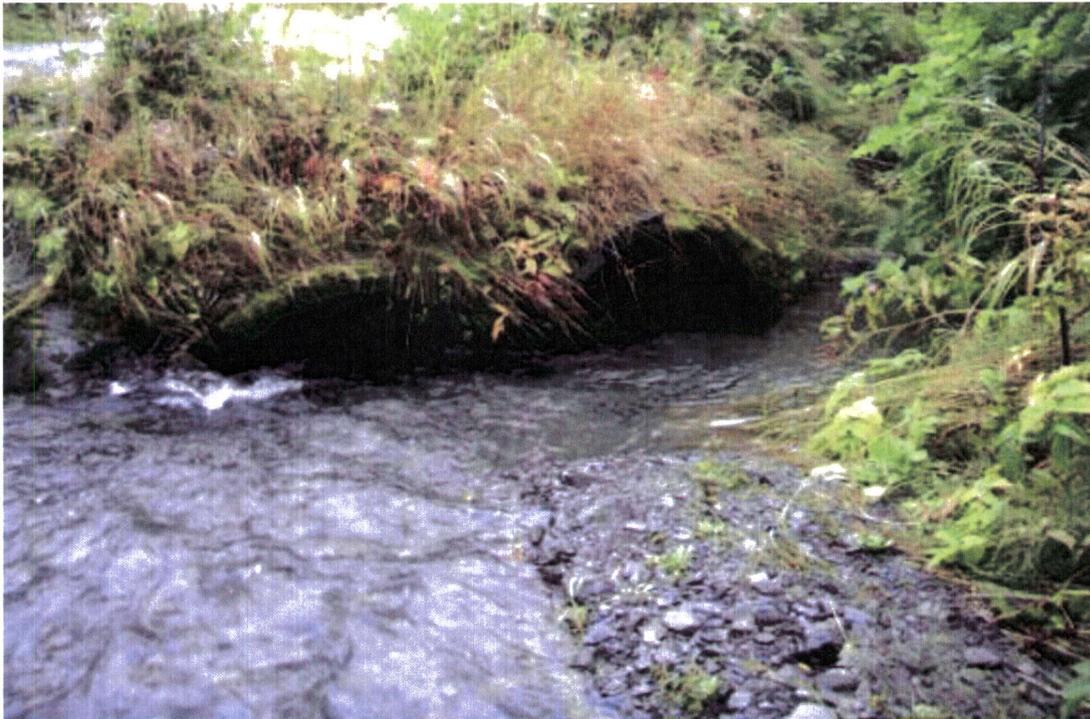
On the morning of September 13, I drove to Battery Creek (Stream No. 259-21-10120-2011). I conducted a foot survey to determine if adult salmon were present above the specified reach of Battery Creek. I observed adult pink salmon spawning throughout the reach, up to about 3,500 linear feet above the specified reach. I set one baited minnow trap about 3,000 linear feet above the specified reach. The trap soaked about one hour and captured 4 juvenile coho salmon. While conducting the foot survey, I identified a perched 38-inch diameter culvert located in a tributary to Battery Creek. The culvert is a barrier to fish passage (Figure 9). Further upstream, I located twin wood stave 32-inch diameter culverts that may be a partial barrier to fish passage (Figure 10). The culverts are located under the U.S. Coast Guard Battery Road. The ADF&G recommends the culverts be removed and replaced with culverts designed for fish passage. The pink salmon and coho salmon will be nominated for update to the Anadromous Waters Catalog.

Figure 10. Twin wood stave culverts located in Battery Creek. View looking downstream.

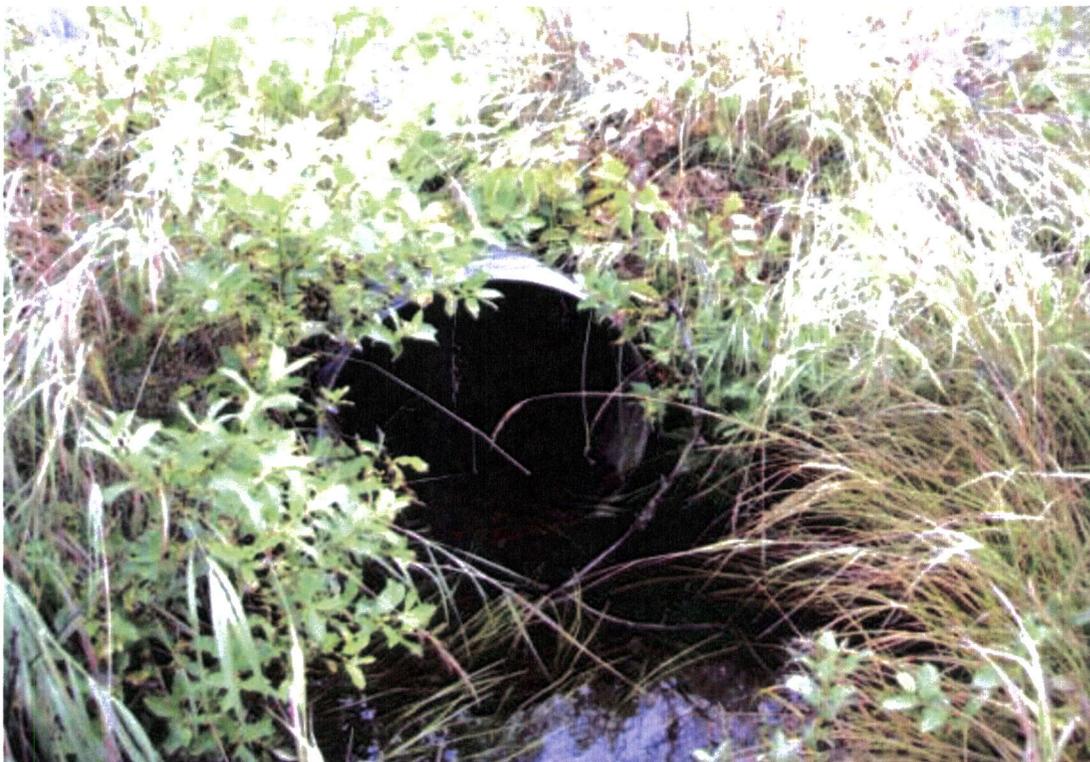
I located an unnamed tributary to Battery Creek that flows under the Battery Road through a 24-inch diameter culvert (Figure 11). I set two baited minnow traps above the road. The traps soaked about one hour and captured 10 juvenile coho salmon. The culvert may be a partial barrier to fish passage. The ADF&G recommends the culvert be removed and replaced with culvert designed for fish passage. The unnamed tributary will be nominated to the Anadromous Waters Catalog.

Figure 11. Culvert located in tributary to Battery Creek. View looking downstream.
