State of Alaska  
Department of Fish and Game  
Division of Sport Fish

Nomination Form  
Anadromous Waters Catalog

Region Southwest USGS Quad(s) Kodiak D-2 SW  
 Anadromous Waters Catalog Number of Waterway 259-21-10120-2011- 3121  
 Name of Waterway Unnamed Tributary Battery Creek  USGS Name  Local Name  
 Addition  Deletion  Correction  Backup Information

SUBJECT: U.S. Coast Guard Survey: Kodiak Island  
September 2013

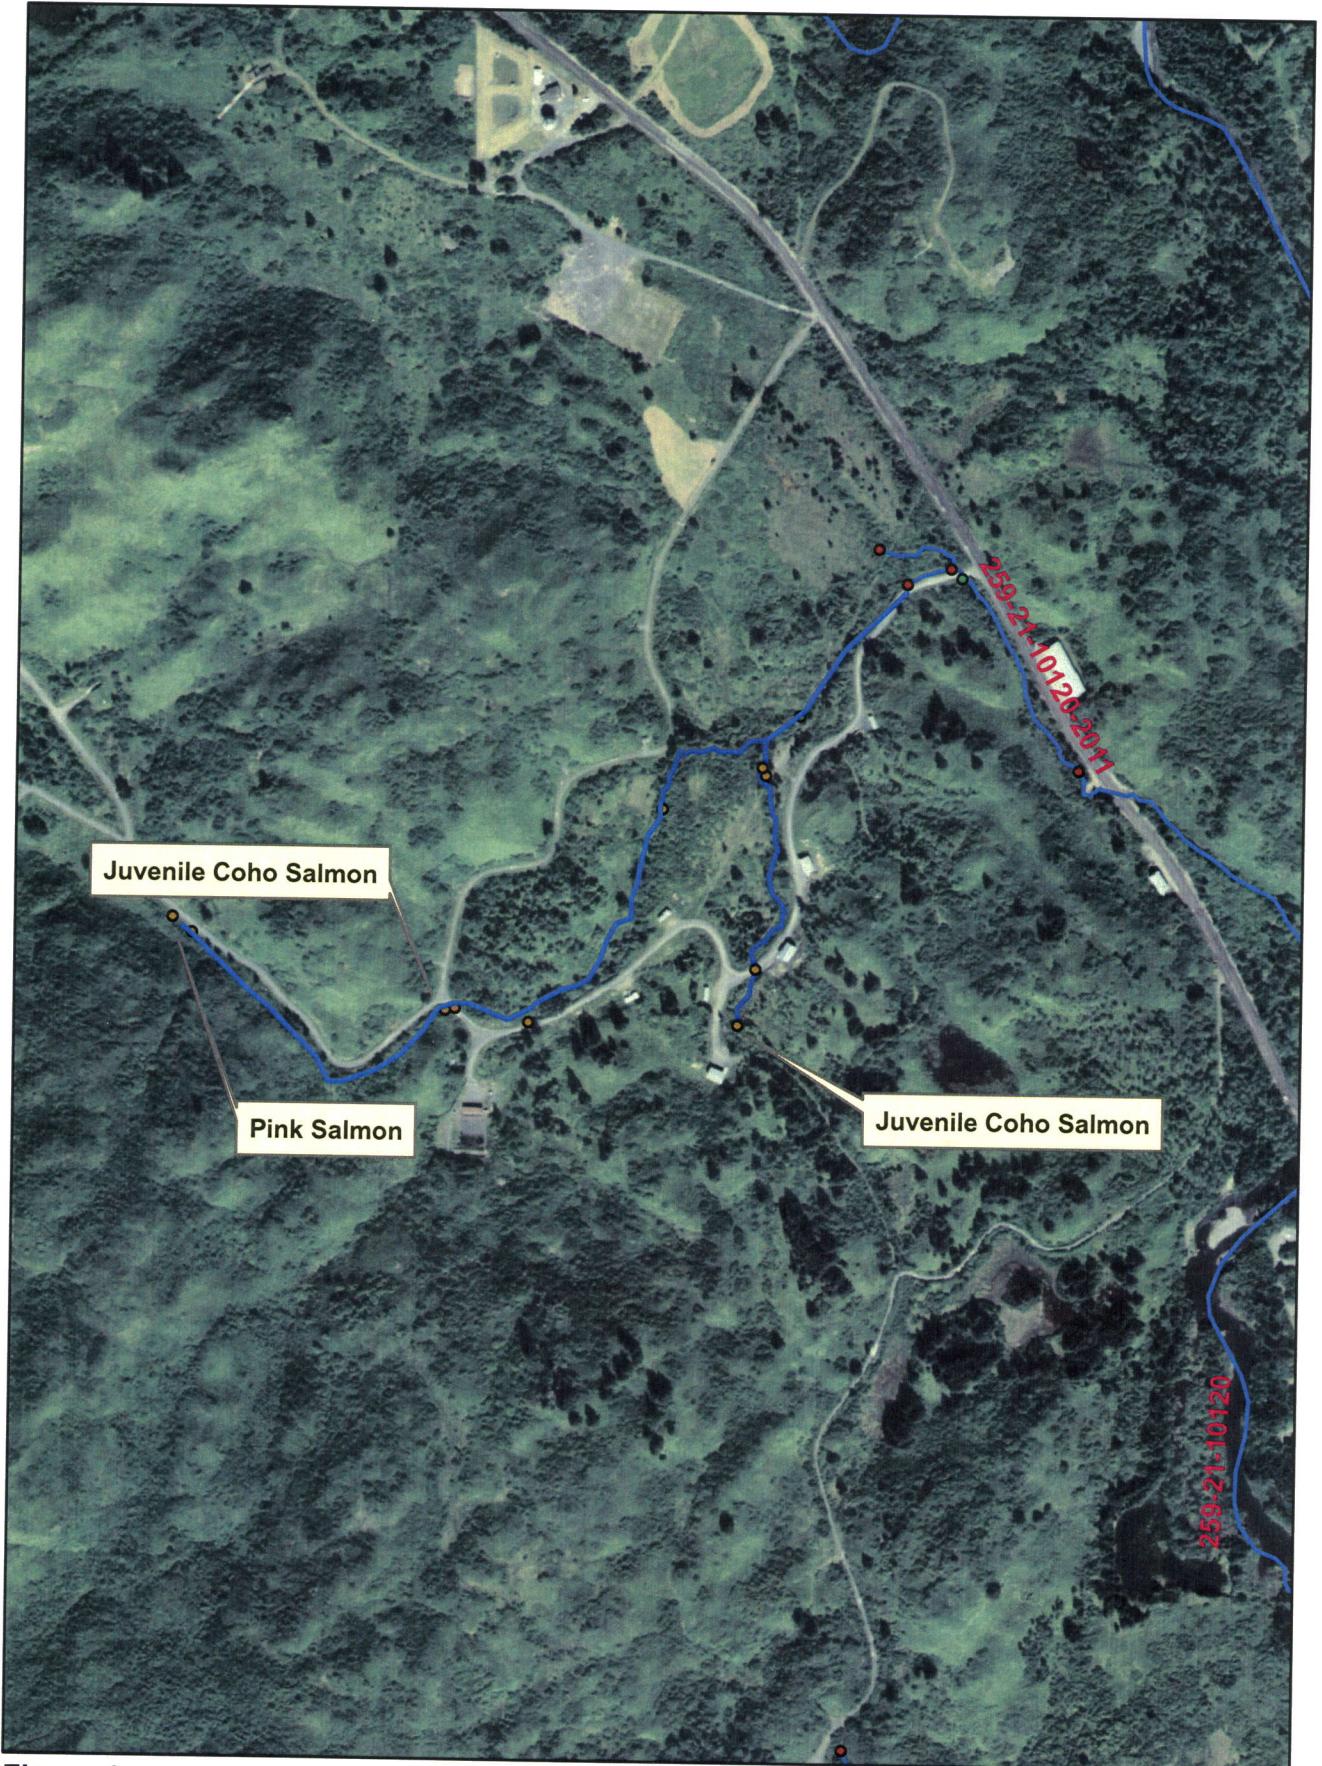
Figure 1

I set two baited minnow traps in an unnamed tributary to Battery Creek. The traps captured juvenile coho salmon (Figures 1 and 2). September 12 and 13, 2013 trip report:

38 INCH BARRIER

24 NCH

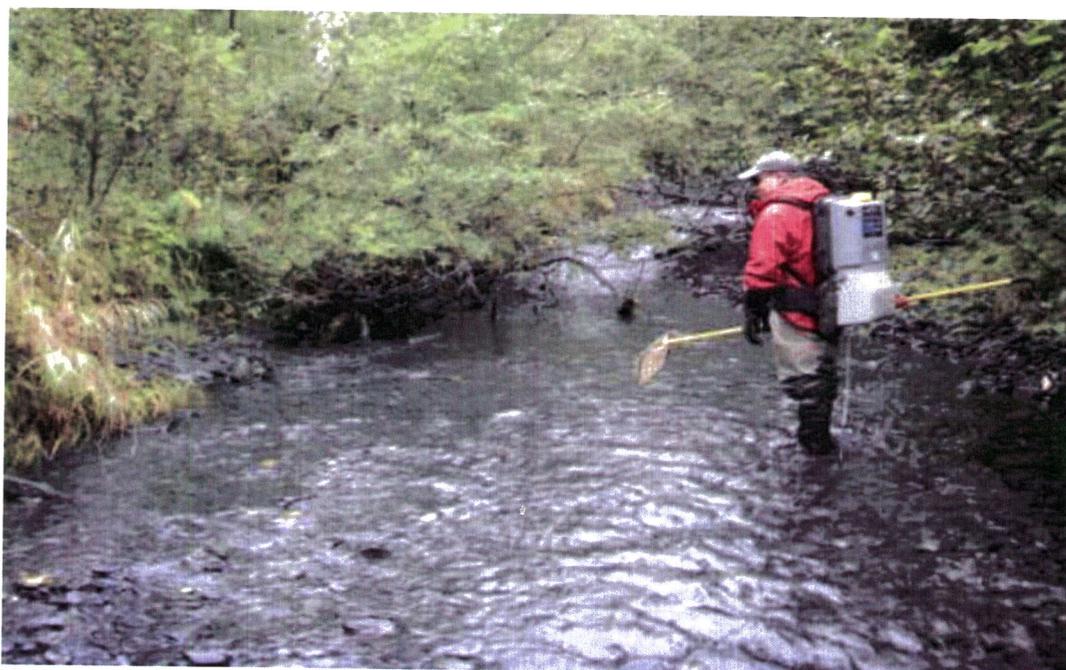
Figure 3. Will Frost, Habitat Biologist sampling Holiday Creek.

On the morning of September 12, we drove to "Holiday Beach" (Happy Beach, U.S. Geologic Survey Map) (Figure 1). Two streams are located near the beach. We began sampling the first stream ("Holiday Creek") where the creek enters Middle Bay (Figure 2). We used an electrofisher to sample the stream for the presence of juvenile fish (Figure 3). We captured about 10 Dolly Varden. About 500 linear feet above the stream mouth we observed about 200 adult pink salmon spawning throughout the reach. Because of the presence of adult pink salmon, we stopped using the electrofisher. About 300 linear feet below the Chiniak Highway we located a concrete box in the stream that may date from the WW II era, containing abandoned power cables (Figures 4 and 5). No adult salmon were observed above the box. The box is a barrier to fish passage. We were able to remove the accumulated woody debris and stream substrate from behind the barrier to temporarily restore fish passage. The Alaska Department of Fish and Game (ADF&G) will require the U.S. Coast Guard to remove the barrier in a timely manner. We walked up to the Chiniak Highway and located twin 5-foot diameter culverts located under the highway (ADF&G, KOD05-CR25) (Figure 6). The culverts may be a barrier to fish passage. We ended our survey at the culverts. Holiday Creek will be nominated to the Anadromous Waters Catalog.

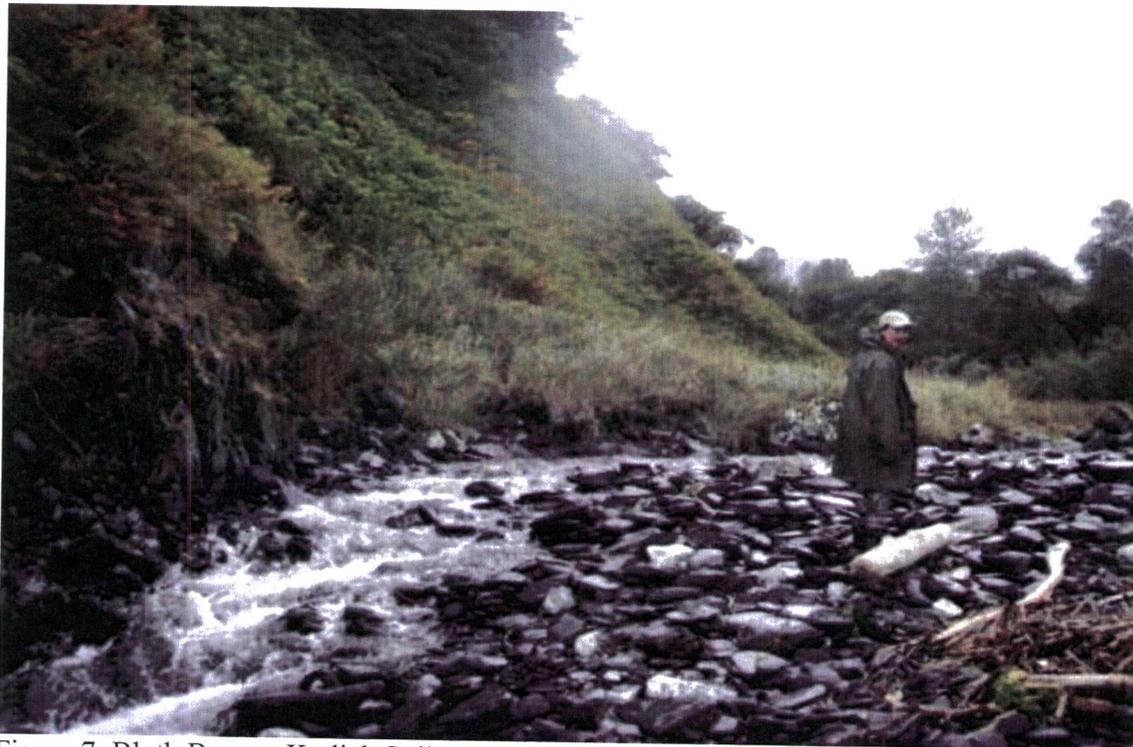
Figure 7. Blyth Brown, Kodiak Soil and Water Conservation District walking in unnamed stream.

We walked to the north end of Holiday Beach to an unnamed stream. We conducted a foot survey to determine if adult salmon were present in the stream (Figure 7). We began the survey at the beach and walked upstream to the Chiniak Highway. We observed 5 anadromous Dolly Varden in the lower reach. We estimated the length of the Dolly Varden were about 300-350 mm fork length. We observed about 15 adult pink salmon spawning throughout the stream. We ended our survey at the 9-foot diameter culvert located under the Chiniak Highway (ADF&G,

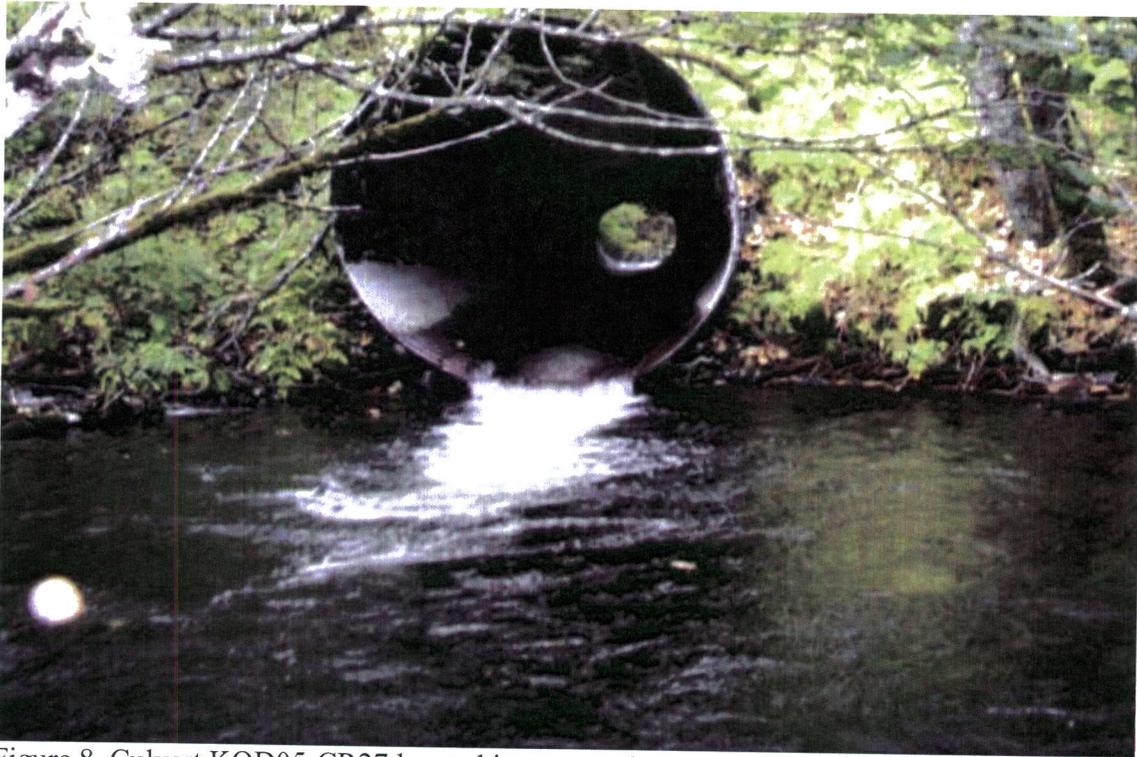
Figure 8. Culvert KOD05-CR27 located in unnamed stream. View looking upstream.

KOD05-CR27) (Figure 8). The culvert may be a barrier to fish passage. The unnamed stream will be nominated to the Anadromous Waters Catalog.

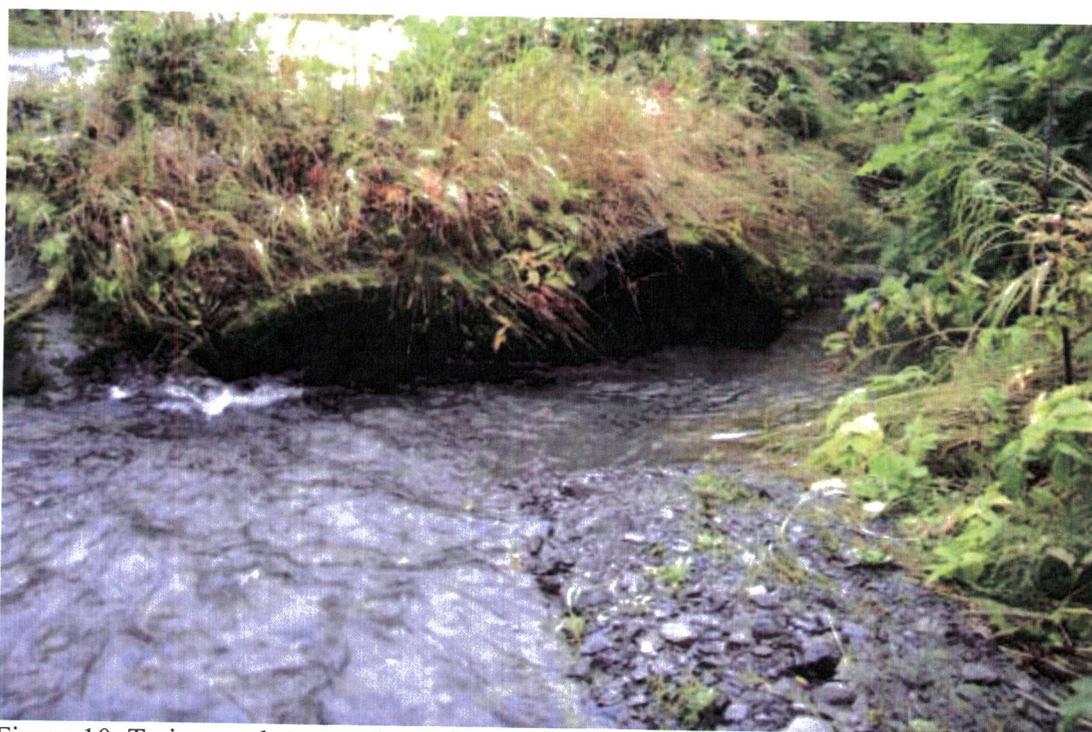
Figure 10. Twin wood stave culverts located in Battery Creek. View looking downstream.

On the morning of September 13, I drove to Battery Creek (Stream No. 259-21-10120-2011). I conducted a foot survey to determine if adult salmon were present above the specified reach of Battery Creek. I observed adult pink salmon spawning throughout the reach, up to about 3,500 linear feet above the specified reach. I set one baited minnow trap about 3,000 linear feet above the specified reach. The trap soaked about one hour and captured 4 juvenile coho salmon. While conducting the foot survey, I identified a perched 38-inch diameter culvert located in a tributary to Battery Creek. The culvert is a barrier to fish passage (Figure 9). Further upstream, I located twin wood stave 32-inch diameter culverts that may be a partial barrier to fish passage (Figure 10). The culverts are located under the U.S. Coast Guard Battery Road. The ADF&G recommends the culverts be removed and replaced with culverts designed for fish passage. The pink salmon and coho salmon will be nominated for update to the Anadromous Waters Catalog.

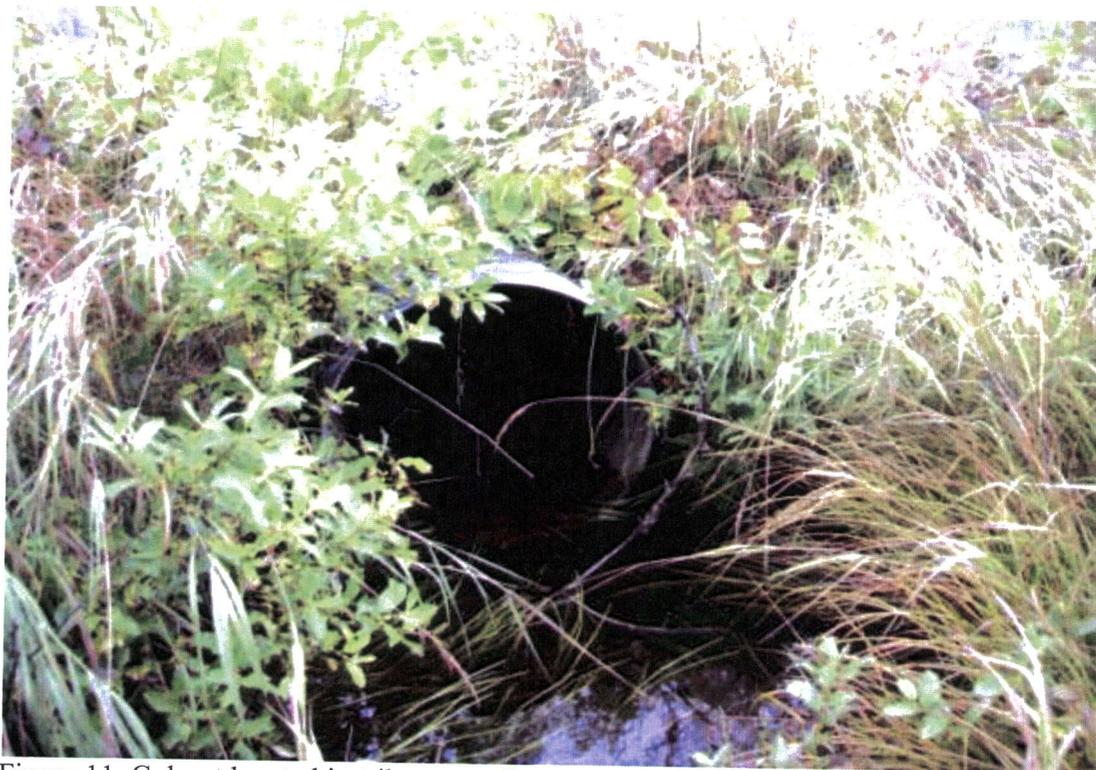
Figure 11. Culvert located in tributary to Battery Creek. View looking downstream.

I located an unnamed tributary to Battery Creek that flows under the Battery Road through a 24-inch diameter culvert (Figure 11). I set two baited minnow traps above the road. The traps soaked about one hour and captured 10 juvenile coho salmon. The culvert may be a partial barrier to fish passage. The ADF&G recommends the culvert be removed and replaced with culvert designed for fish passage. The unnamed tributary will be nominated to the Anadromous Waters Catalog.
