State of Alaska
Department of Fish and Game
Division of Sport Fish

Nomination Form
Anadromous Waters Catalog

Region Southwest USGS Quad(s) Afognak A-2, A-2 NE
 Anadromous Waters Catalog Number of Waterway 251-82-10050-2031-3012
 Name of Waterway Unnamed Tributary Upper Portage Lake USGS Name Local Name
 Addition Deletion Correction Backup Information

SUBJECT: AKSSF AWC Survey: Afognak Island
September 2015

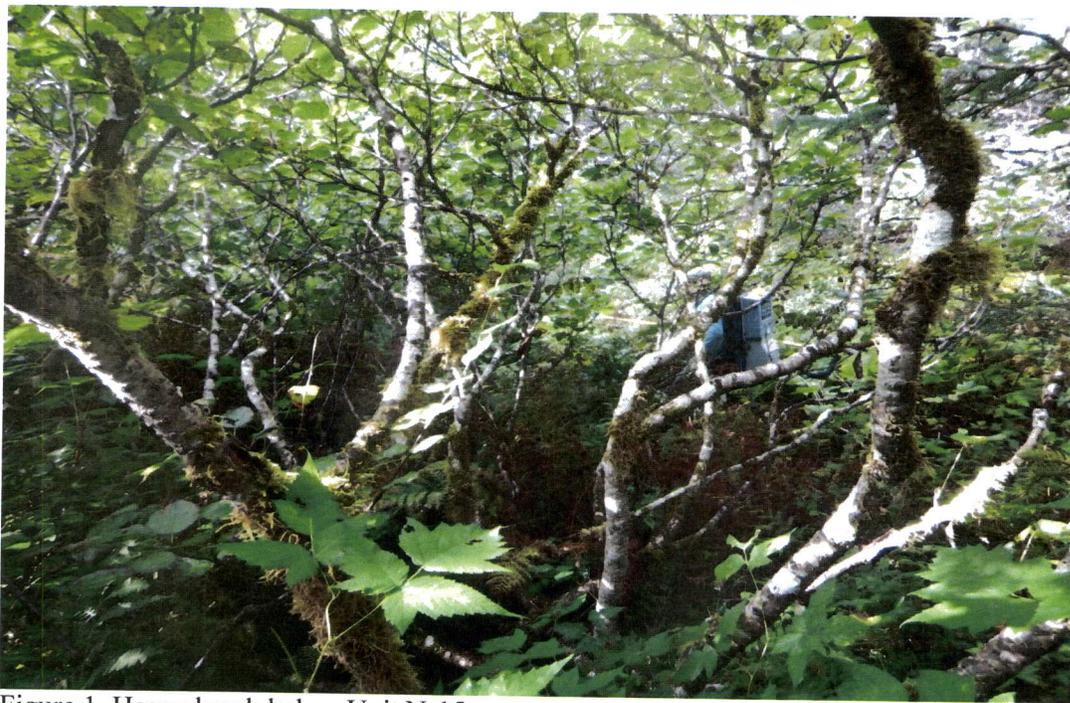
We drove to the 300 Road and walked into Unit N-15. The unit is on land managed by Koncor. We used an electrofisher to sample an unnamed tributary to the upper reach of Stream No. 251-82-10052 located above the 1100 Road. The stream flows through the unit into an old harvest unit that was cut in the 1970s. The brush and regenerated trees made sampling difficult (Figure 1). We located an old spur road that has caused the stream to flow subsurface, blocking fish passage (Figure 2). The ADF&G will work with Koncor to open the road for fish passage. Below the road, we captured 10 Dolly Varden (50-75 mm FL). We plan to re-sample the unnamed tributary in October 2015.

Figure 1. Heavy brush below Unit N-15.

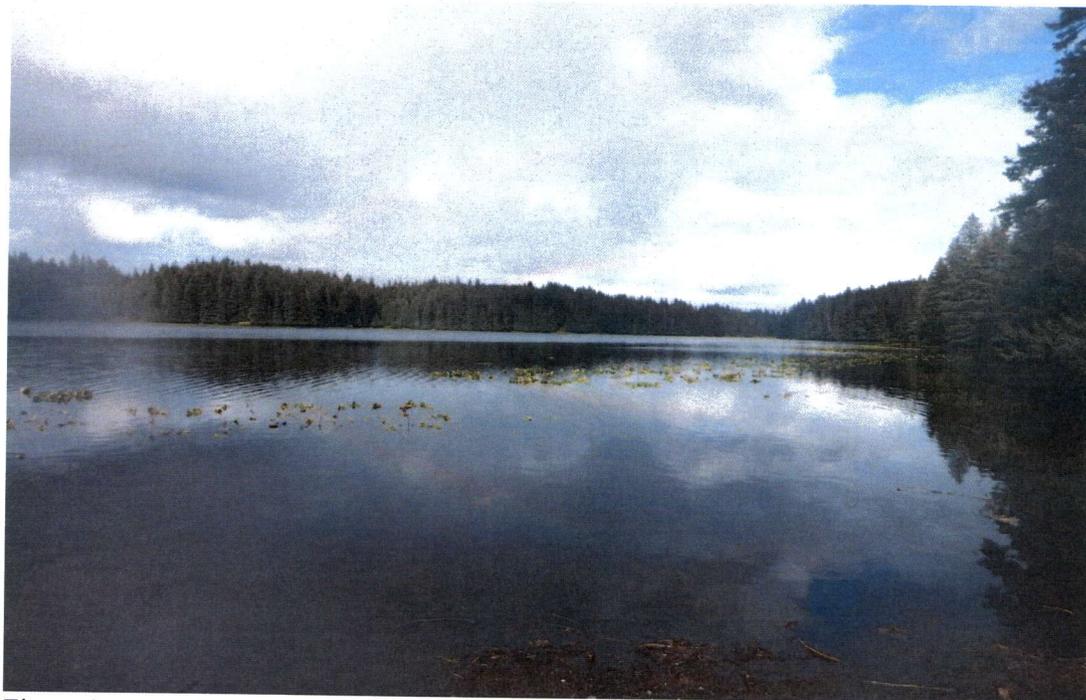
We drove the 1100 Road to MP 10. We sampled about 375 meters of an unnamed stream below the 1100 Road to Upper Portage Lake (Lake No. 251-82-10050-0020) (Figure 3). We captured 15 Dolly Varden (55-100 mm FL).

At Upper Portage Lake, we captured 3 juvenile coho salmon (55-65 mm FL) in the lake. We observed about an additional 100 fish. The rearing coho salmon will be nominated for update to the Anadromous Waters Catalog.

Figure 3. Upper Portage Lake.

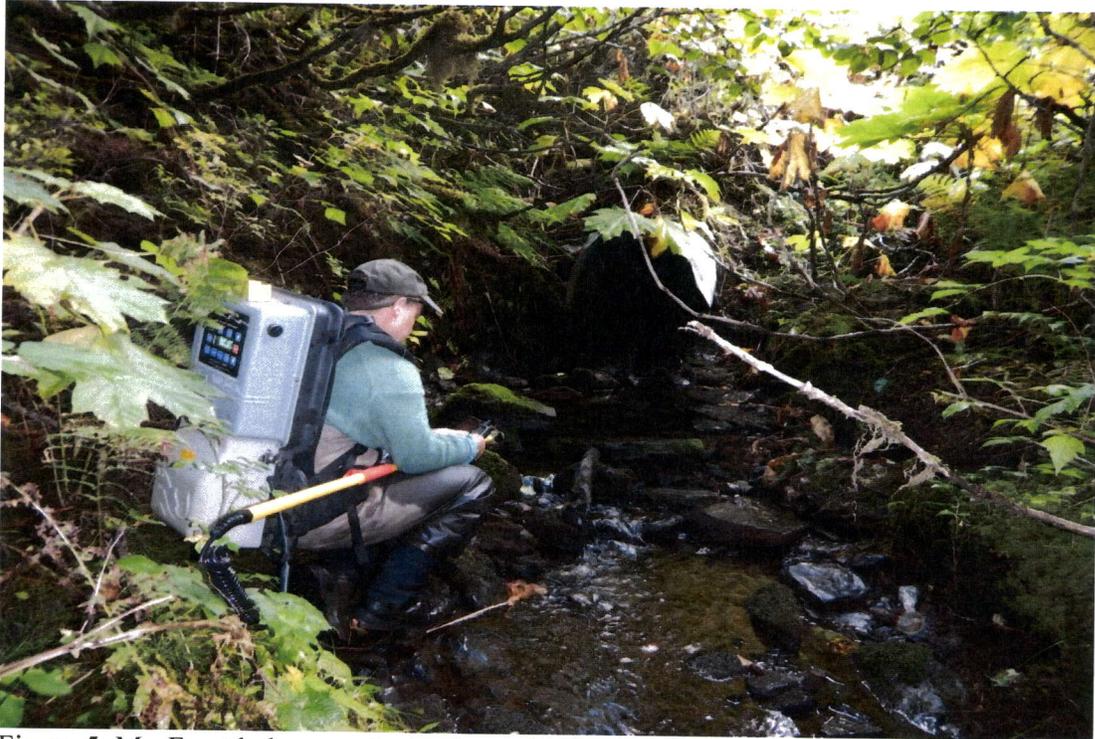
Figure 5. Mr. Frost below perched culvert, 1100 Road MP 9.9.

We continued walking south and located an additional unnamed stream. We sampled upstream about 400 meters to the 1100 Road MP 9.9. We captured about 30 juvenile coho salmon and measured 10 fish (50-70 mm FL) (Figure 4). We captured 10 Dolly Varden and measured 5 fish (45-100 mm FL). We ended our sampling at a perched culvert on the 1100 Road (Figure 5). The culvert is a barrier to fish passage and must be removed. The ADF&G will work with Koncor to schedule the removal of the culvert and installation of a log stringer bridge. The unnamed stream will be nominated to the Anadromous Waters Catalog.

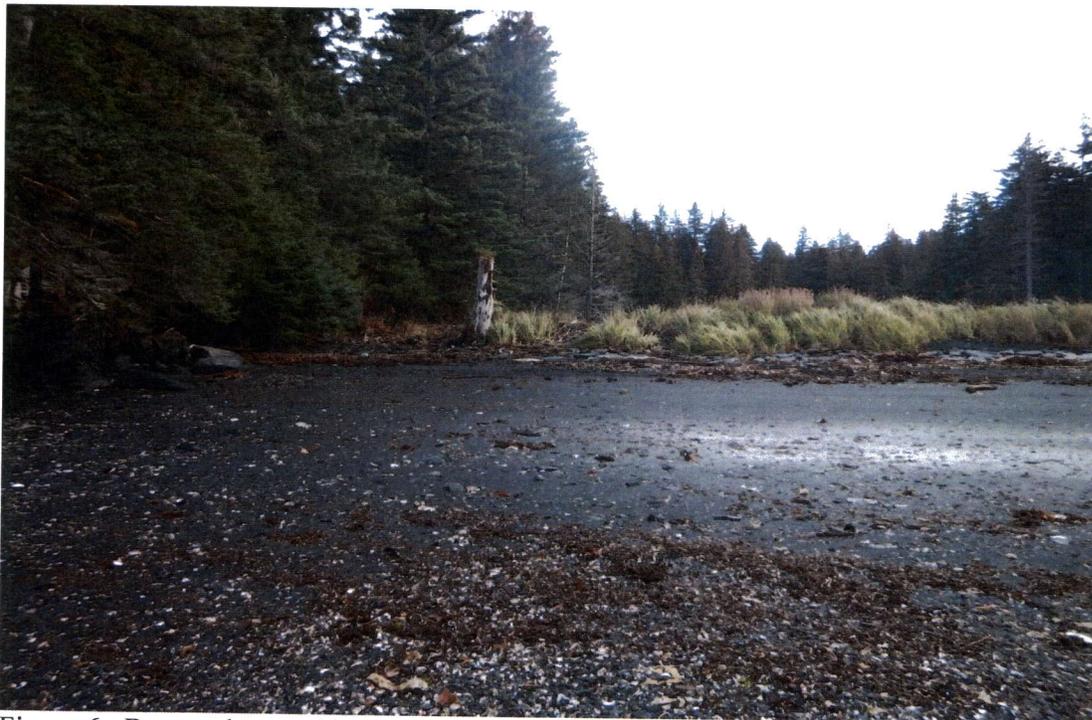
Figure 6. Beaver dam at tidewater in Unit KNG-11.

On the morning of September 12, Mr. Harris, Ms. Alas and I drove the 1100 Road to Unit KNG-11 on Discoverer Bay. The land is managed by Koniag. We walked to an unnamed stream and located a barrier to fish passage about 30 meters above a 5 acre beaver pond. A beaver dam is located at about mean high water level to Discoverer Bay (Figure 6). No defined stream channel exists below the beaver dam and no adult fish were observed below the beaver dam or in the lake. No riparian retention area will be required along the lake.

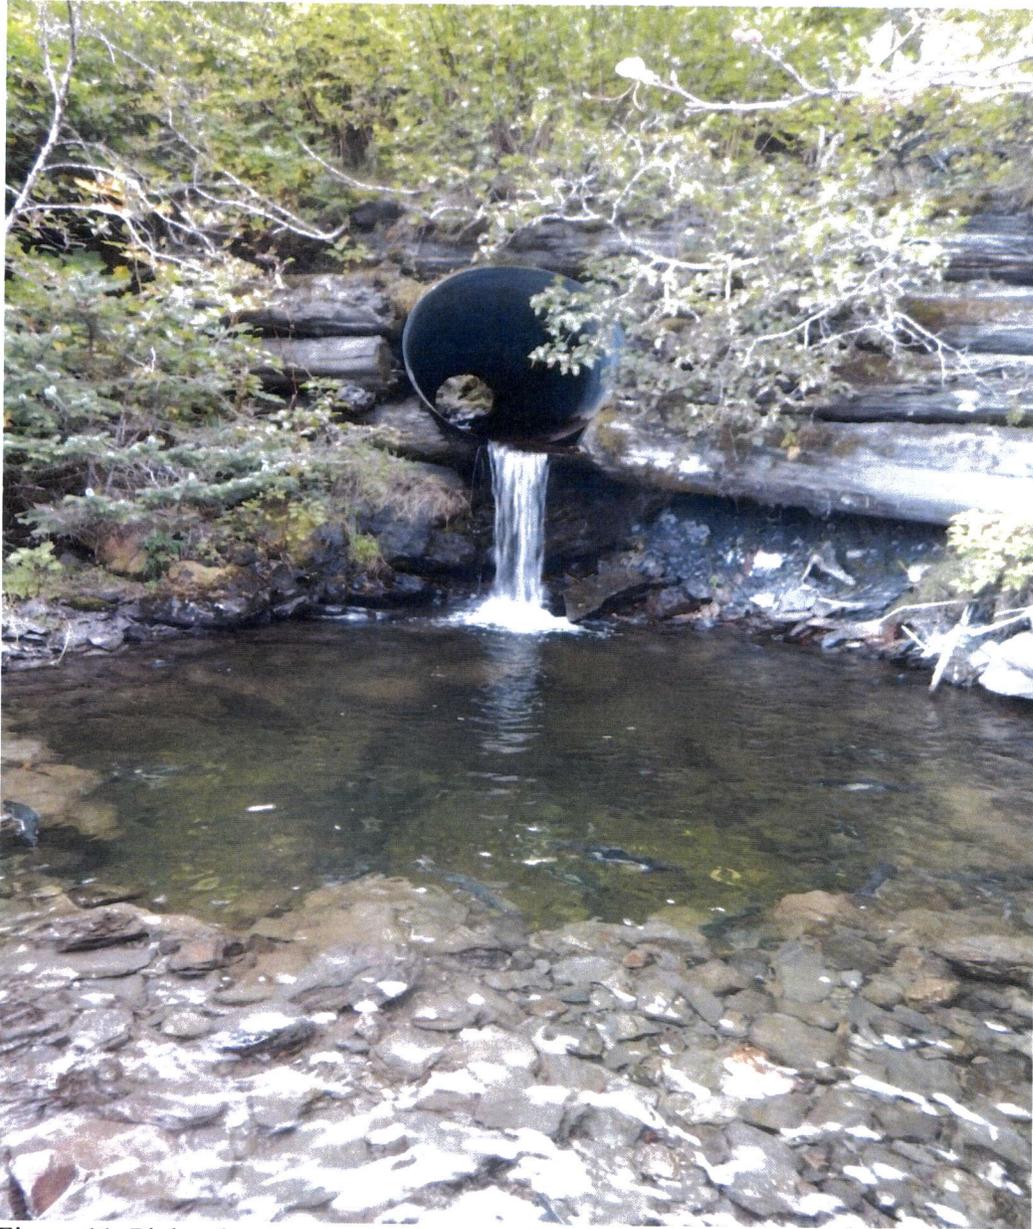
Figure 11. Pink salmon spawning in unnamed stream in ANC camp.

On the morning of September 13, Ms. Alas and I located about 40 adult pink salmon spawning in an unnamed stream located in the ANC camp. The salmon were below a perched culvert located on a camp road (Figure 11). The culvert is directly below a natural barrier. The pink salmon will be nominated to the Anadromous Waters Catalog.
