LEES CABIN CREEK ROUTE CORRECTION

Stream: Lees Cabin Creek (106-44-10240-2011, cataloged for COp)

Date Surveyed: July 28, 2013

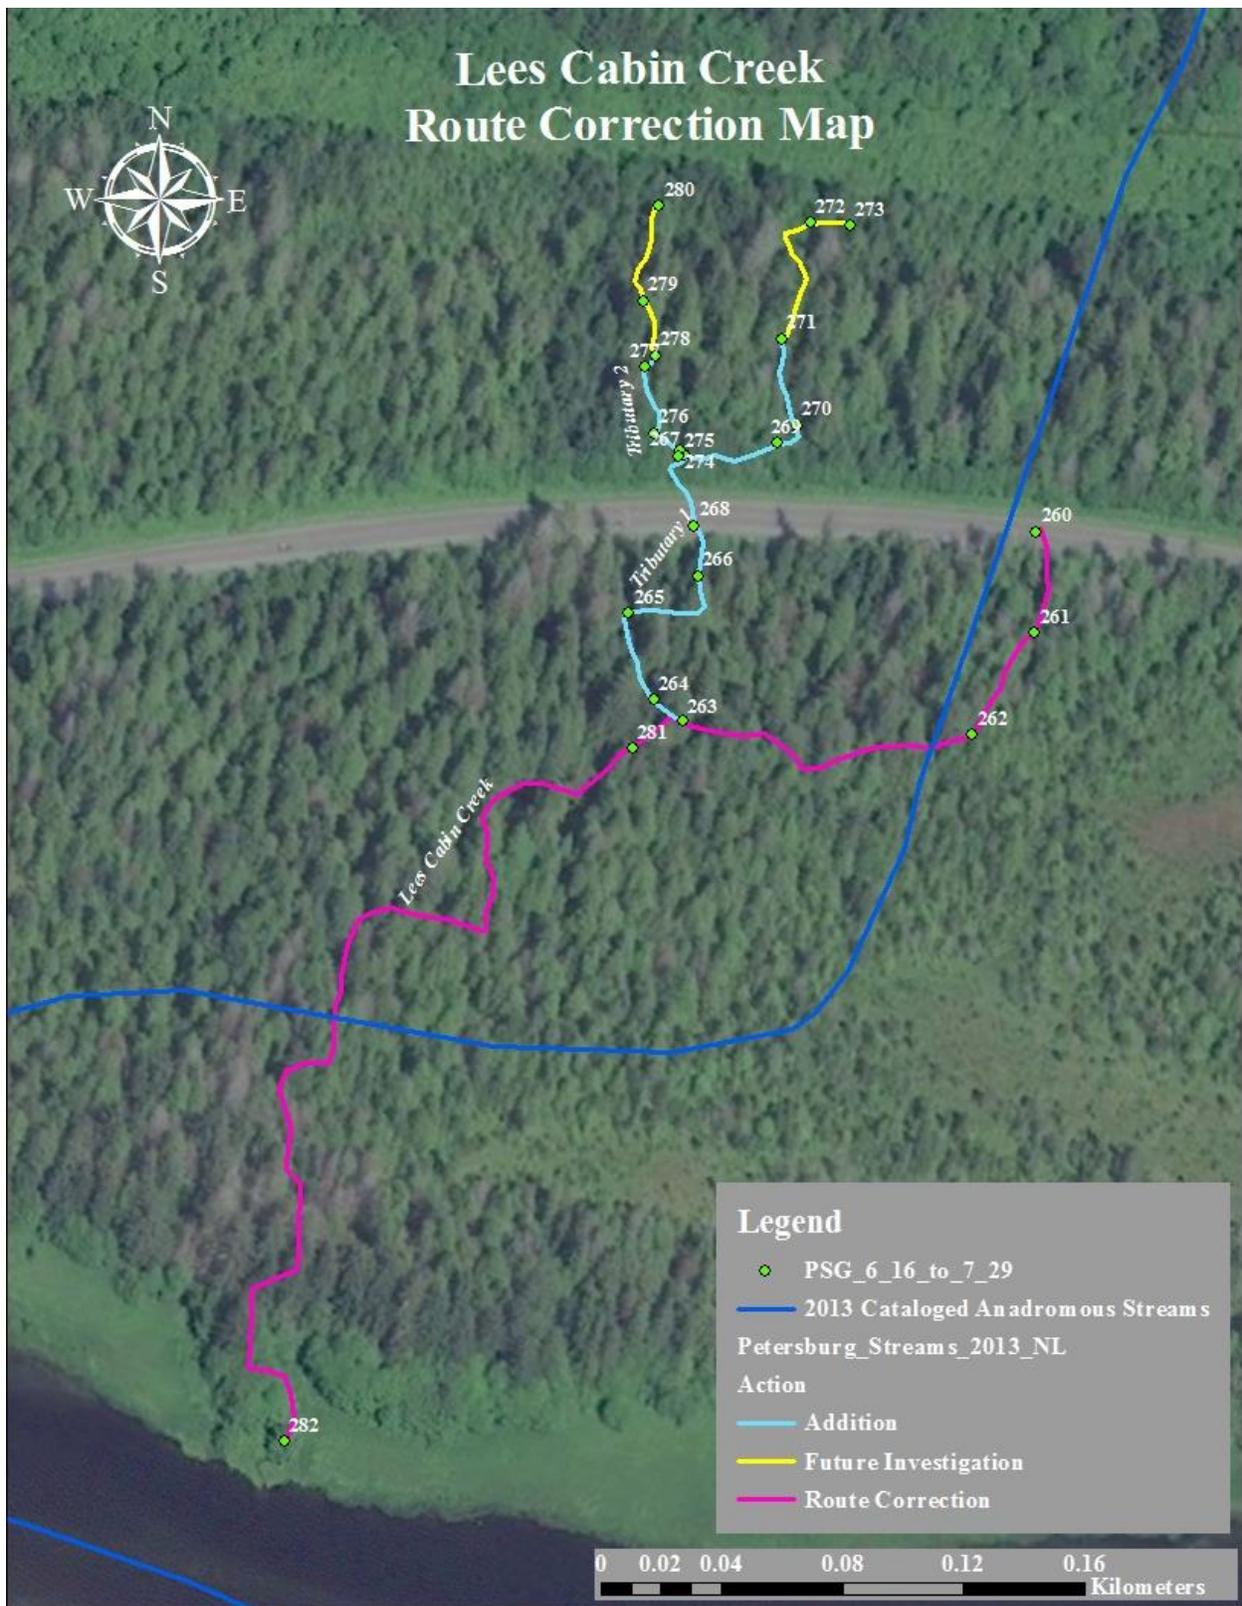
Figure 1.— Lees Cabin Creek route correction map.

Findings: We tracked the lower portion of this creek and found the route differs from the AWC (Table 1 and Figure 1). We did not track Lees Cabin Creek above the culvert.

Recommendations: Update the stream route in the AWC.
