114-40-10280**CORRECTION****Water body name:****Survey date:** 4/30/2014**Water body number:** 114-40-10280**Species & Lifestage:** Ps**Watershed:** Idaho Inlet-Frontal Icy Strait**MTR:** C042S057E **Quad:** Mt Fairweather A-1

Table 1.-114-40-10280 survey data

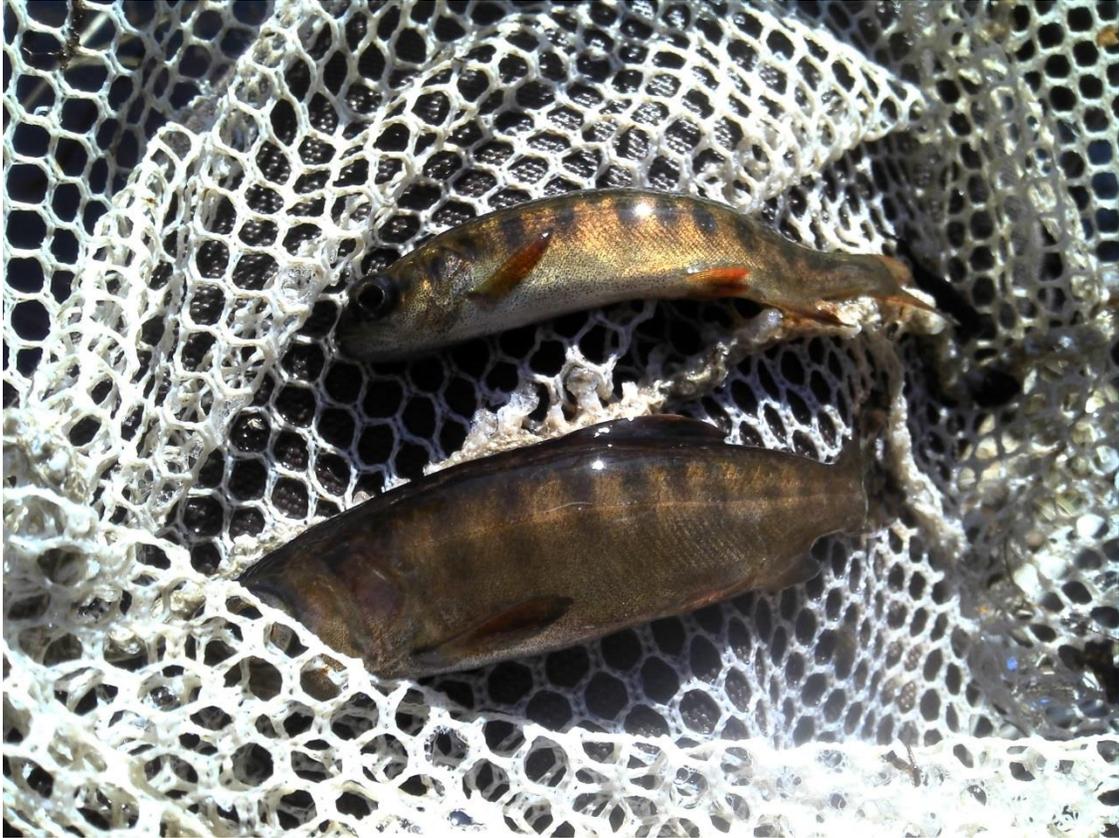
Findings: We tracked and surveyed this stream for fish using a GPS and an electrofishing unit. The route for this stream differs from the current AWC and rearing coho salmon were caught throughout the stream, including above the current anadromous section. Due to time constraints we had to stop the survey early, but there was no change in habitat so there is a possibility there are salmon present above documented area.

Figure 1.-Coho salmon caught in Stream No. 114-40-10280.

Recommendations: Continue survey on this creek until a barrier is reached. Extend and correct the current route and add rearing coho salmon to the AWC.

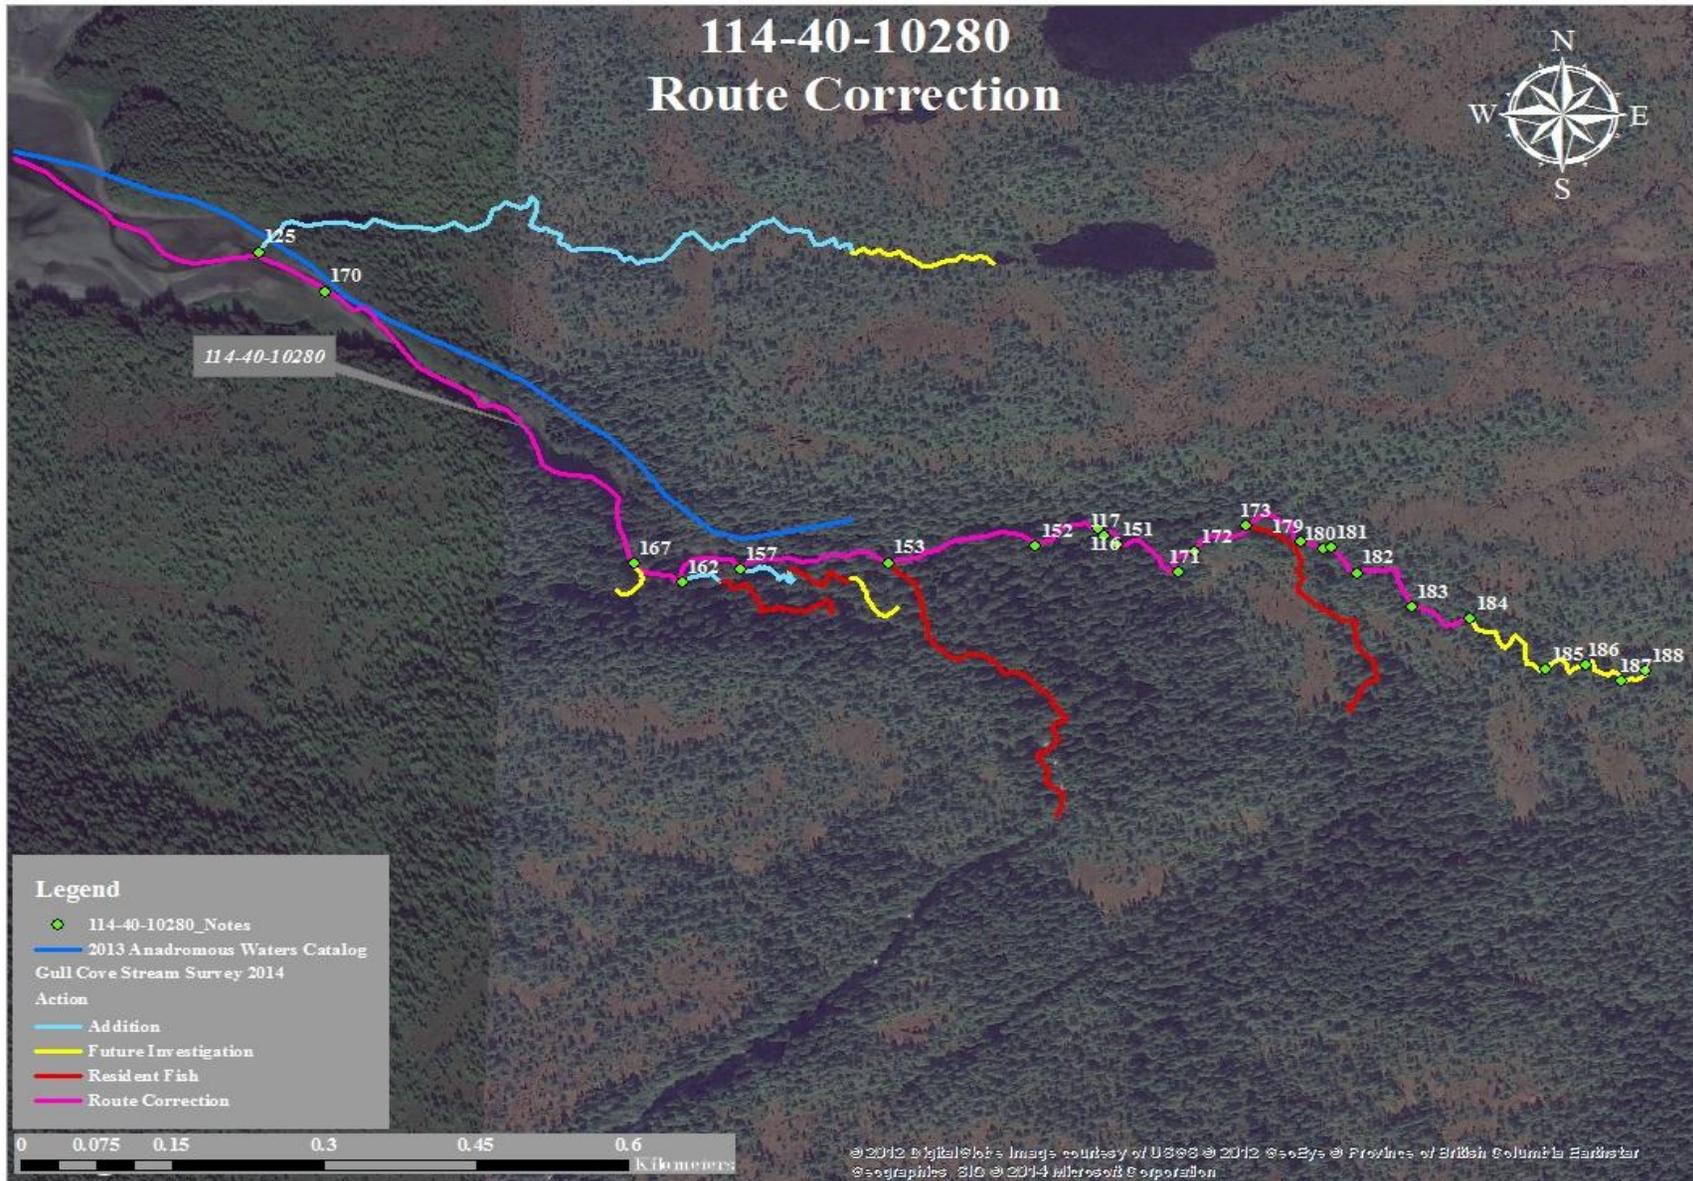
Figure 2.-114-40-10280 route correction map.
