LATITUDE: 55 21' 16"
 LONGITUDE: 131 41' 25"
 TIDE AT TIME OF SURVEY: Half flood
 WEATHER: Broken clouds, fair, 50 F
 TREES: Mixed deciduous shrubs.
 MAP NO: Ketchikan B-6
 WATER SUPPLY: Runoff
 LENGTH: 1 mile
 DRAINAGE: 1 sq. mile

101-47-18 101-47-01
 6-11-76
 Jackinsky

SUBURBAN HOUSING AREA

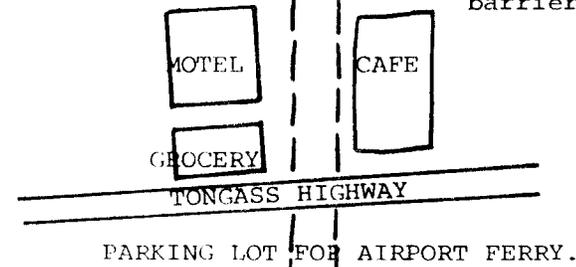
Creek flows through subterranean culvert here to saltwater (100 yds) possible barrier.

Rip-rap with gravel fill.

Culvert empties below high tide level.
