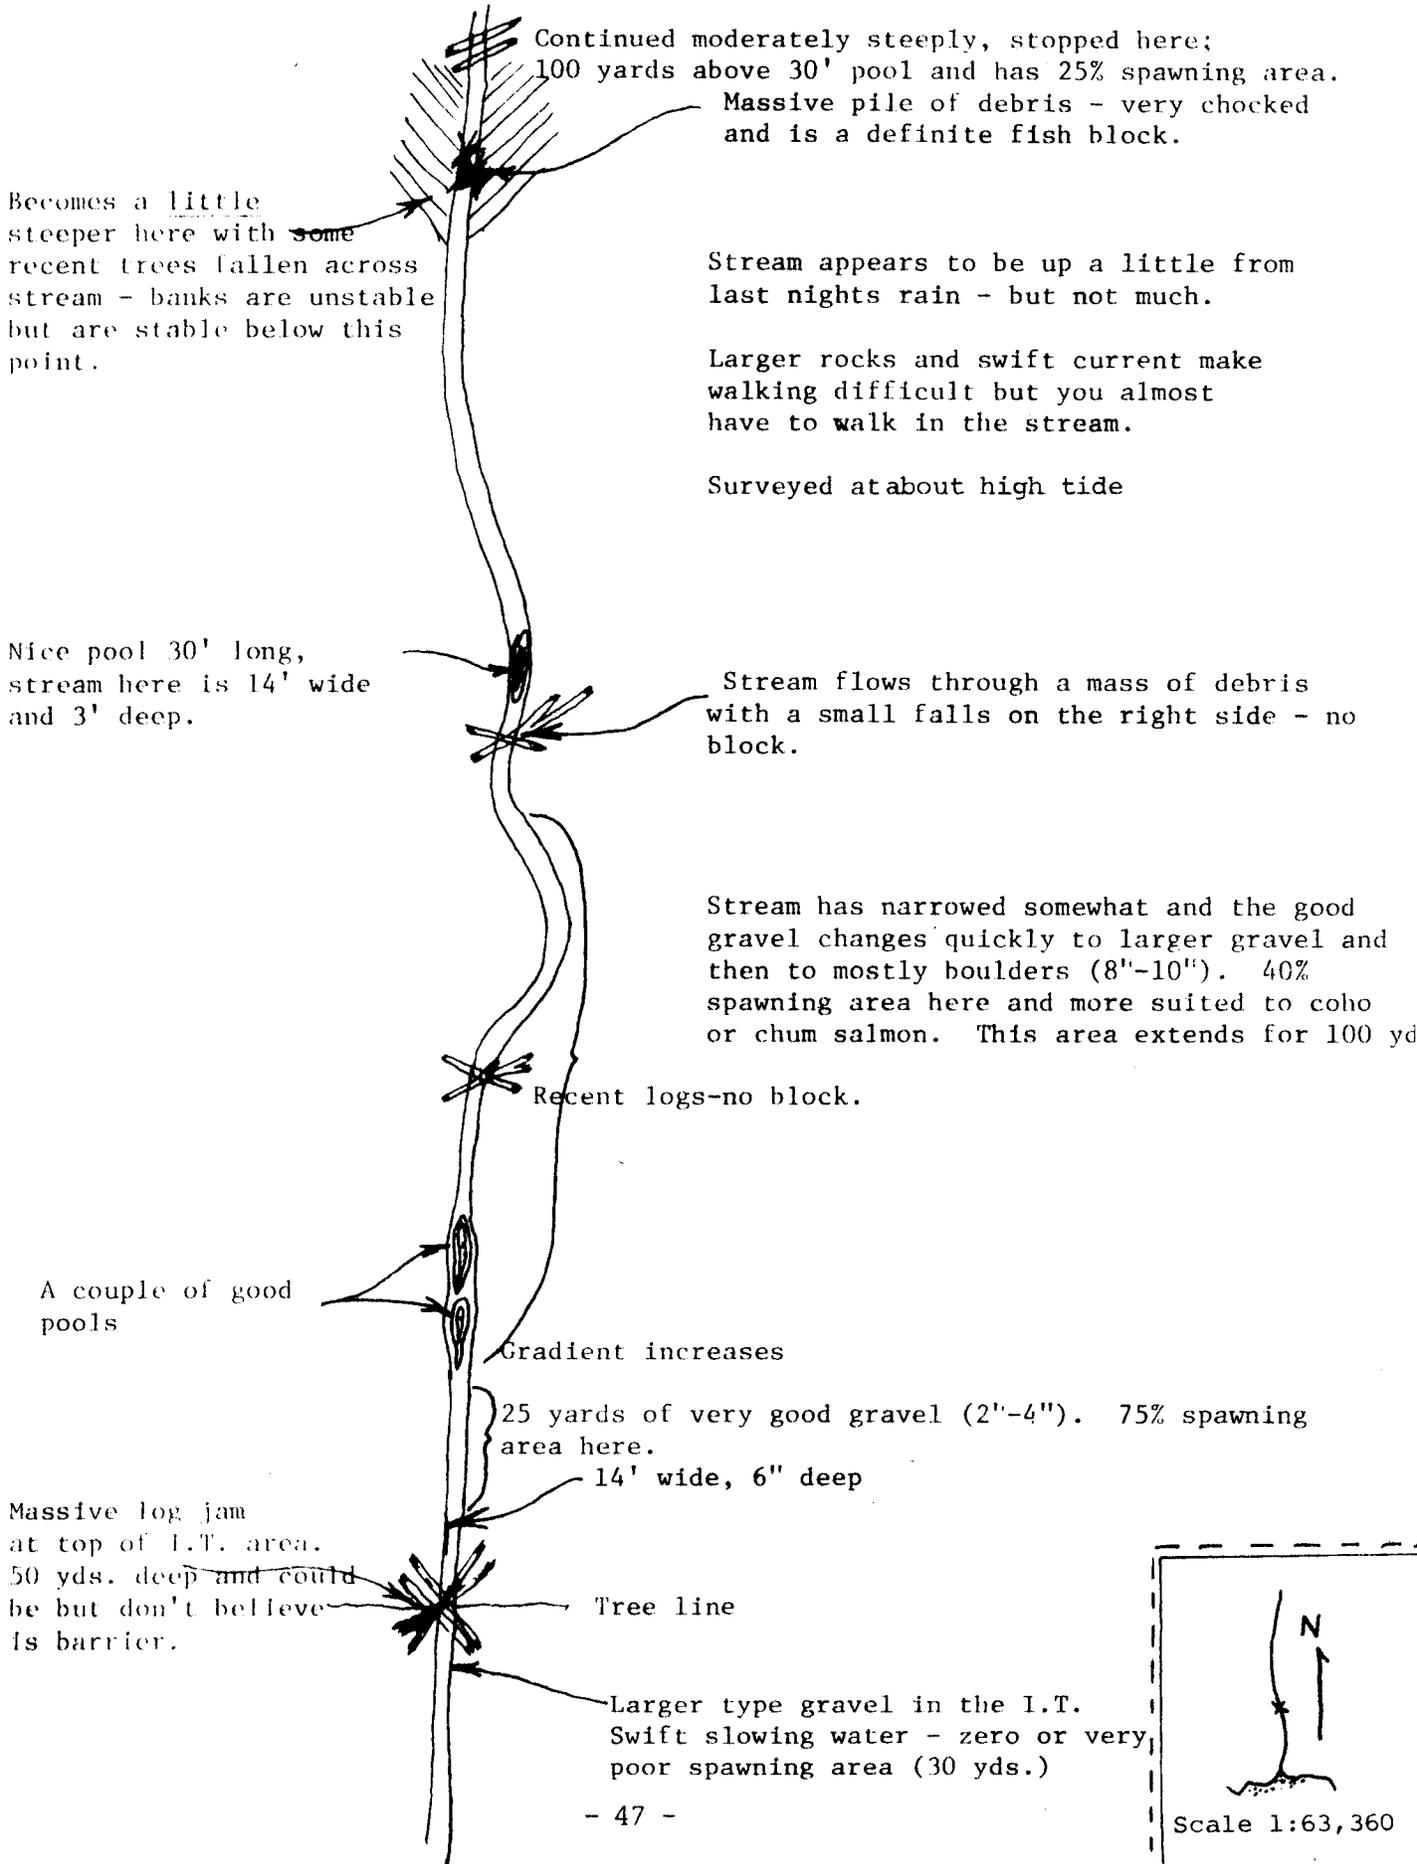
Becomes a little steeper here with some recent trees fallen across stream - banks are unstable but are stable below this point.

Continued moderately steeply, stopped here; 100 yards above 30' pool and has 25% spawning area. Massive pile of debris - very chocked and is a definite fish block.

Larger rocks and swift current make walking difficult but you almost have to walk in the stream.

Nice pool 30' long, stream here is 14' wide and 3' deep.

Stream flows through a mass of debris with a small falls on the right side - no block.

Stream has narrowed somewhat and the good gravel changes quickly to larger gravel and then to mostly boulders (8"-10"). 40% spawning area here and more suited to coho or chum salmon. This area extends for 100 yd

Recent logs-no block.

25 yards of very good gravel (2"-4"). 75% spawning area here. 14' wide, 6" deep

Massive log jam at top of I.T. area. 50 yds. deep and could be but don't believe is barrier.

Larger type gravel in the I.T. Swift slowing water - zero or very poor spawning area (30 yds.)
