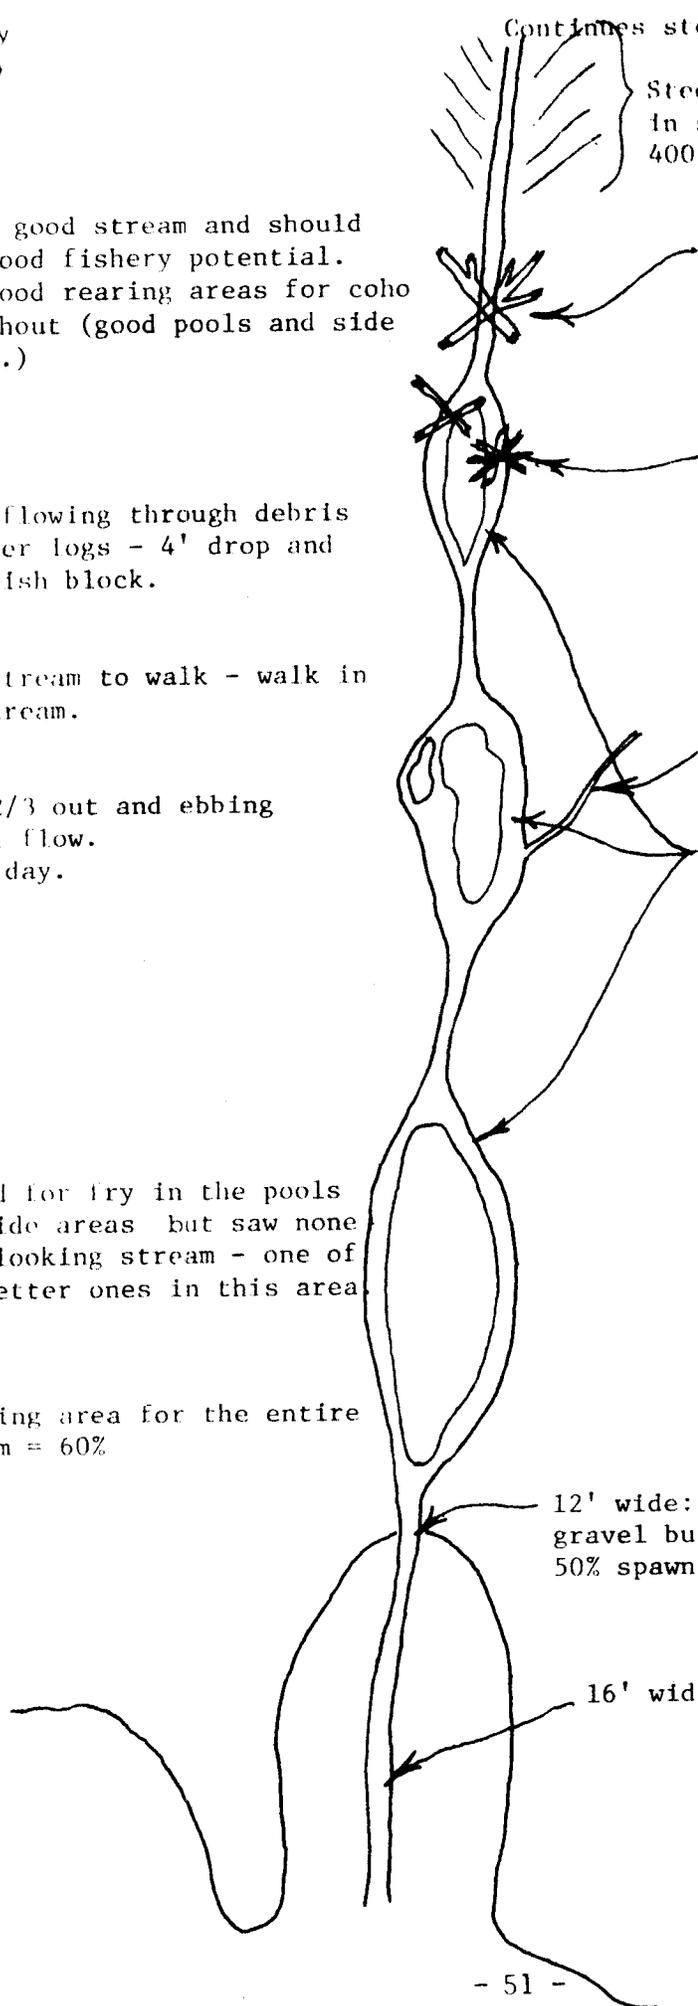
A very good stream and should have good fishery potential. Some good rearing areas for coho throughout (good pools and side areas .)

Water flowing through debris and over logs - 4' drop and is a fish block.

Looked for fry in the pools and side areas but saw none. Good looking stream - one of the better ones in this area.

Spawning area for the entire stream = 60%

Continues steeply.

Steep - much slumpage and debris in stream. Stopped here, approx. 400 yds. above the top of the ITZ.

Log jam and probable barrier with water flowing thru debris.

Smaller channel - 3' wide and is blocked by debris (fish block).

Small tributary

Braided areas but good gravel throughout and generally each channel is 6' wide and 4"-6" deep with pools 2'-3' deep

12' wide: Top of I.T. = 100 yds. of good gravel but has some bedrock throughout. 50% spawning area.

16' wide
