BIOLOGICAL AND HYDROLOGICAL STUDIES
KLAWOCK LAKE, RIVER AND ESTUARY
1976-77

W. Steven Bates

Alaska Department of Fish and Game
Division of Fisheries Rehabilitation,
Enhancement and Development

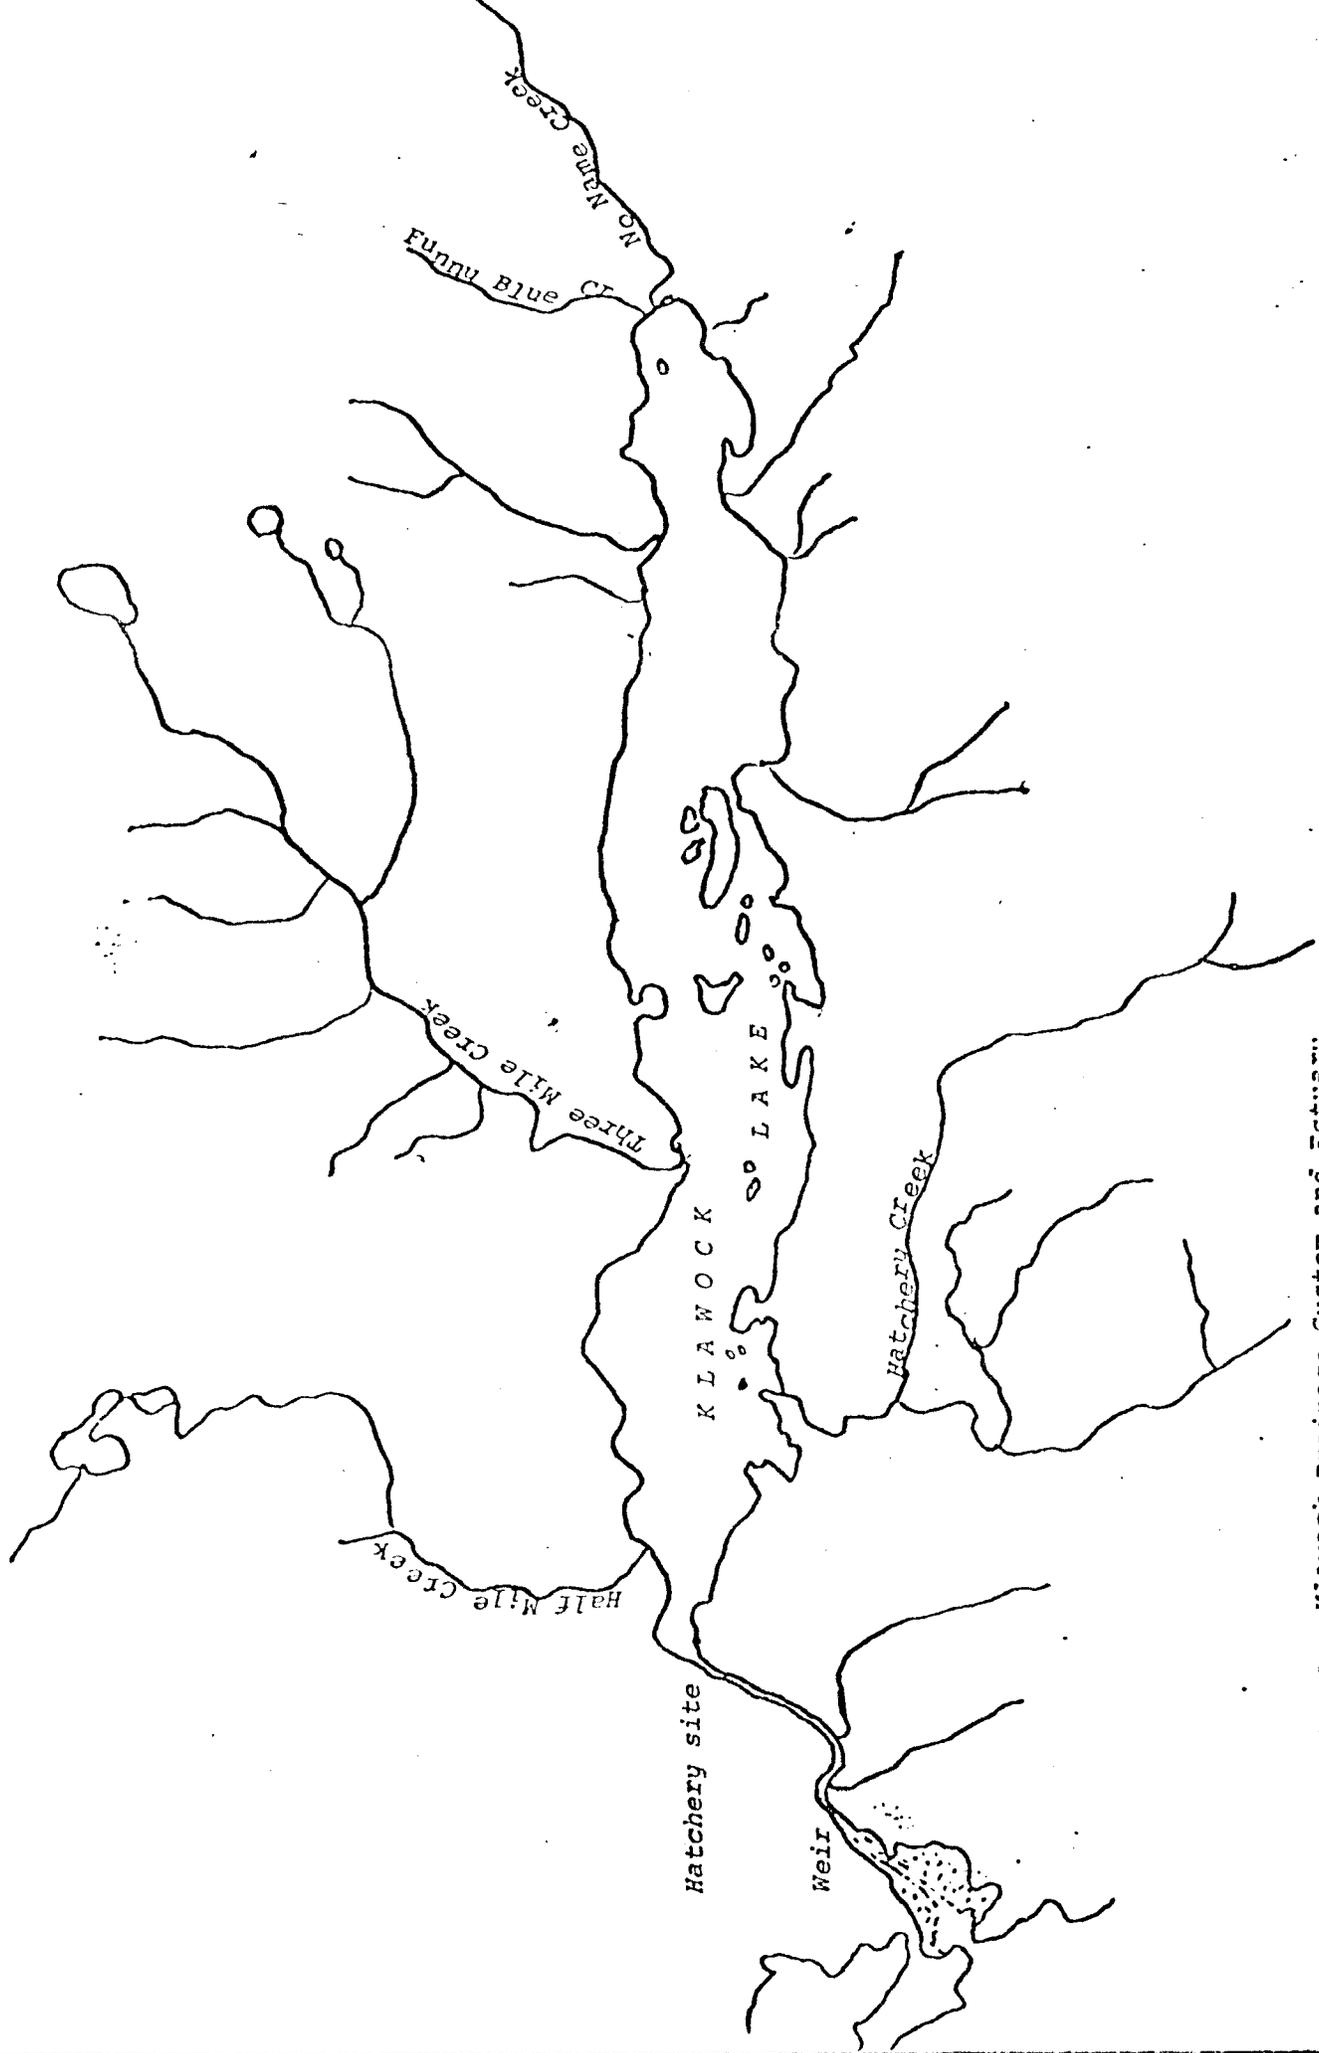
Fig. 1. Kiaxock Drainage System and Estuary.

Klawock Lake, a 1,176.7 hectare (2,906.4 acre) muskeg lake, forms the collecting basin for a 10,891.4 hectare (26,899 acre) drainage system (Fig. 1). Numerous small streams flow into this 12 km long, 1.1 km wide lake. Klawock Lake has a volume of $20.9 \times 10^7 \text{ cm}^3$ and a maximum depth of 49 m (Schmidt, 1974).

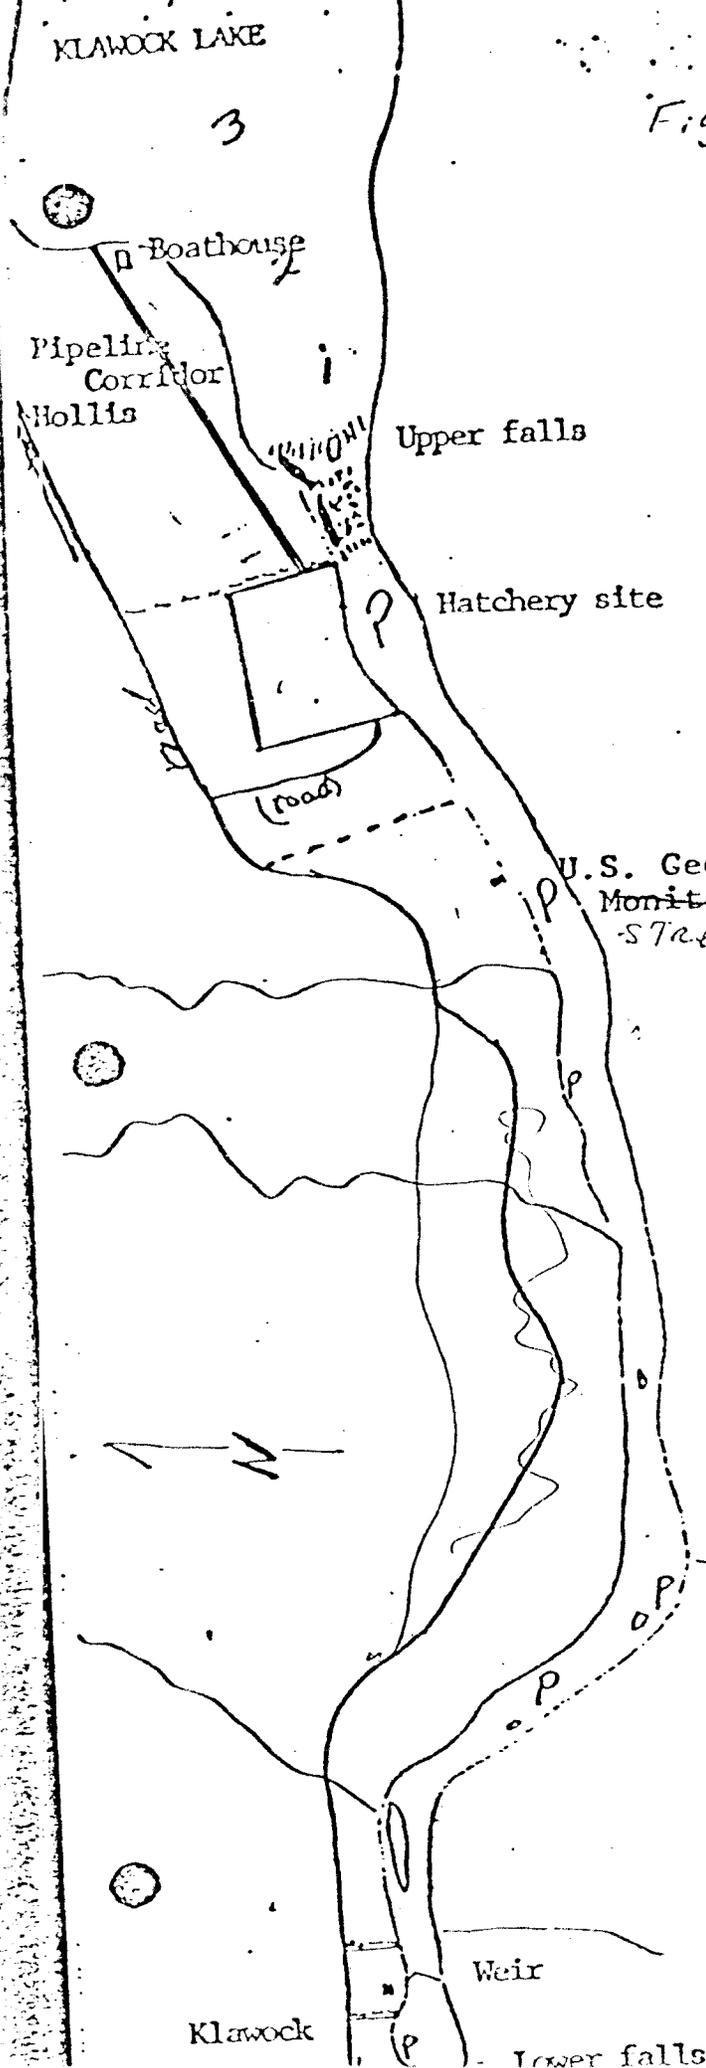
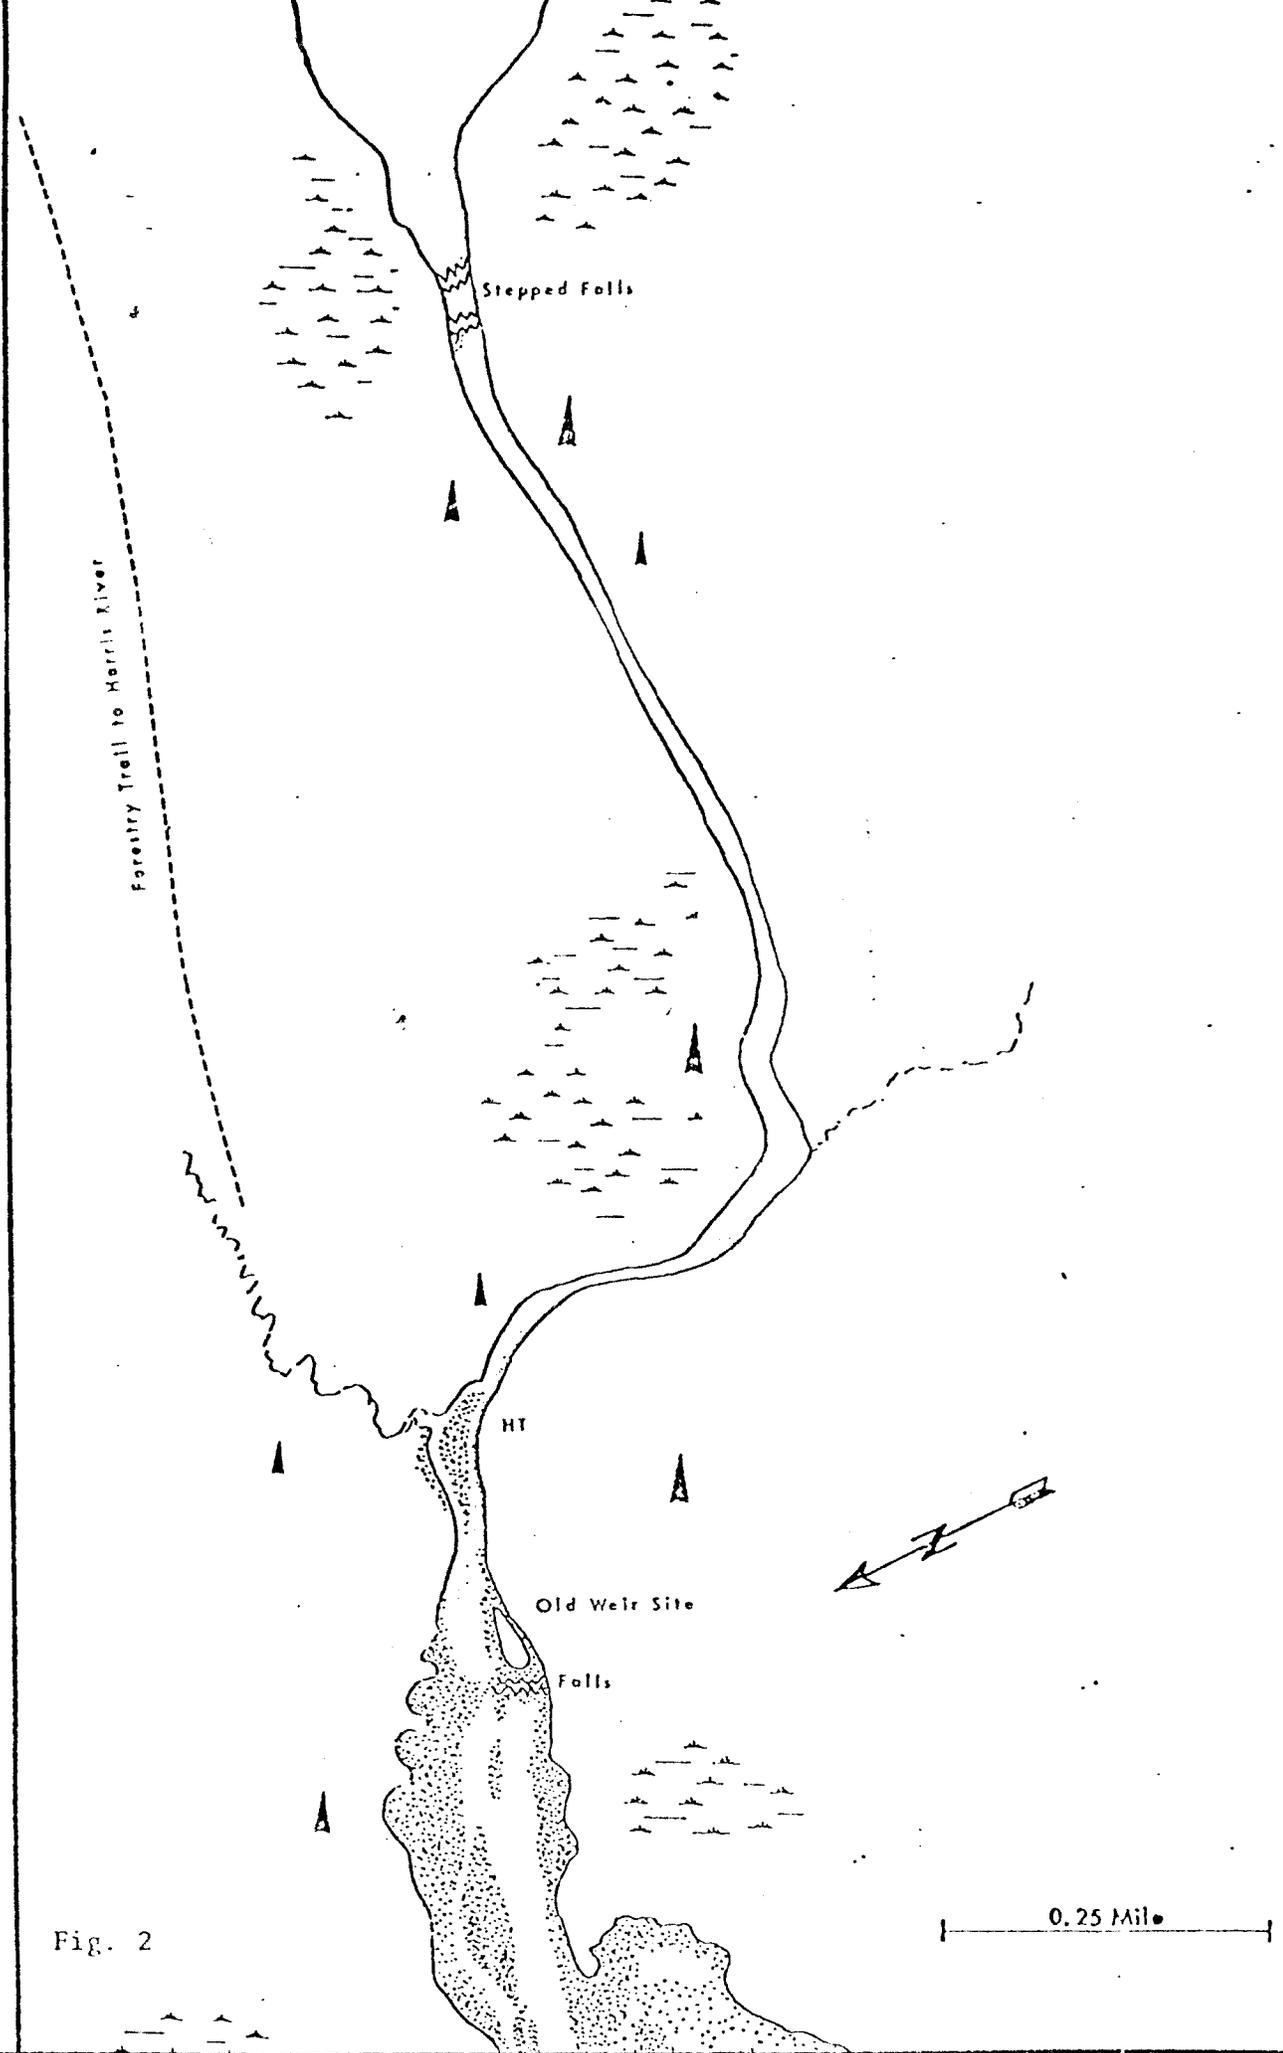
Fig. 2

Klawock River
ADF&G stream # 103-60-47

The Klawock River is one mile length with six large pools (P) of 3' of depth or greater. The remainder is riffles with large stones in the upper 2/3 of the streambed and small rock and gravel in the lower 1/3 of the streambed.

#1-4 are monitoring stations in the lake.

The temporary egg take site will be at the weir site.

The hatchery site shows appropriate excavation area. dotted lines indicate

dotted lines indicate leased land

The Klawock River flows from the west end of the lake, descending 9.15 m in 1.6 km before entering the Klawock estuary (Figs. 2 and 3). The hatchery is located near the base of the stepped outfall of Klawock Lake.

Four data collecting stations were set up at the lake (Fig. 2). Dissolved oxygen and temperature data were recorded at all four monitoring stations and pH and suspended solids data were recorded from Station 3. Recording thermographs were anchored and buoyed at Station 3. All data were collected following standard procedures given in the instructions accompanying the equipment.
