103-90-10470

103-90-94 (new)

Edgington

6/16/78

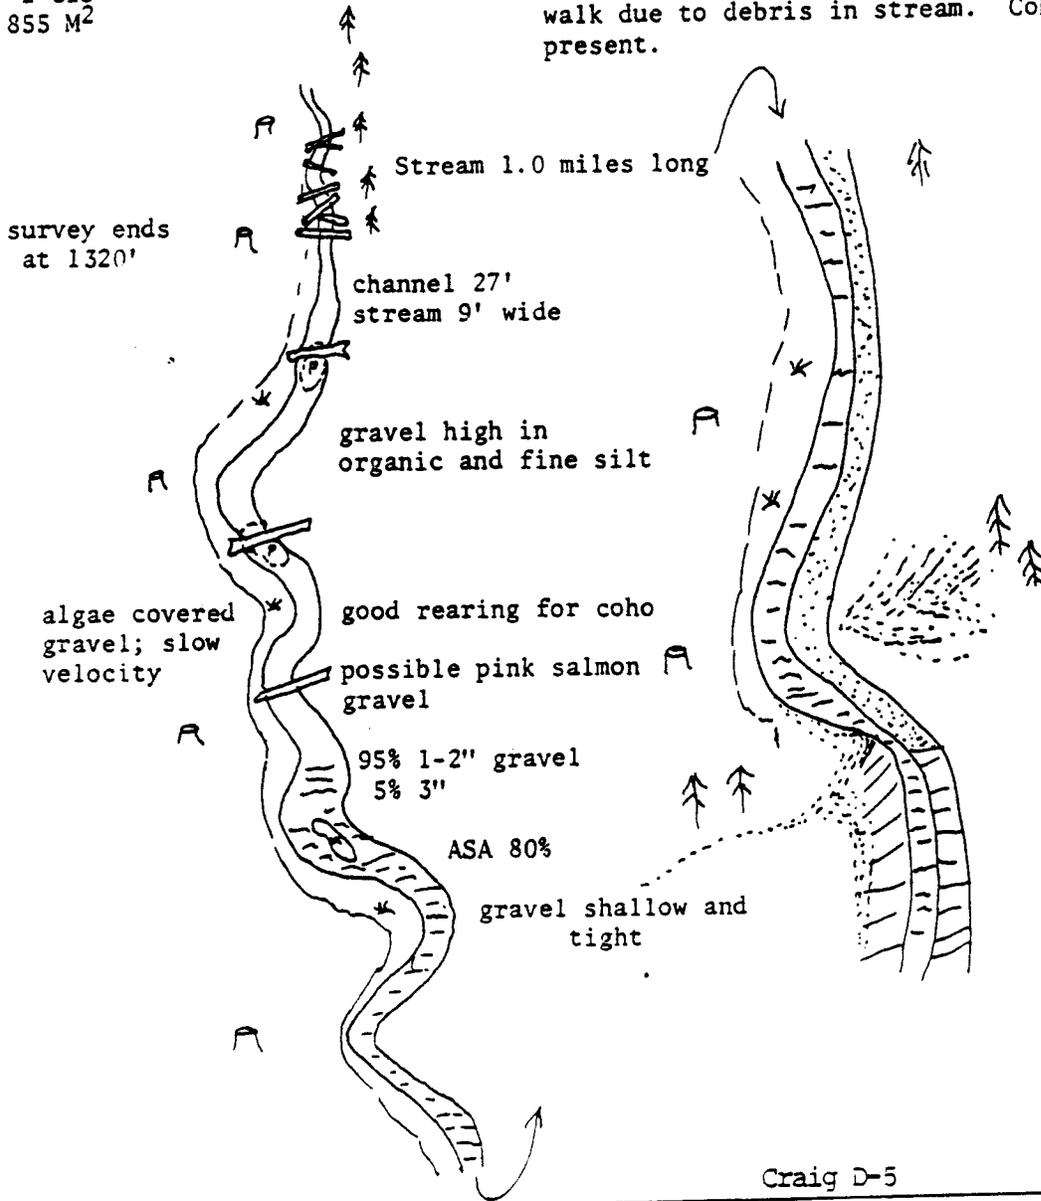
Stream continues to lake. Impossible to walk due to debris in stream. Coho fry present.

SPAWNING AREA: 855 M<sup>2</sup> (see map)

REHABILITATION POTENTIAL: A large amount of debris in the stream may cause a  
blockage in the future.
