Port Santa Cruz

Head stream

104-30-10

8-10-75

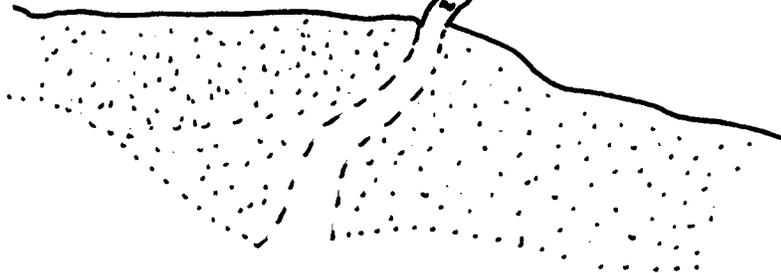
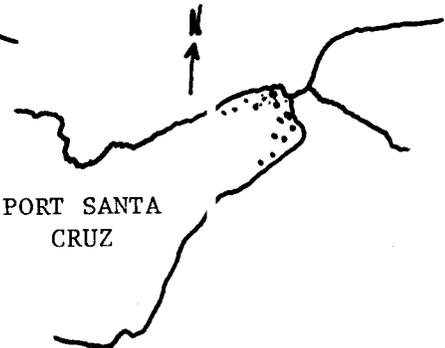
Station #1

Stream begins steepening

200 yards

4' waterfall - no barrier

Average width - approx. 8'

8-14" rubble 50%

2-4" gravel 50%

30% ASA

25% pools 2' deep w cf stream

Cut bank

No fry

4-12" round rocks

20% ASA

Much red sandstone
