Juvenile Fish Passage Through Culverts in Alaska: A Field Study

Publication Number FHWA-AK-RD-00-03

Report No. INE/WERC 00.05

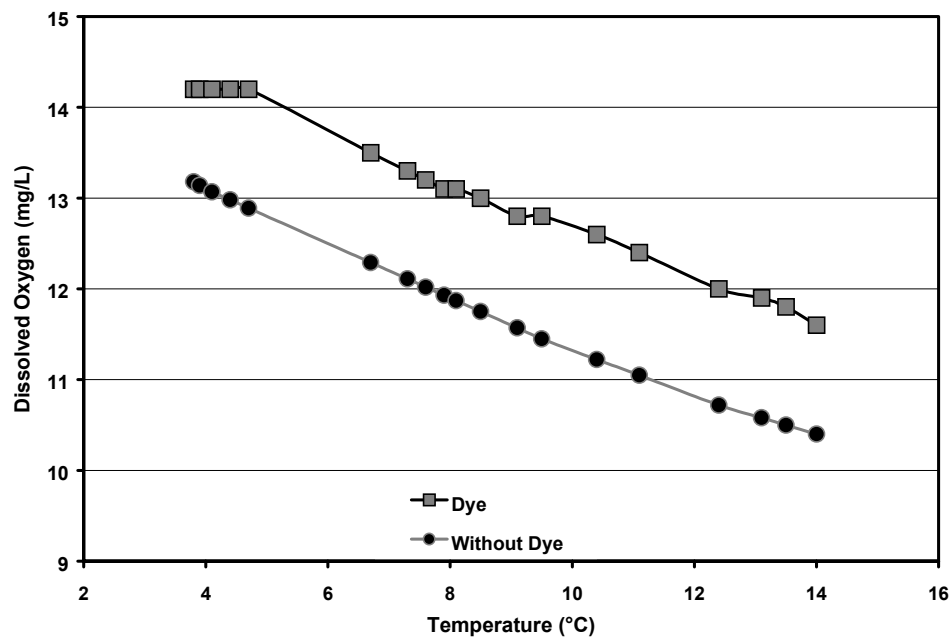
Figure 1. Oxygen saturation levels for a range of temperatures for water with and without dye.

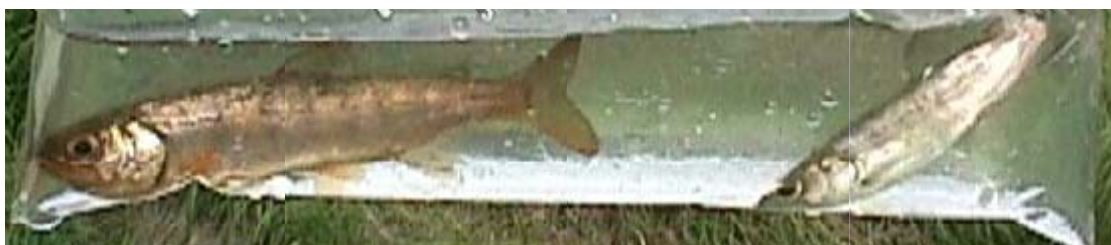
Figure 2. Comparison of two Coho, one stained (left) and one unstained (right).

2. While waiting on the traps, we set-up our fish-staining equipment and installed a staff gage in the stream. We used neutral red and Bismark brown dyes at concentrations of 1:64,000 or less. We prepared about three gallons of dye solution by putting the dye in a coffee strainer and running stream water through it. The strainer prevented large clumps from forming in the make-up water for the fish. To avoid unnecessary stress on the fish, the solution was continually aerated with an aquarium-type aerator that was run off a 12-volt battery with an inverter. Contrary to our expectations, laboratory measurements showed that the oxygen saturation level over a range of temperatures was raised over 1 mg/l in the solutions of Bismark brown we used (Figure 1). Therefore the dye did not add any stress to the fish by reducing oxygen saturation levels. We also began using only Bismark brown the second year, because of a paper by Ward and Verhoeven (1963) which reported that the neutral red dye was fatal to juvenile salmon (although we never observed any fatalities from this dye). Either dye proved suitable for staining the fish (for at least 4 to 5 days) from an identification viewpoint.

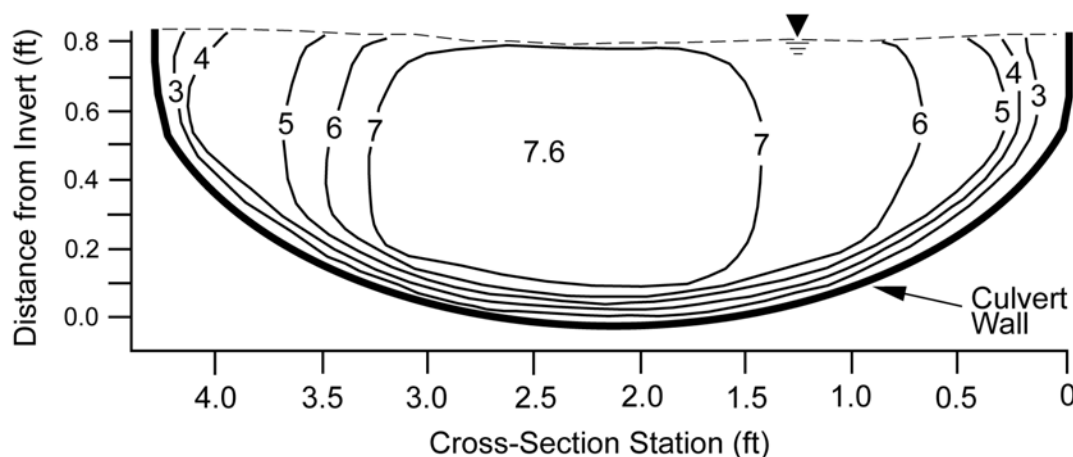
Figure 10. Cross-section of the velocity at 10 ft. (3 m) into Beaver Creek culvert from the upstream outlet (looking downstream).

At the upstream inlet, at a point in the culvert near what appeared to be maximum velocities, we took numerous measurements of the velocities (Figure 10). This cross-section shows the high velocity gradients that exist near the boundaries. The highest water velocity gradients along the boundary are near the centerline at the bottom of the culvert; the lowest velocity gradients are near the water surface on each side. It is interesting to note that when we observed juvenile fish moving upstream in this section of culvert, they were near the water surface on either side of the culvert. Velocity profiles along the centerline of the culvert and near the edge of the culvert are shown in Figure 11 for the cross-section of Figure 10. Attempts to measure the velocity along the culvert wall at various points showed considerable variability depending upon the cross-section. At the shallowest depth and highest average velocity, the point velocities near the wall (as close as we could measure, approximately 0.15 feet (4.5 cm)) were around 3 fps (0.9 m/s).

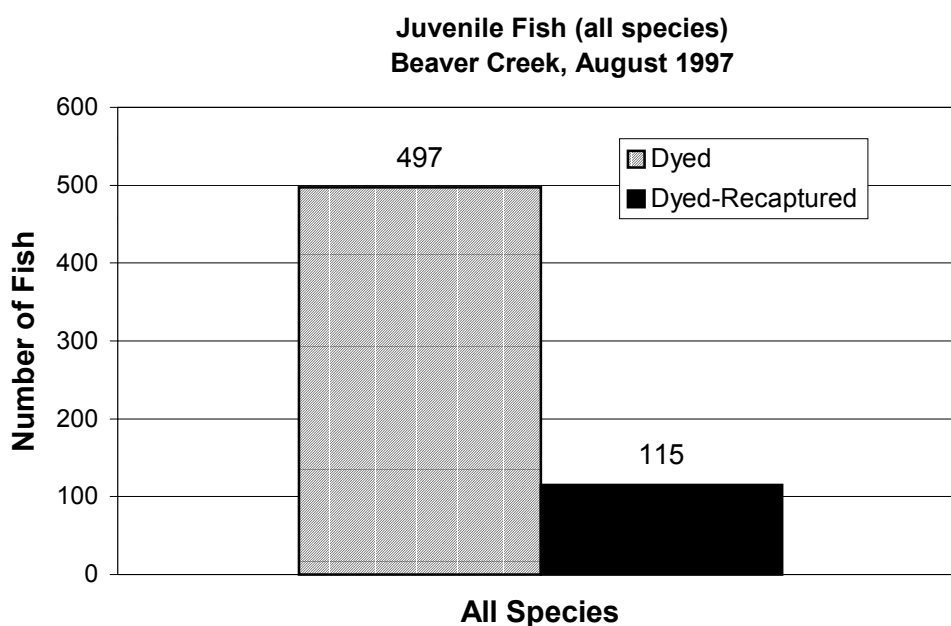
Figure 12. Plot of total number of juvenile fish stained and total number of fish recaptured at Beaver Creek (July 31 – August 4, 1997).

Of the approximately 500 dyed juvenile fish released downstream at Beaver Creek, 115 were recaptured upstream (Figure 12). It is not likely that we were successful in capturing all of the fish that successfully traveled upstream through the culvert, so all plots of the number of fish dyed-recaptured are conservative on the low side (or more fish succeeded than we indicate in graphs). Generally larger fish passed through the culvert first (true for all sites). We maintained our traps upstream for several days to allow young-of-the-year fish an opportunity to pass

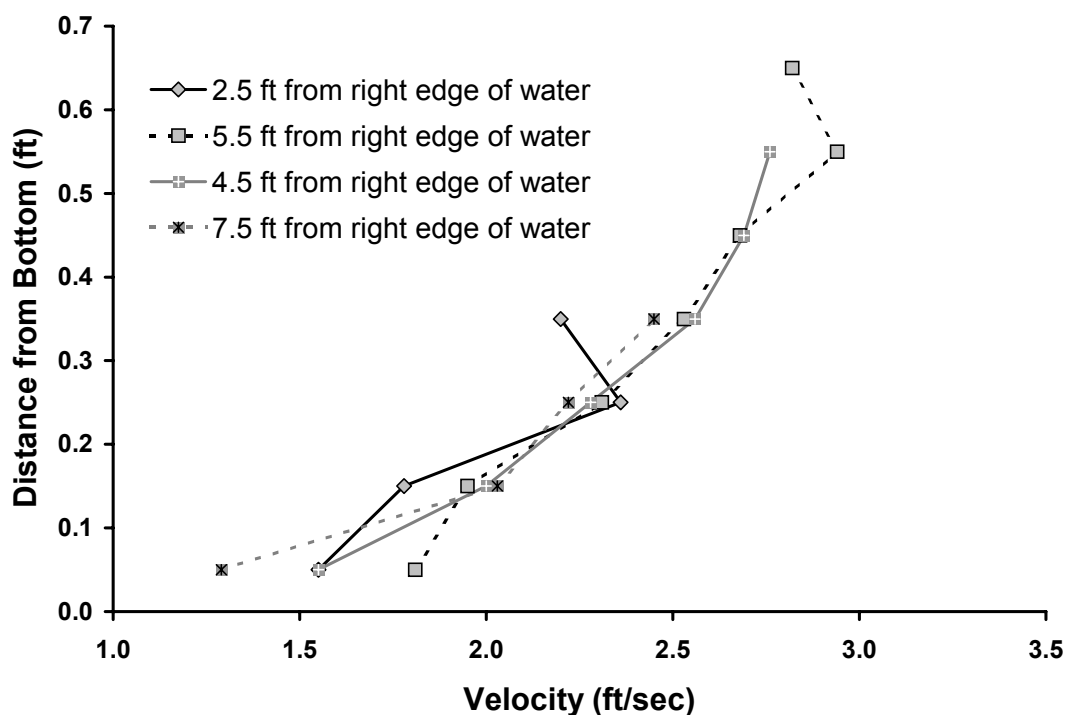
Figure 14. Velocity profiles of a cross-section located 6 feet upstream from culvert outlet on No-Name Creek.

are 3.0 fps (0.9 m/s) on the centerline near the surface. Velocities along the boundary are closer to 1 fps (0.3 m/s).

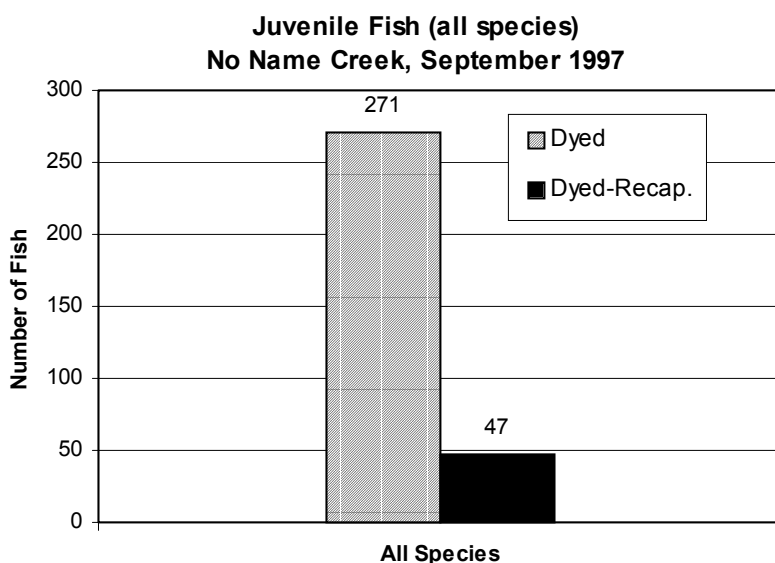
Figure 15. Plot of the total number of juvenile fish dyed against the total number of dyed fish recaptured for No-Name Creek (September 13-17, 1997).

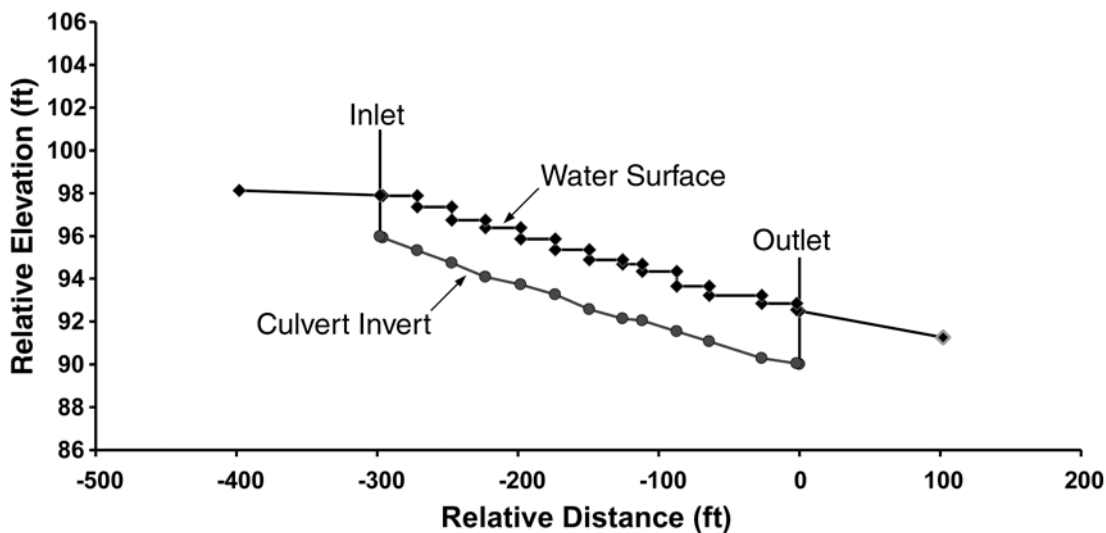
Figure 19. Water surface and culvert invert profiles for Soldotna Creek on August 2, 1997.

There was generally no flow over the baffle along the wall at the high side of a baffle. The drop in the water surface at each baffle (Figure 19) ranged from 0.25 (7 cm) to 1.0 ft (30 cm). Since we used just one dye, we could not separate recaptured fish according to the date dyed.

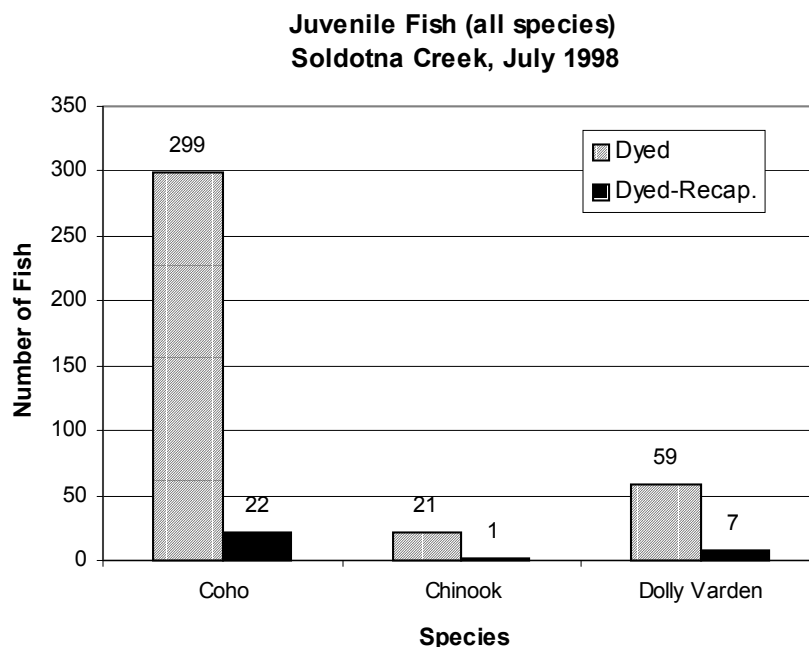
Figure 20. Comparison of the number of juvenile fish dyed against the total number of dyed fish recaptured upstream for Soldotna Creek (July 8-10, 1998).

It appears that no young-of-the-year fish made it through the culvert on the day they were released; dyed fish were released on July 8 and 9 and young-of-the-year were first recaptured on July 10. A summary of the dyed fish that successfully passed the culvert and were recaptured is shown in Figure 20.

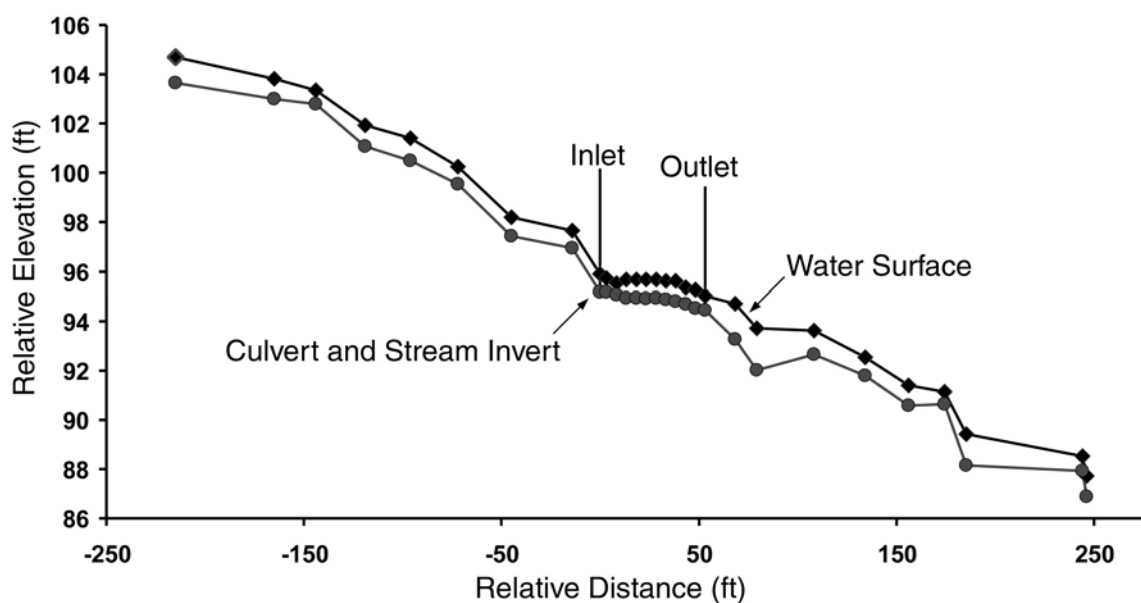
Figure 22. Water surface, stream and culvert invert profiles for Pass Creek Tributary on 14.4 mile Polk Inlet Road, Prince of Wales Island.

After our experience at the other three sites, we decided that a culvert with high velocities uniformly distributed throughout the full culvert length would be worthwhile to study. We expended considerable time on Prince of Wales (POW) Island trying to locate a culvert satisfying such criteria. Many culverts on POW Island are interesting from a hydraulic viewpoint; unfortunately we could not verify that sufficient fish were present for our study. We finally selected a culvert at mile 14.4, Polk Inlet Road. The culvert was only 53.25 ft (16.2 m) long, but depth of flow was fairly uniform throughout its length. The water surface and culvert invert elevation profiles appear in Figure 22 (Numerical values for slope shown in Table 1).

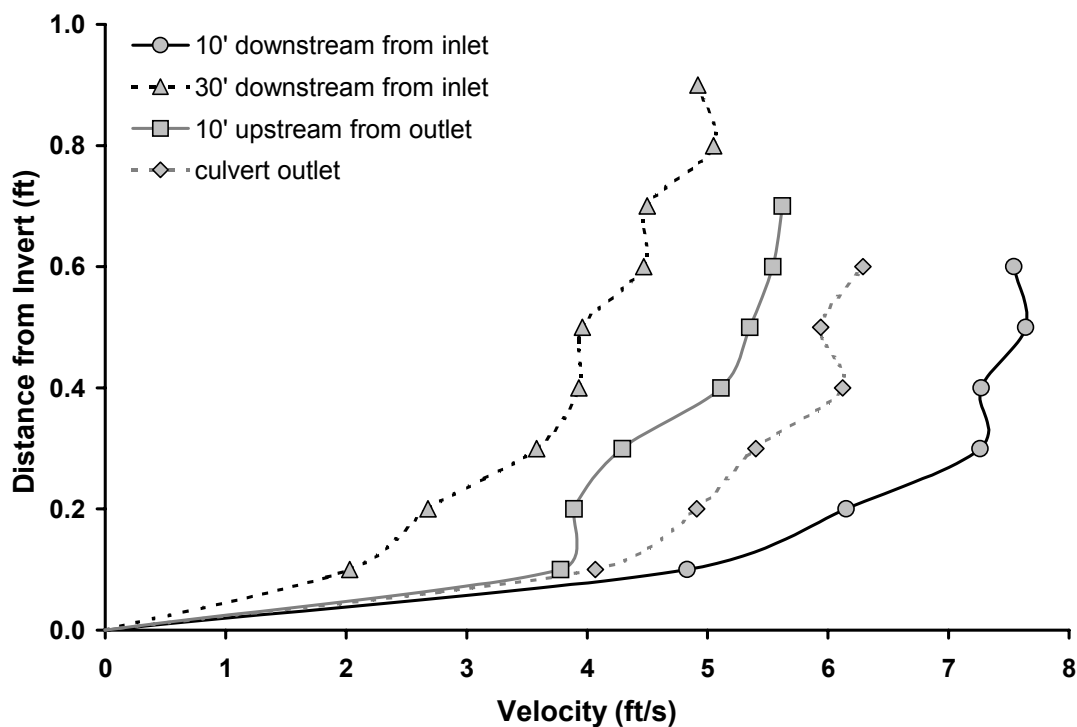
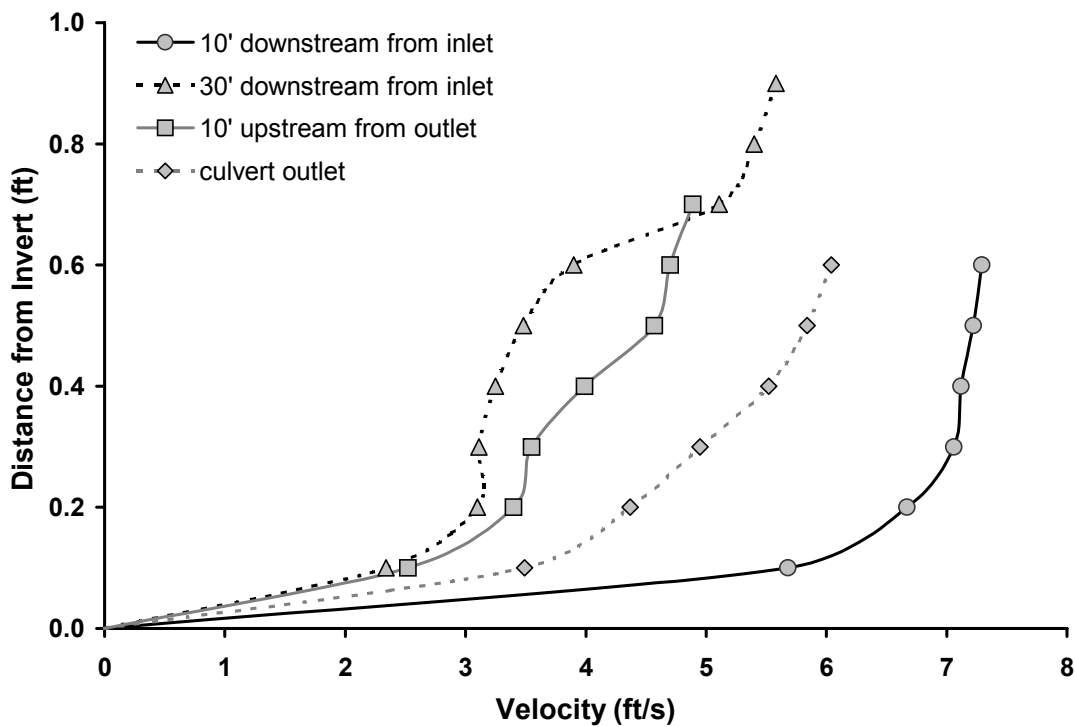
a. October 5, 1998.

b. October 8, 1998.

Figure 23a and b. Velocity profiles along centerline of culvert on Pass Creek Tributary on October 5 and 8, 1998.

A staff gage was placed in an upstream pool. During most of the visit, the discharge was approximately 10 CFS ($0.3 \text{ m}^3/\text{s}$). Maximum culvert velocities (Figures 23 a and b) along the centerline ranged from 5 to >7 fps (1.5 to $>2.1 \text{ m/s}$) on October 5, 6 and 8, 1998. The Froude number for this culvert ranges around 1, in the deepest sections of the culvert the flow was subcritical and in the shallower sections the flow was supercritical.

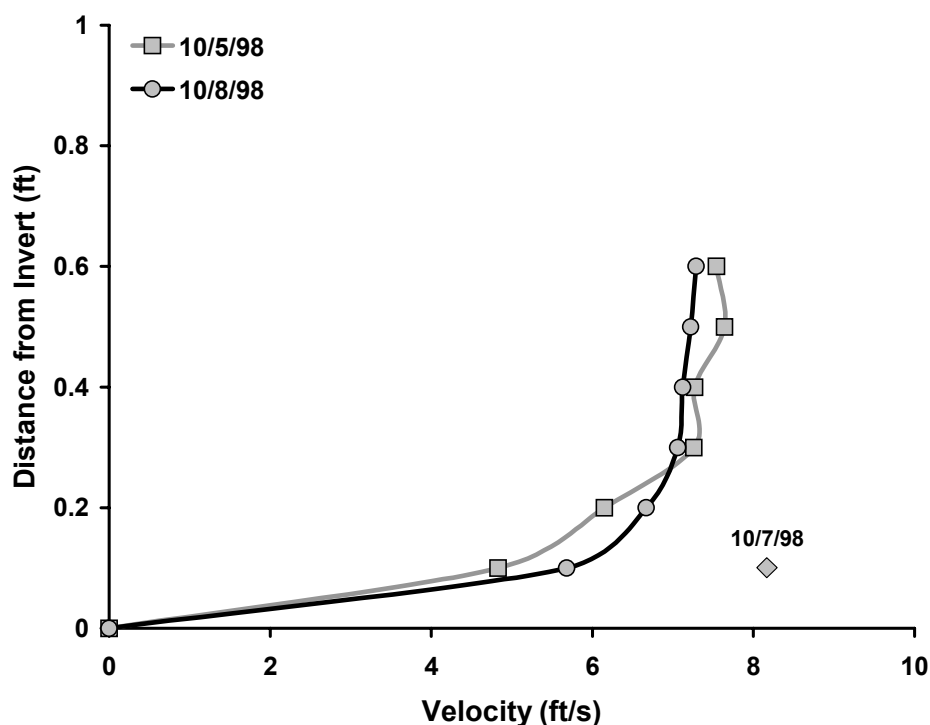
Figure 24. Velocity profiles 10 ft. (3 m) downstream from culvert inlet on Pass Creek Tributary. Note, these profiles can be compared with the solitary velocity measurement at 0.1 ft (0.03 m) from the culvert invert that was made on October 7, 1998.
