Nomination Form
Anadromous Waters Catalog

Anadromous Waters Catalog Number of Water Body 114-31-10130-2051

114-31-10130 Tributary 7

ADDITION

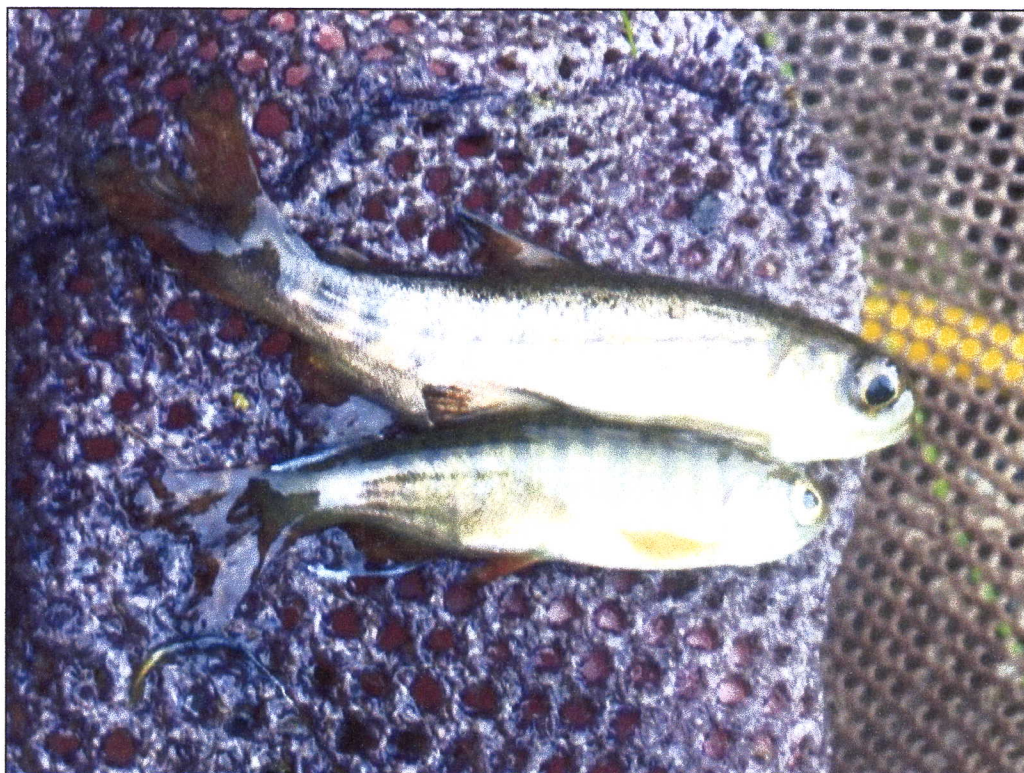
Figure 1.—Juvenile coho salmon captured at waypoint 1028.

Findings: We surveyed this uncataloged stream using a backpack electrofisher and GPS. We captured juvenile coho salmon and Dolly Varden. The tributary stream maintains a low gradient along the base of a hillside and flows through several beaver dams (Table 1; Figures 1–3).

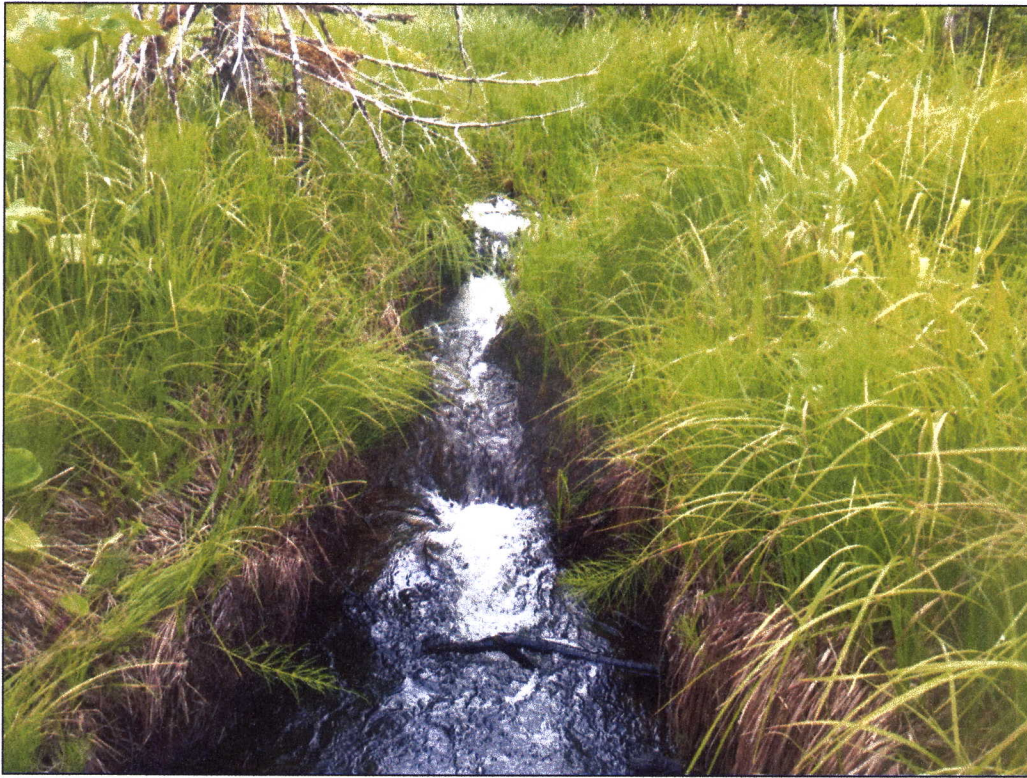
Figure 2.—Channel at waypoint 1028.

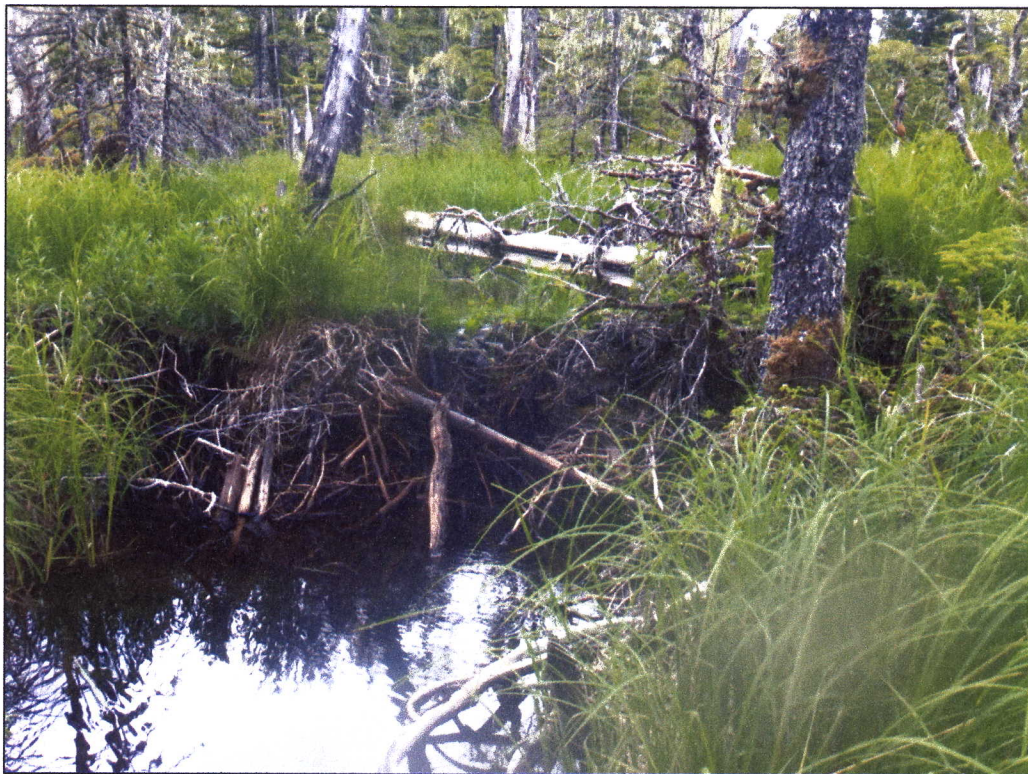
Waypoint	Latitude	Longitude	Notes	Stream Width ft	Stream Substrate	Habitat Features	Gradient %	Sample Effort	Sample Results
1040	57.973481	-135.450086	Small beaver dam ~1-2' high from downstream water level with some water running over/through. Likely not a temporary barrier to fish passage. Advancing upstream.			Cut Banks Beaver Pond		Not Fished	
1041	57.973443	-135.449650	Beaver dam ~2-3' high from downstream water level with some braiding/spillover to river-left that should facilitate fish passage. Ponding upstream makes electrofishing less effective.	6-8	Fine Organic	Cut Banks Beaver Pond	2-4	EF	No Fish
1042	57.973296	-135.449560	1-yr CO capture in somewhat disconnected shallow water adjacent to deeper ponded water.			Beaver Pond LWD		EF	1 CO
1043	57.972822	-135.449211	Another small (1-2' high) beaver dam; busted through on river-left side, should facilitate fish passage. Stream becoming channelized and more restricted than downstream of larger beaver dams.	4-6	Fine Organic		2-4	EF	No Fish

Figure 3.—Beaver dam with ponding above at waypoint 1041.

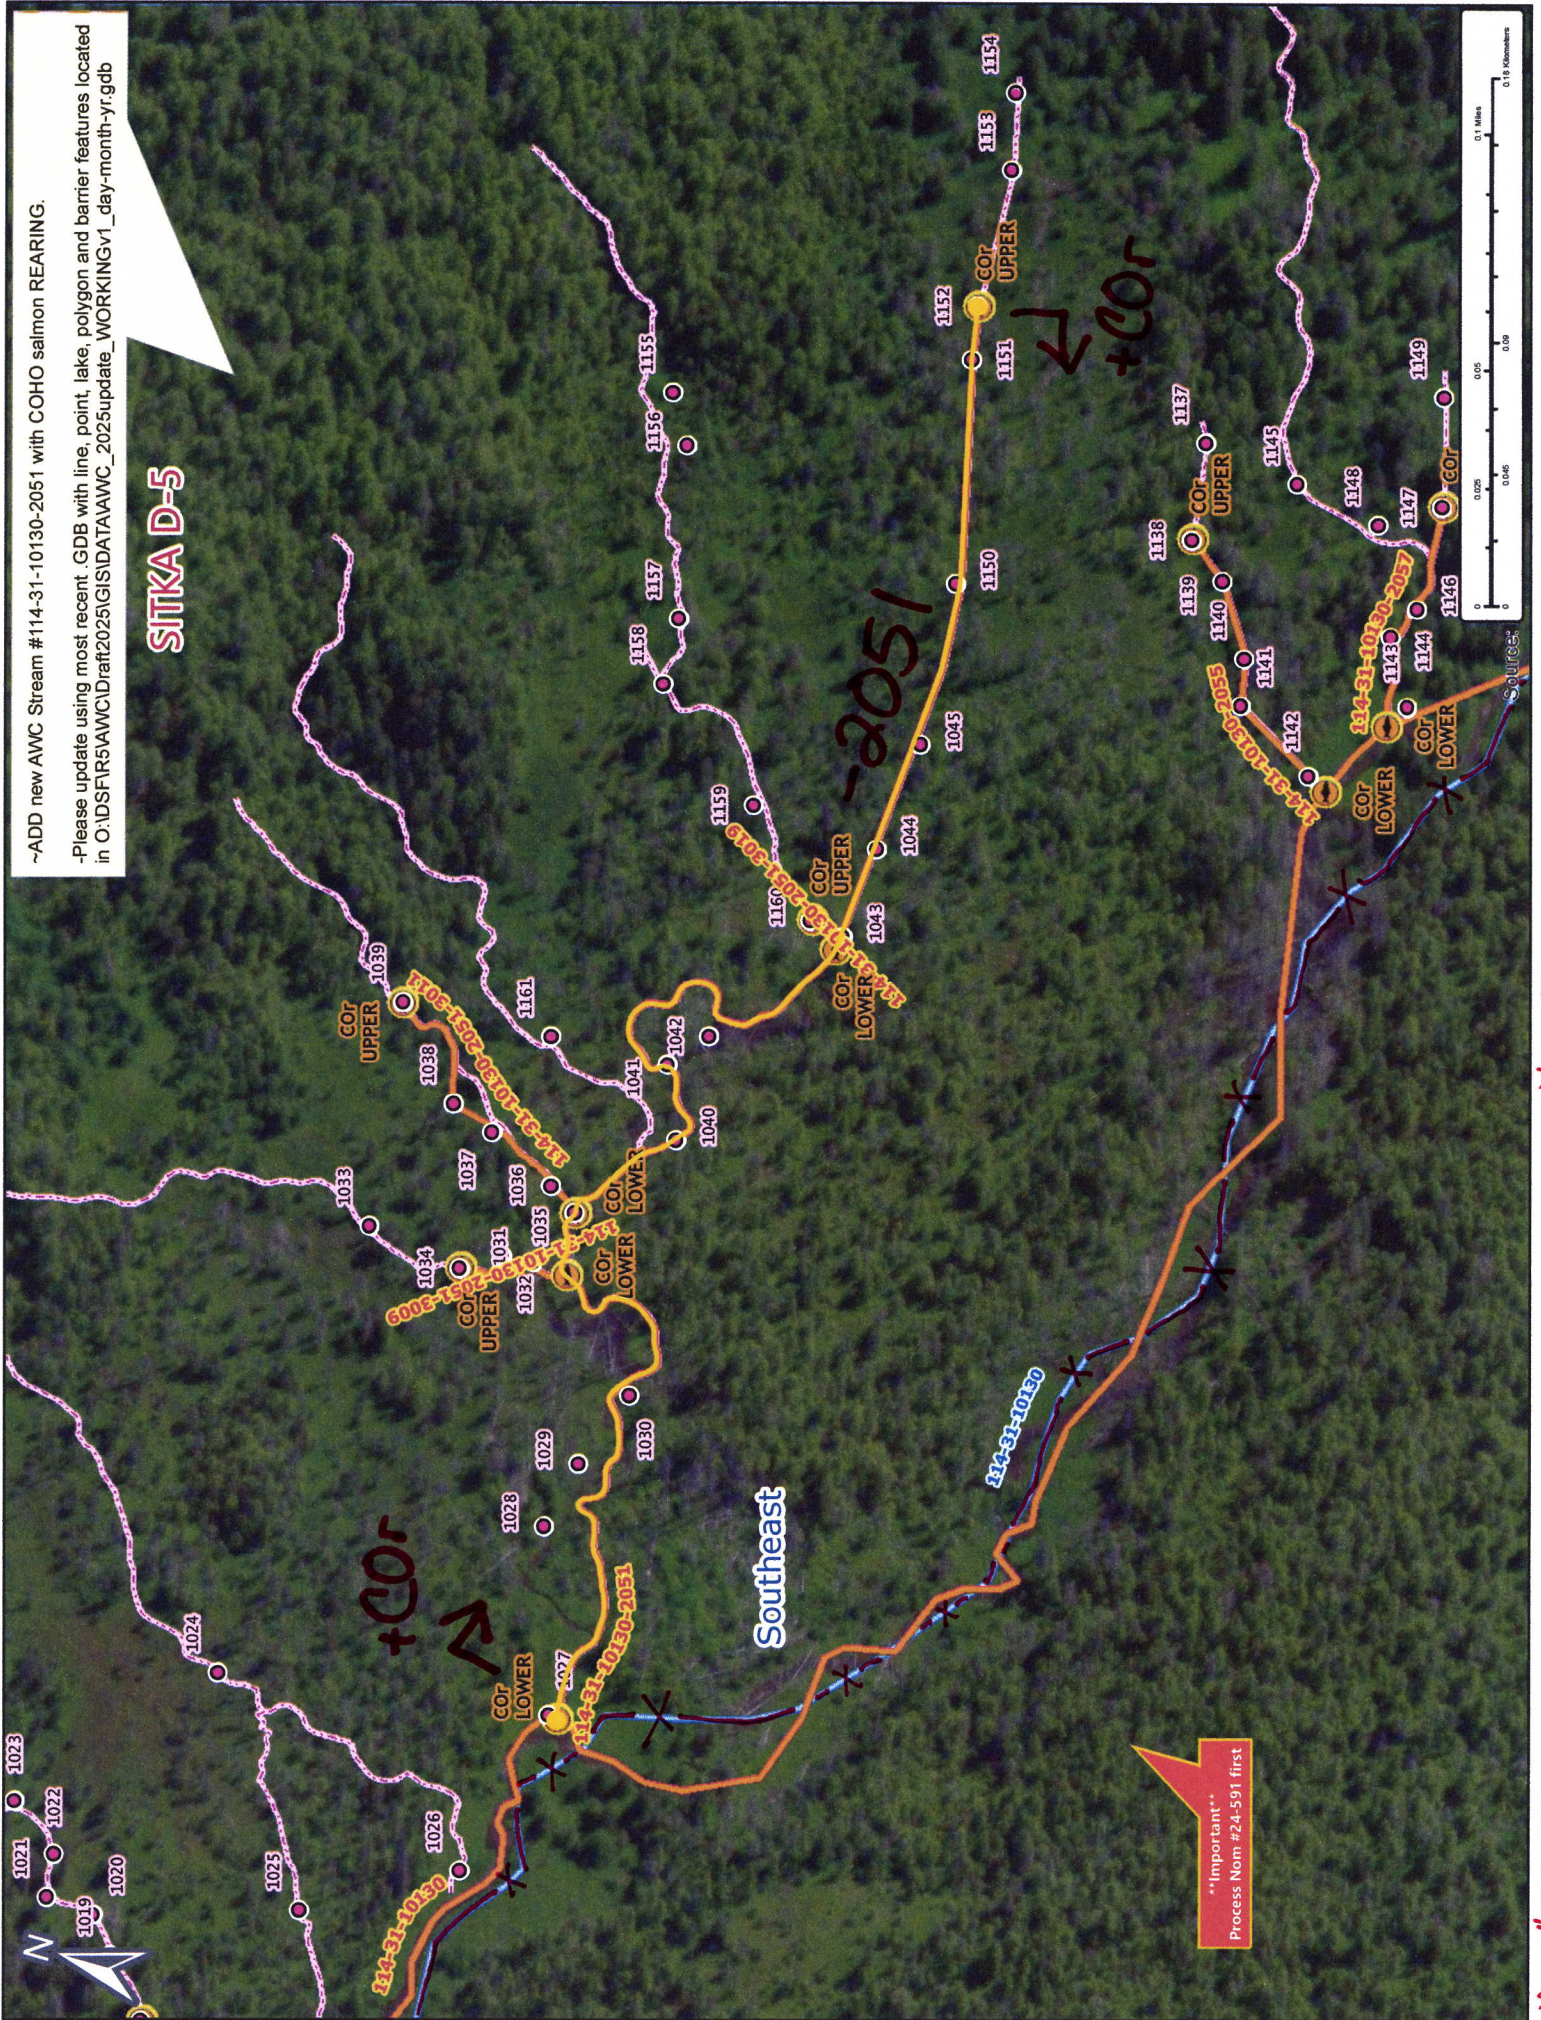
Map #2

~ADD new AWC Stream #114-31-10130-2051 with COHO salmon REARING.
