## Nomination Form Anadromous Waters Catalog

## 114-31-10130 Tributary 13

ADDITION

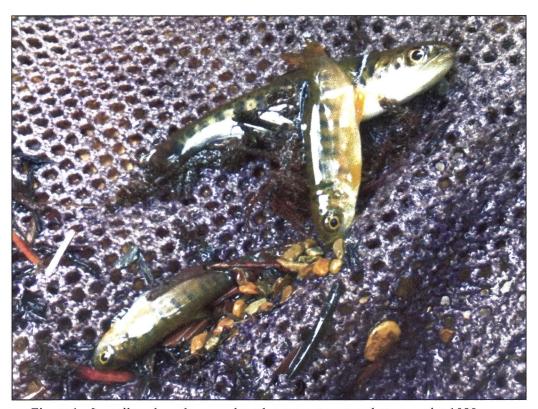
Figure 1.-Juvenile coho salmon and cutthroat trout captured at waypoint 1090.

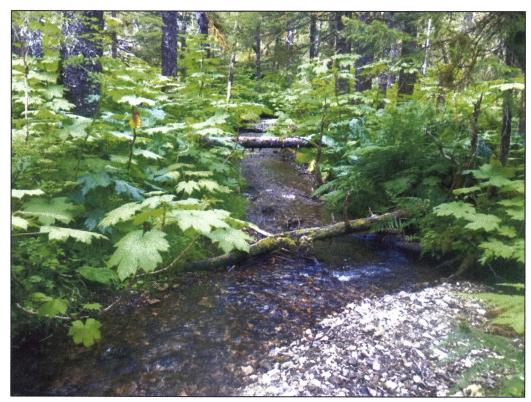
Figure 2.—Channel at waypoint 1089.

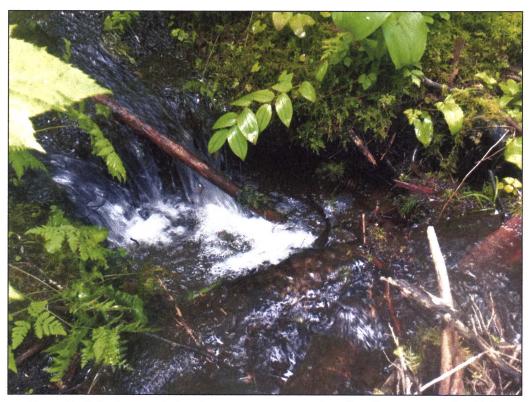
**Findings:** We surveyed this uncataloged stream using a backpack electrofisher and GPS. We captured juvenile coho salmon, Dolly Varden, and cutthroat trout. Channel erosion at the base of a tree has formed a 3 ft diameter hole, which likely constitutes a temporary barrier to fish passage (Table 1; Figures 1–3).

Figure 3.–3 ft diameter hole where stream enters subsurface flow at waypoint 1100.

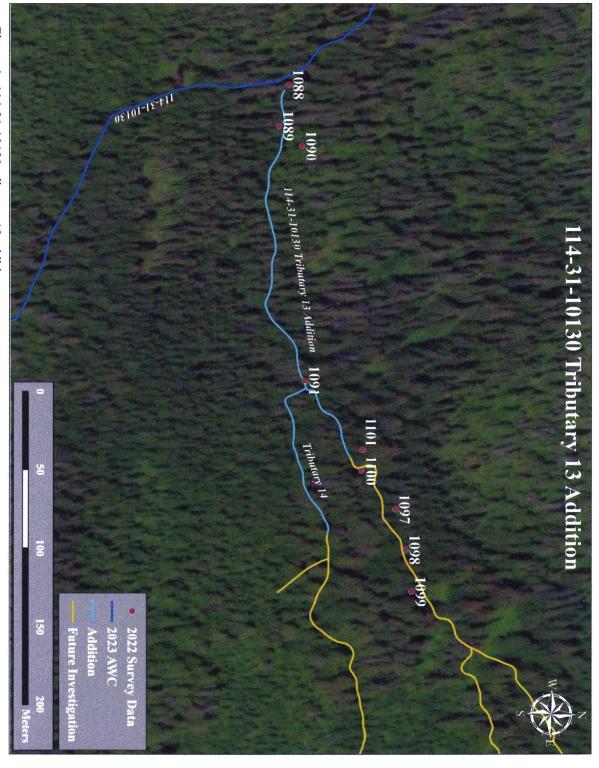
Figure 4.-114-31-10130 tributary 13 addition map.

Recommendations: Add this uncataloged stream to the anadromous waters catalog for rearing

coho salmon (Figure 4). **Nomination:** Pending
