Nomination Form Anadromous Waters Catalog

Alaska Department of Fish and Game

112-42-10160-2021

ADDITION and CORRECTION

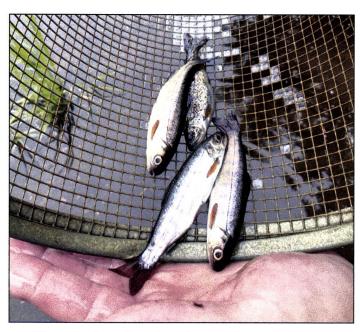
Figure 1.—Juvenile coho salmon and a cutthroat trout captured at waypoint 1440.

Findings: We surveyed this cataloged stream using a backpack electrofisher and GPS and captured juvenile coho salmon, Dolly Varden, and cutthroat trout (Figure 1). The stream is forested, low gradient, and flows from the lake where we ended our survey (Table 1; Figures 2,3). We concluded our survey due to a lack of time; anadromous fish habitat potentially continues upstream of final survey point. We also surveyed other reaches this stream and found it incorrectly mapped in the catalog.
