Alaska Department of Fish and Game

Habitat Section
Southeast Region

Fritz Cove Uncataloged Stream

ADDITION

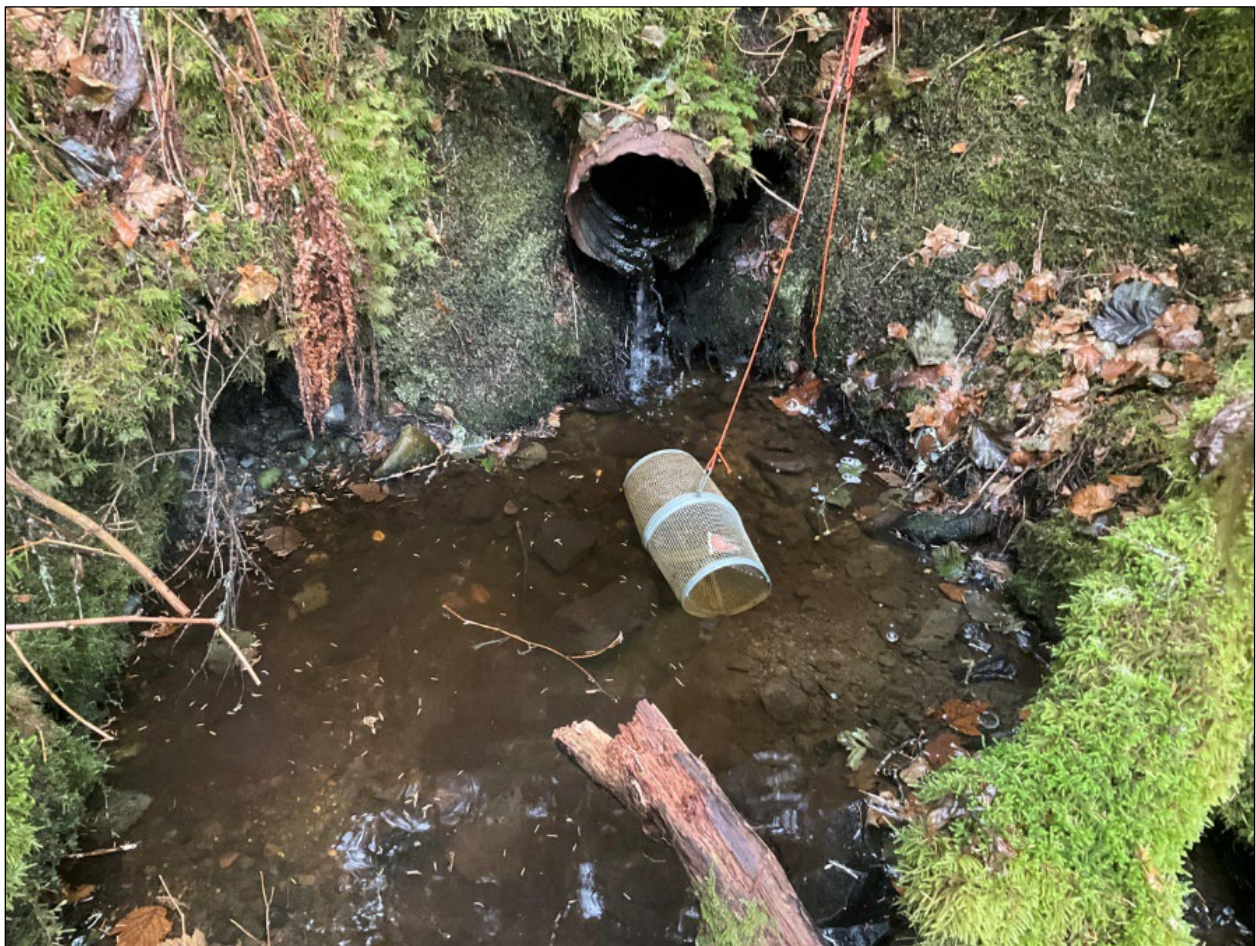
Waypoint	Latitude	Longitude	Notes	Stream Width ft	Stream Substrate	Habitat Features	Gradient %	Sample Effort	Sample Results
1095	58.350106	-134.644917	Minnow trap soaked ~5 hrs in pool just downstream of 1' CMP perched 18" into pool; set at steep grade and significantly rusted, water leaking out rusted-through bottom prior to outlet and headcutting under culvert.	2-4	Small Gravel Large Gravel		4-6	MT	2 CO
1096	58.349919	-134.644744	Minnow trap soaked ~5 hrs in small pool with cut banks ~40' upstream of culvert inlet.	2-4		Cut Banks	2-4	MT	No Fish

Figure 1.—Culvert outlet at waypoint 1095.

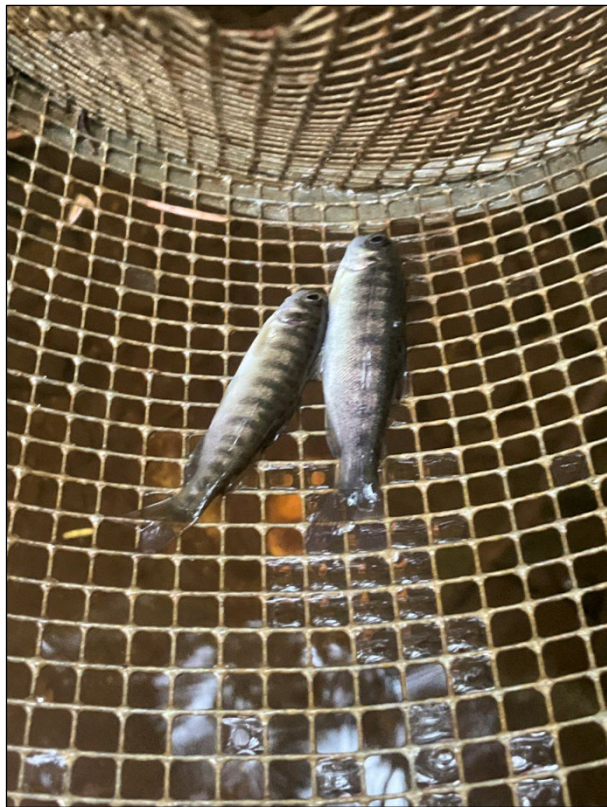
Findings: We surveyed this cataloged stream using a backpack electrofisher, baited minnow traps, and GPS and captured juvenile coho salmon. The intertidal portion of the stream can have very little water at most flows, but we were able to trap juvenile coho salmon just downstream of a perched culvert outlet (Table 1; Figures 1–3).

Figure 2.—Juvenile coho salmon captured at waypoint 1095.

Recommendations: Add this uncataloged stream to the anadromous waters catalog for rearing coho salmon. Please extend stream into the intertidal (Figure 4).

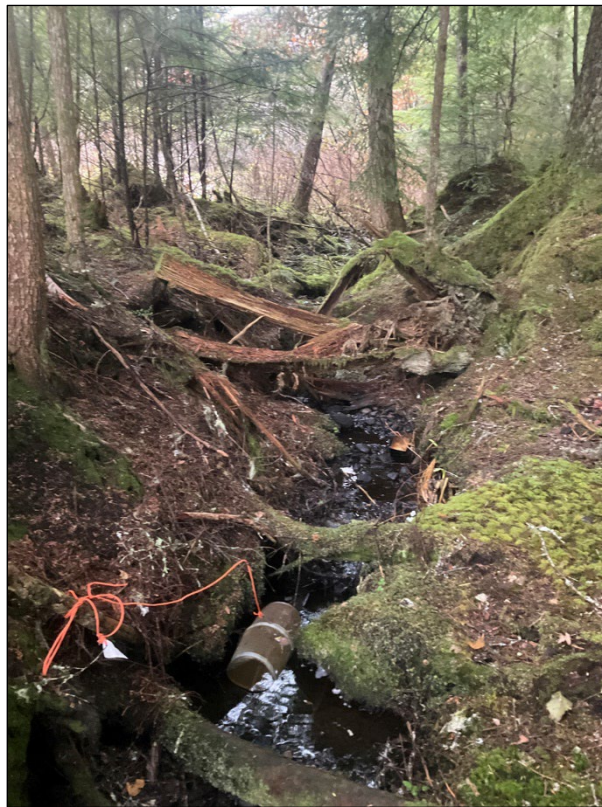
Figure 3.—Upstream view of stream at waypoint 1096.

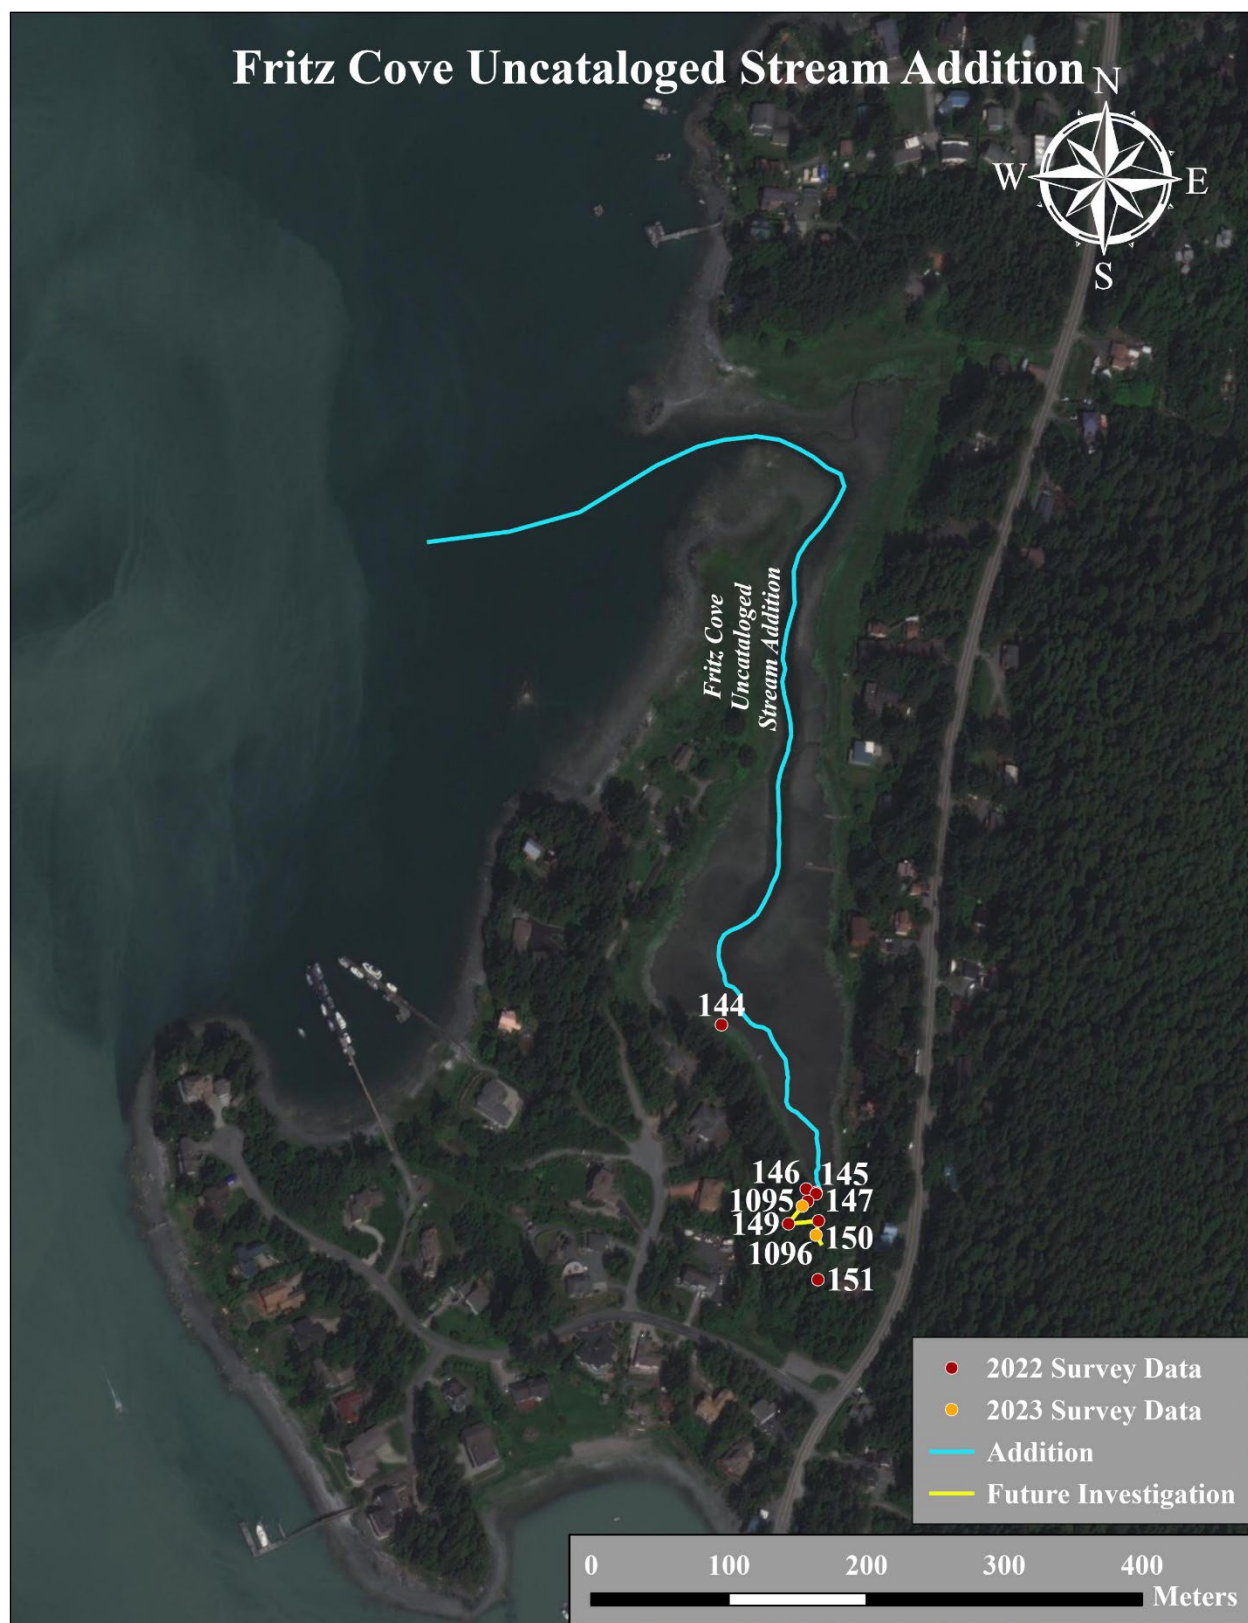
Figure 4.—Fritz Cove uncataloged stream addition map.
