## Alaska Department of Fish and Game

## **Gastineau Channel Uncataloged Stream**

**ADDITION**

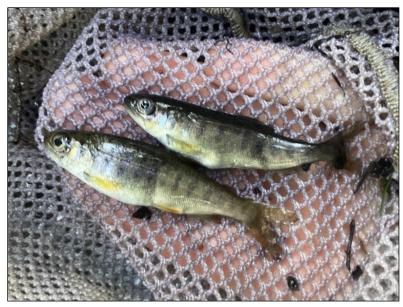
Figure 1.—Juvenile coho salmon captured at waypoint 1027.

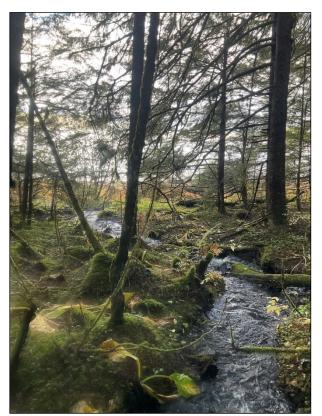
**Findings:** We surveyed this cataloged stream using a backpack electrofisher, baited minnow traps, and GPS. We captured juvenile coho salmon and sculpin. The stream falls out of a significantly perched 2-foot plastic culvert and flows down a steep-gradient hillside, with gradient becoming less severe as it approaches the intertidal (Table 1; Figures 1–3).

Figure 2.—Downstream view of stream at waypoint 1027.

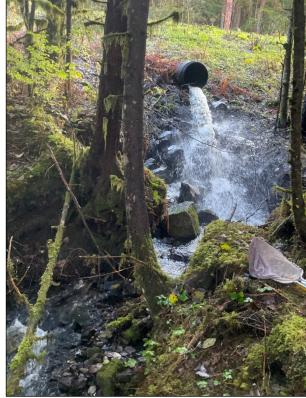
Figure 3.—Perched culvert outlet and conveyance stream at waypoint 1028.

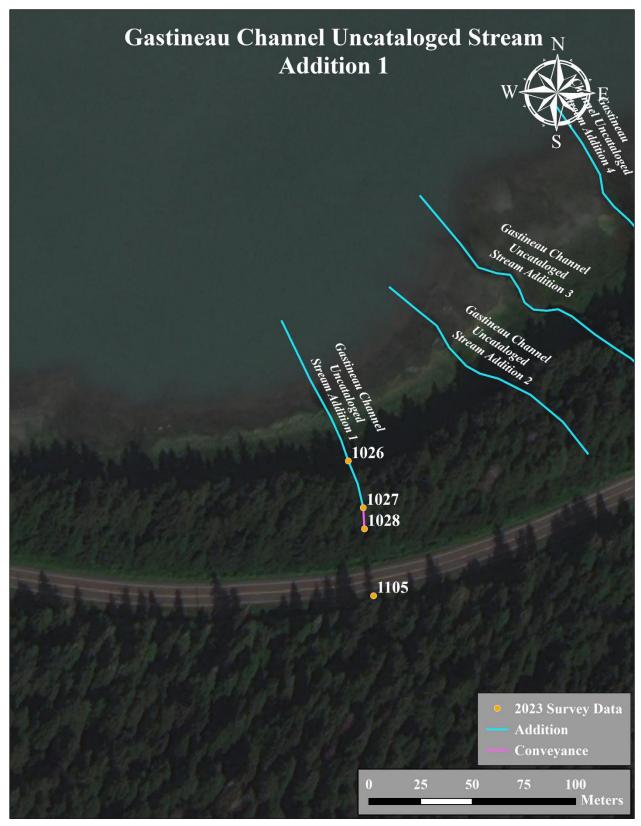
Figure 4.—Gastineau Channel uncataloged stream addition map.

Recommendations: Add this uncataloged stream to the anadromous waters catalog for rearing

coho salmon (Figure 4). **Nomination:** Pending
