Trip Report: Sawmill Creek Tributary - Comstock Culvert

Anadromous Stream #: 115-32-10300-2002-3013-4013Permit: SF2023-115Date: 10/17/2023Technicians: Stacie Evans, Jeremy Taylor# Minnow Traps: 8Trapping Duration: 20hrsSpecies and life stage: CTr, COsLocation:

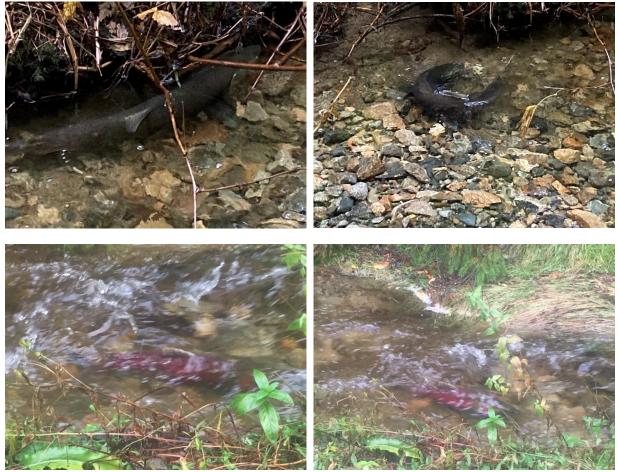
Adult coho observed on 10/16/2023 at 59.240685, -135.463885 (above) and on 10/13/2023 at 59.241445, -135.463190 (below).

Recommendations: Add spawning coho to 115-32-10300-2002-3013-4013 of the Anadromous Waters Catalog with an upstream extent of 59.241445, -135.463190.
