Alaska Department of Fish and Game

Habitat Section
Southeast Region

114-31-10130 Tributary 9

ADDITION

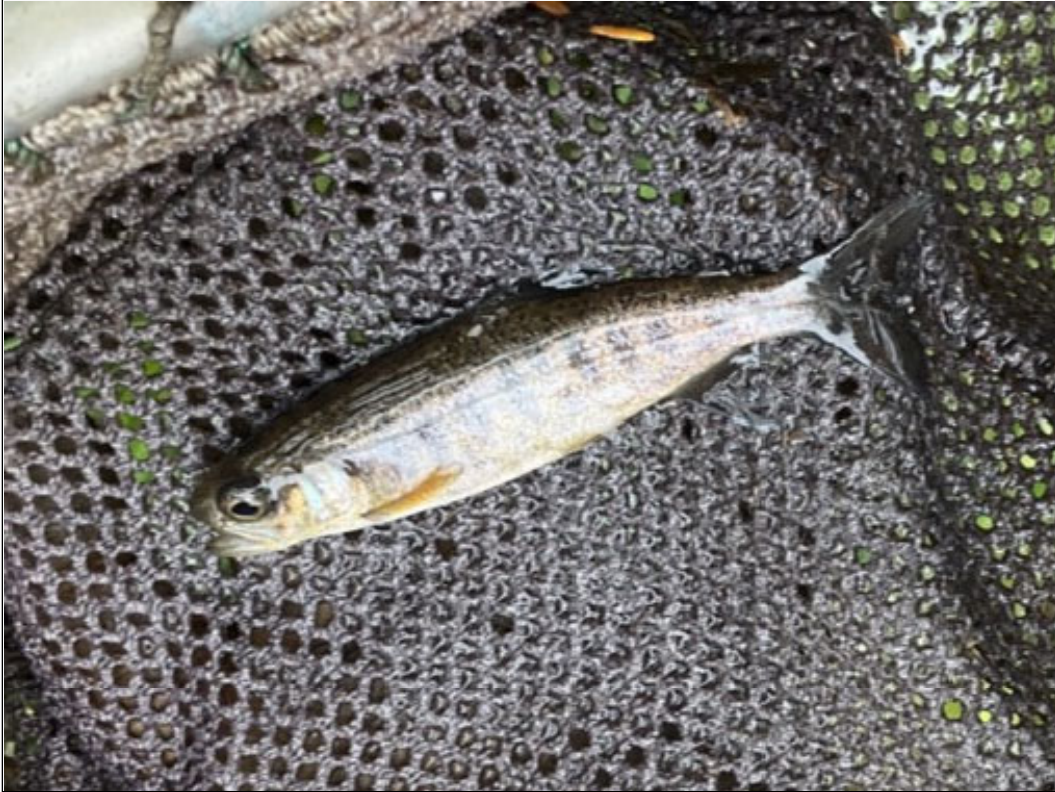
Figure 1.—Juvenile coho salmon captured at waypoint 1039.

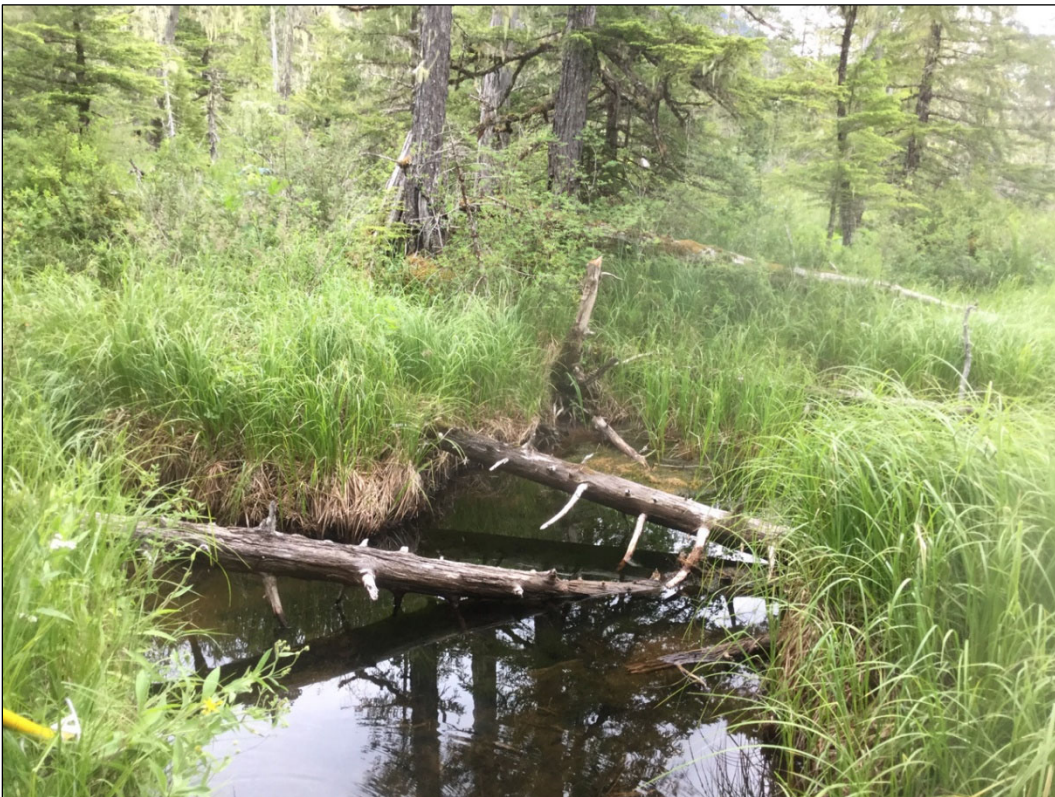
Findings: We surveyed this uncataloged stream using a backpack electrofisher and GPS. We captured juvenile coho salmon, Dolly Varden, and cutthroat trout. The tributary stream descends a slight hillside and has intermittent reaches of gravel and organic sediment (Table 1; Figures 1, 2).

Figure 2.—Channel at waypoint 1035.
