# Alaska Department of Fish and Game

## 109-42-10100-2014 Tributary 2

## ADDITION

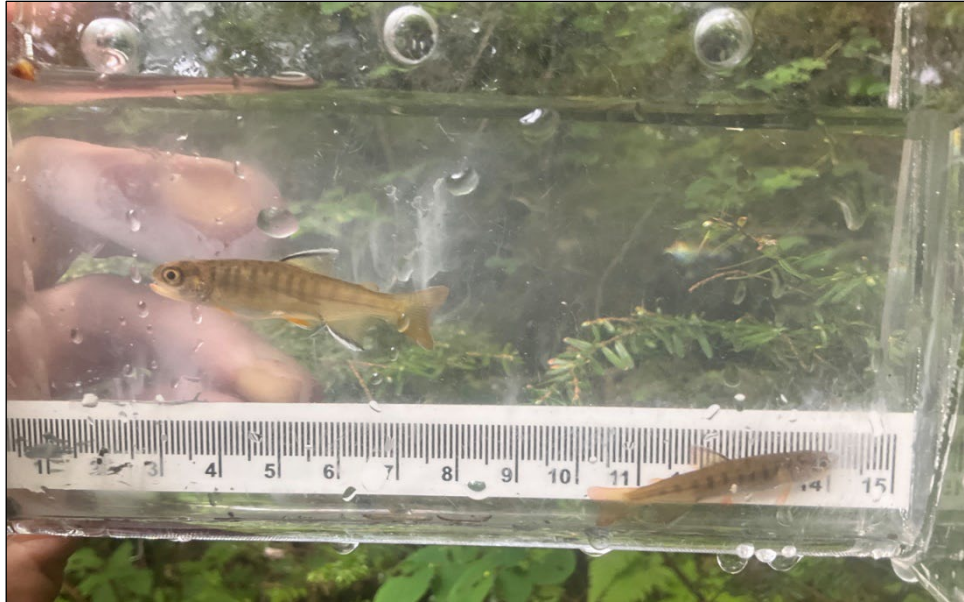
**Findings:** We surveyed this uncataloged stream using a baited minnow trap, a backpack electrofisher and GPS and captured juvenile coho salmon, cutthroat trout, and Dolly Varden (Figure 1) Stream channel is forested and gets increasingly steep upstream of waypoint 289 (Table 1; Figures 2, 3).

Figure 1.—Juvenile coho salmon captured at waypoint 280.

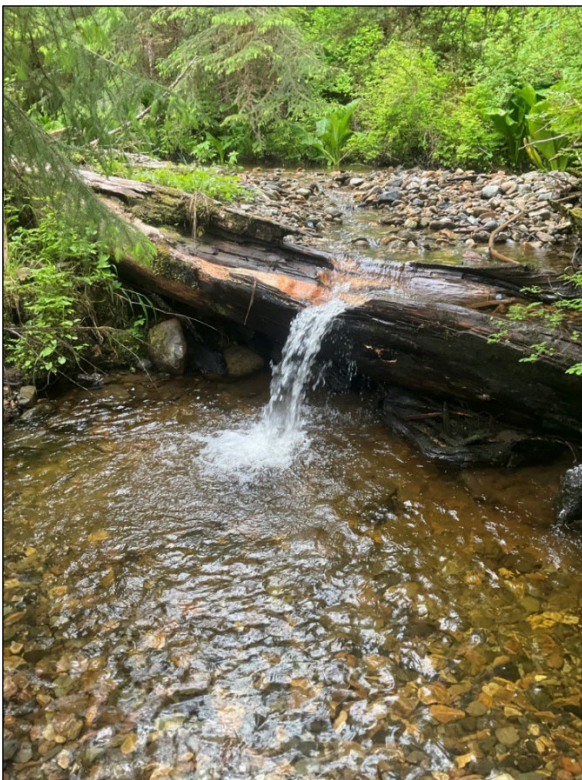
Figure 2.—Channel at waypoint 281.

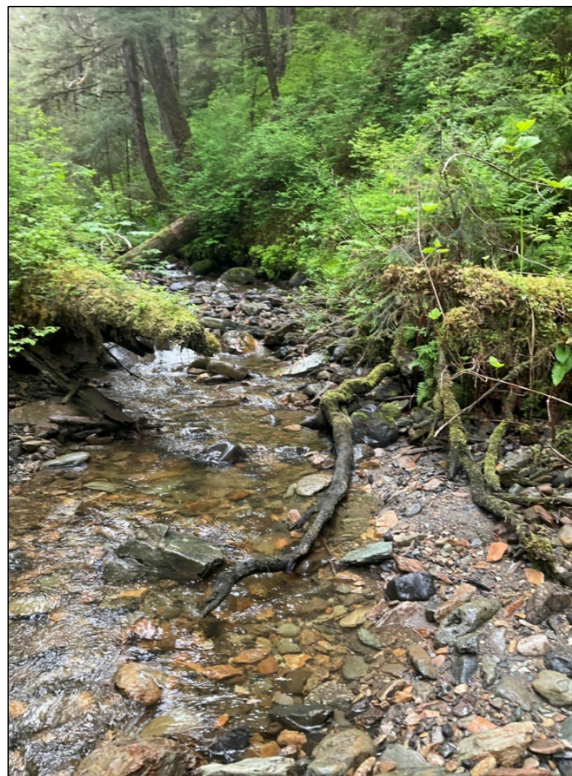
Figure 3.—Channel at waypoint 290.

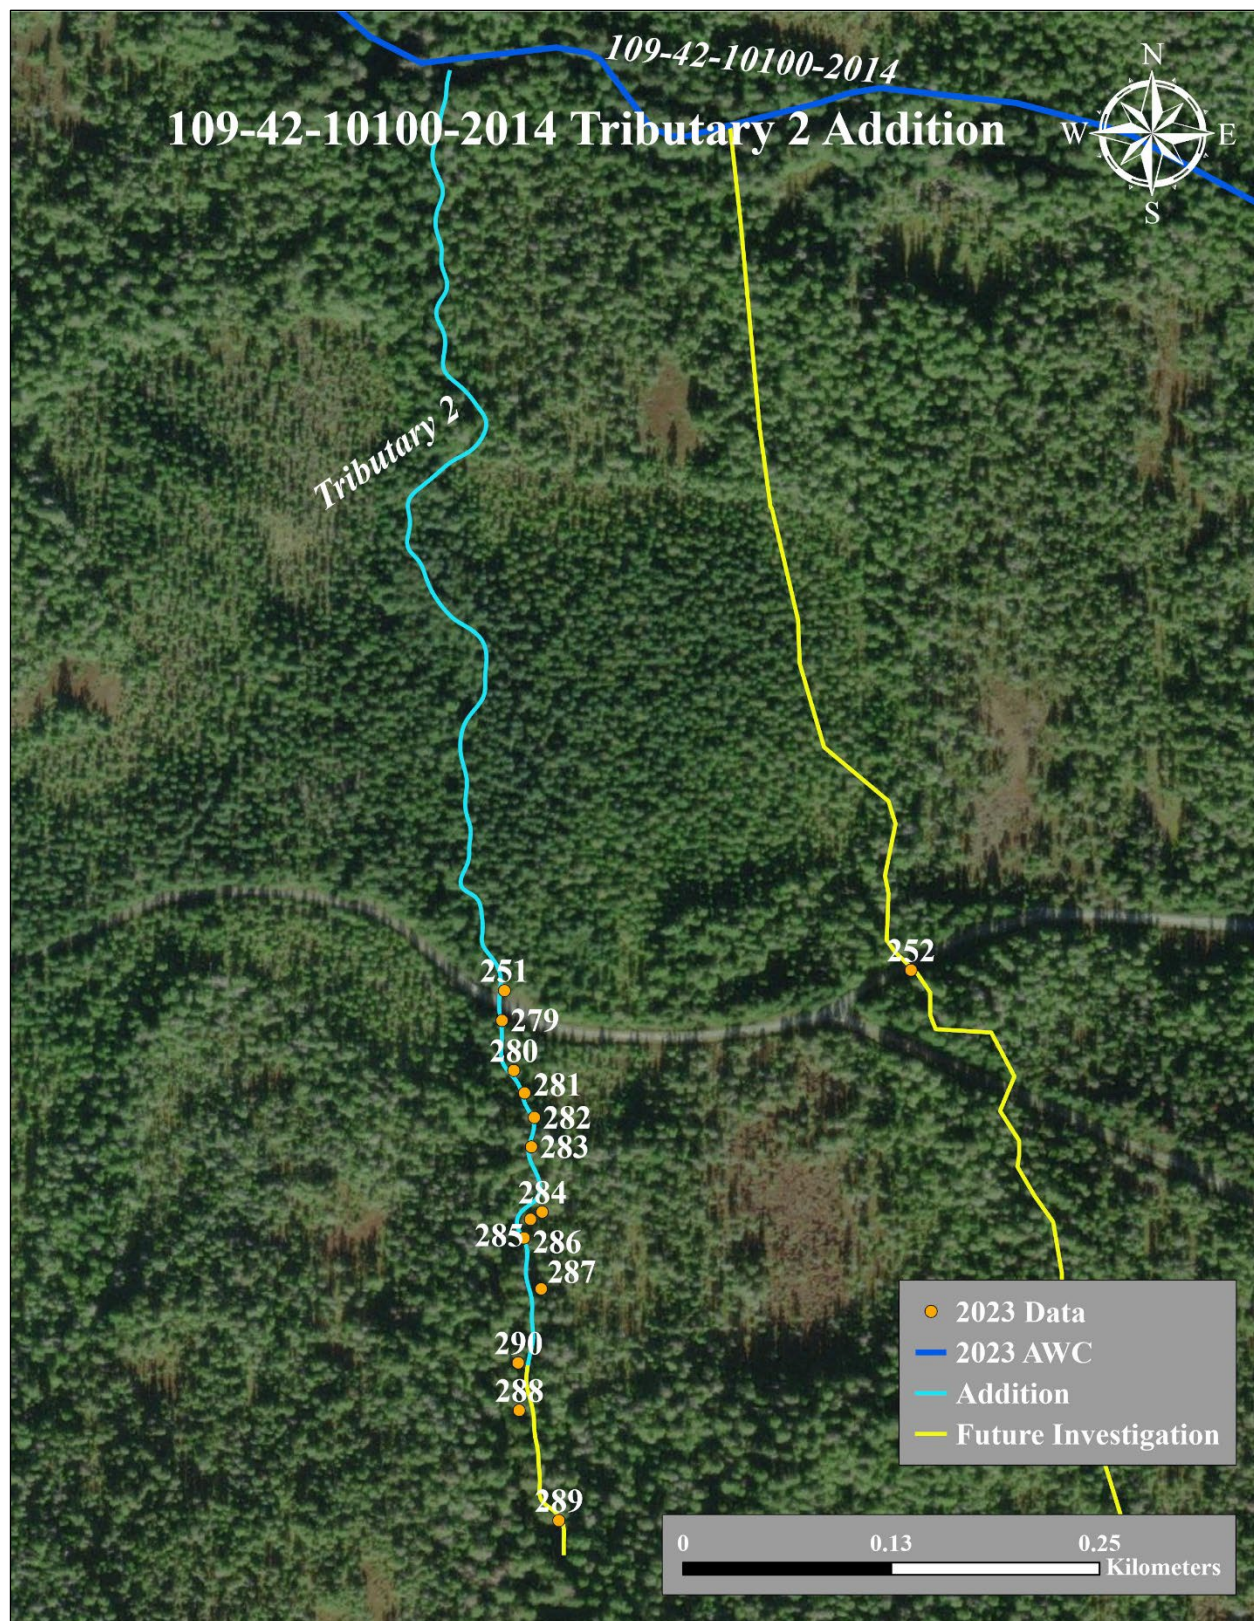
Figure 4.—109-42-10100-2014 tributary 2 addition map.

**Recommendations:** Add this uncataloged stream to the anadromous waters catalog for rearing coho salmon (Figure 4).
