REVISED ANADROMOUS STREAM CATALOG OF SOUTHEASTERN ALASKA

District 106

Northeast Coast of Prince of Wales Island

Subdistricts 106-30 and 106-10

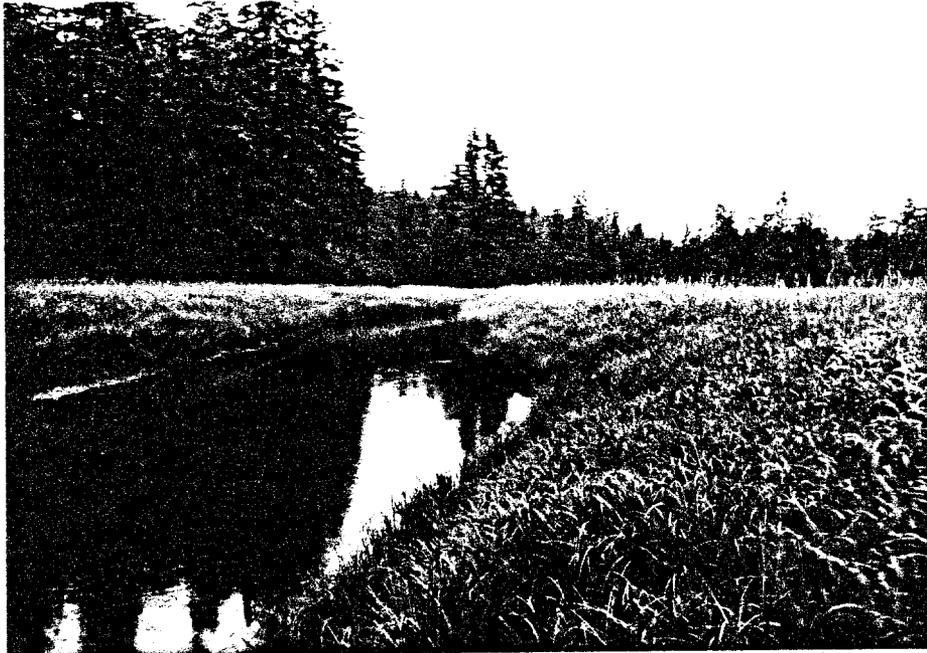
1. Shallow intertidal rearing slough containing SS/DV fry.

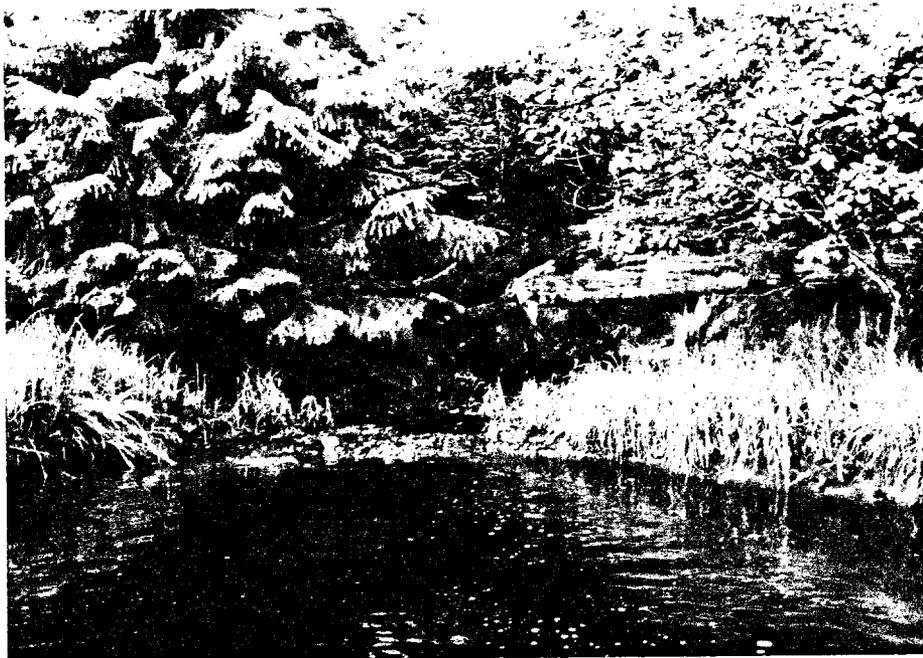
2. Mouth of stream where the ITZ rearing slough ends and stream flow over bedrock begins.

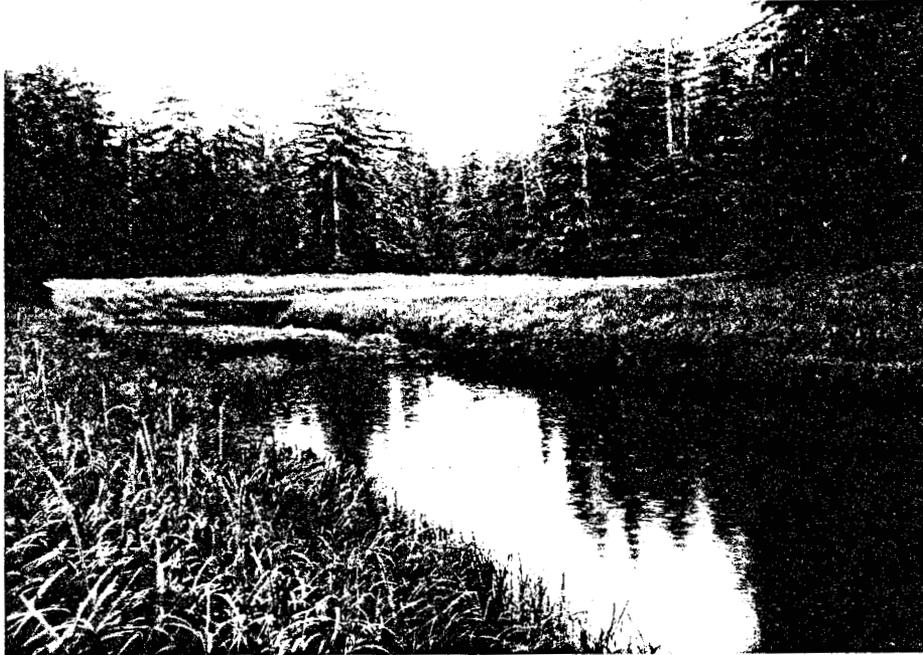
1. Stream mouth lies at the head of an extensive intertidal slough.

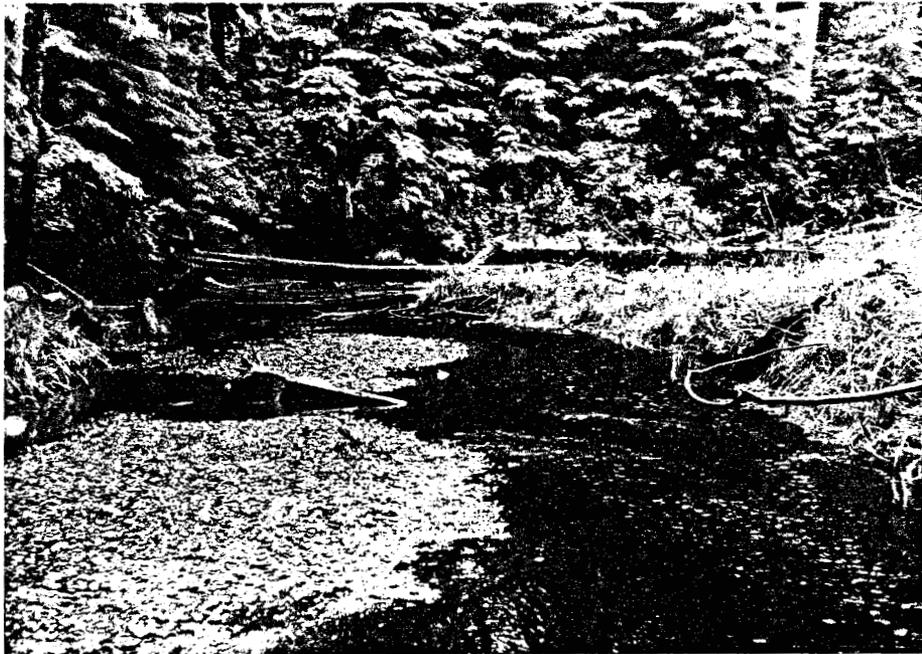
2. The upper ITZ is characterized by gravel riffles and a vegetative transition of marsh grass to timber.

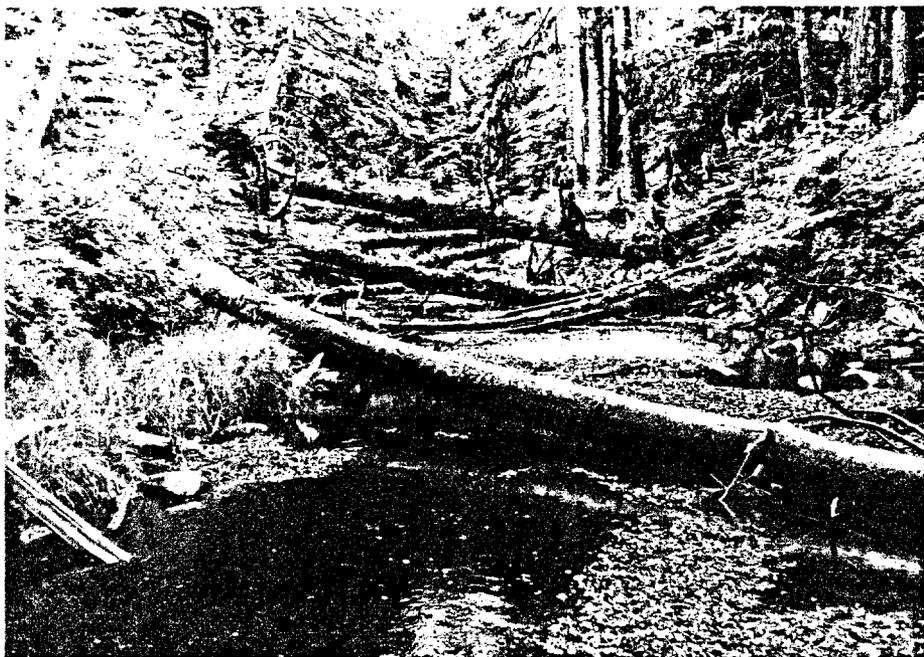
3. Section 1: Gravel riffles, SS pools, and copious blowdown provide excellent spawning and rearing habitat.

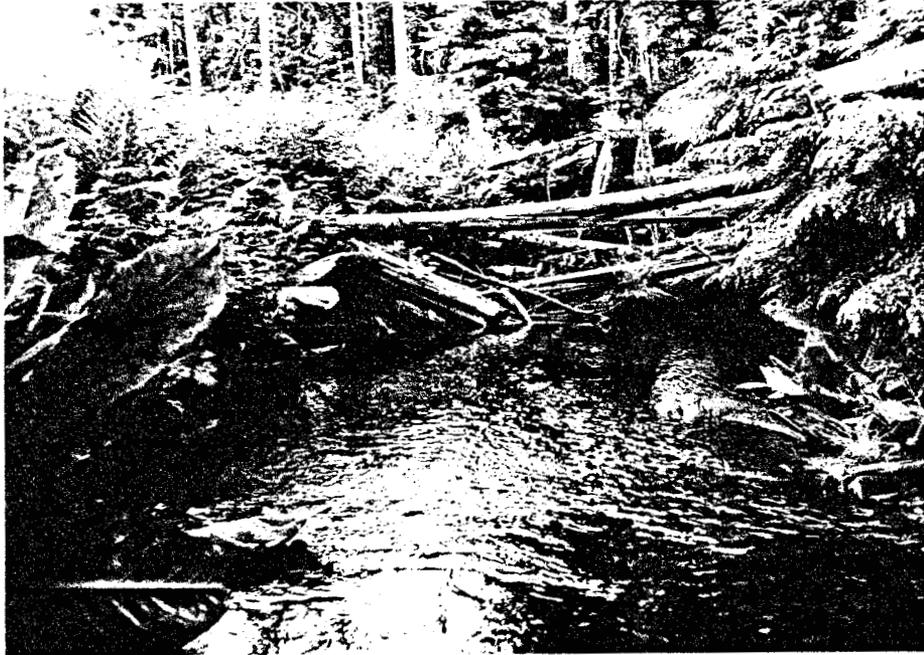
5. Downstream view of copious instream logging debris and the right bank unit boundary.

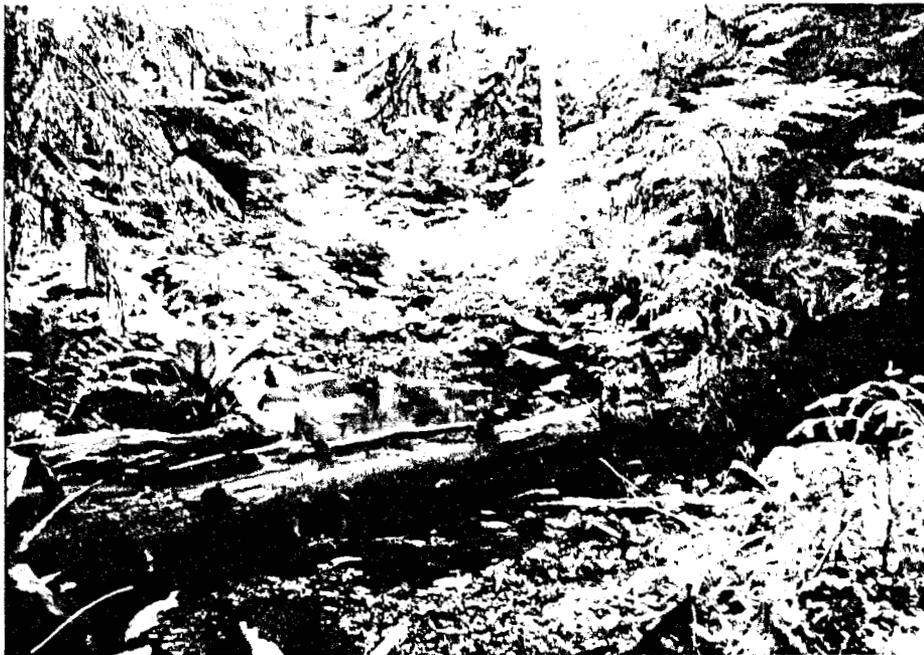
6. Section 9: 60m; Stream has characteristics of a muskeg drainage.

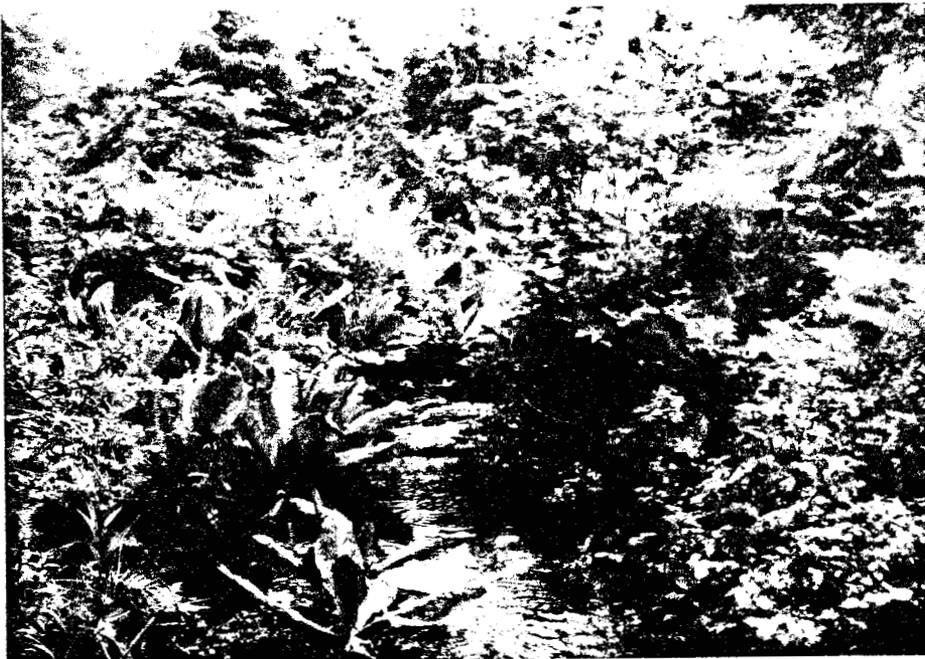
8. Section 1: Tributary "B" with low velocity flow through clearcut.

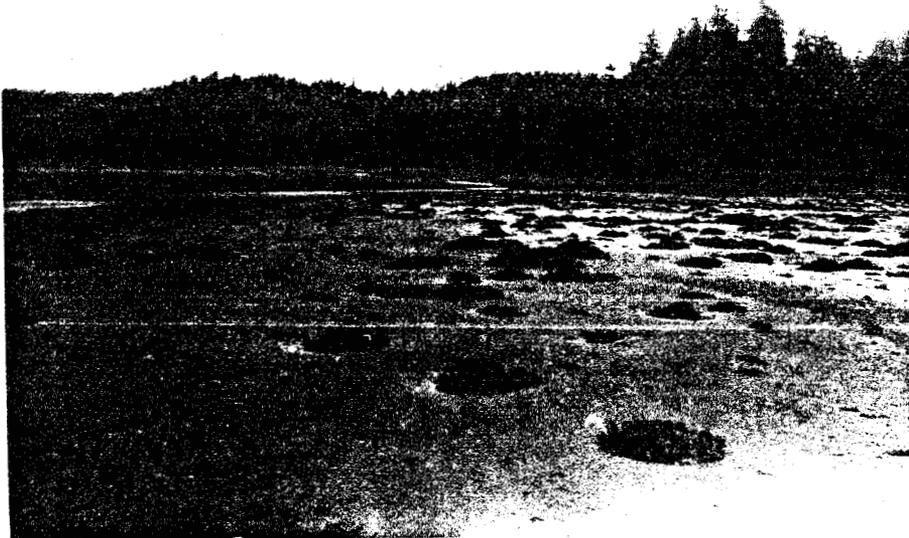
2. Downstream view of lower ITZ extending toward Kashevarof Pass.

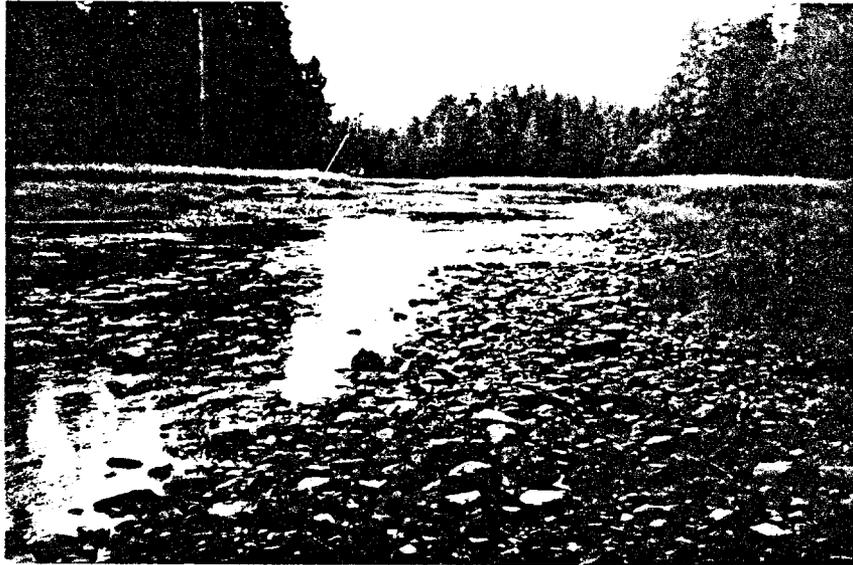
3. Middle ITZ with grass meadow to right.

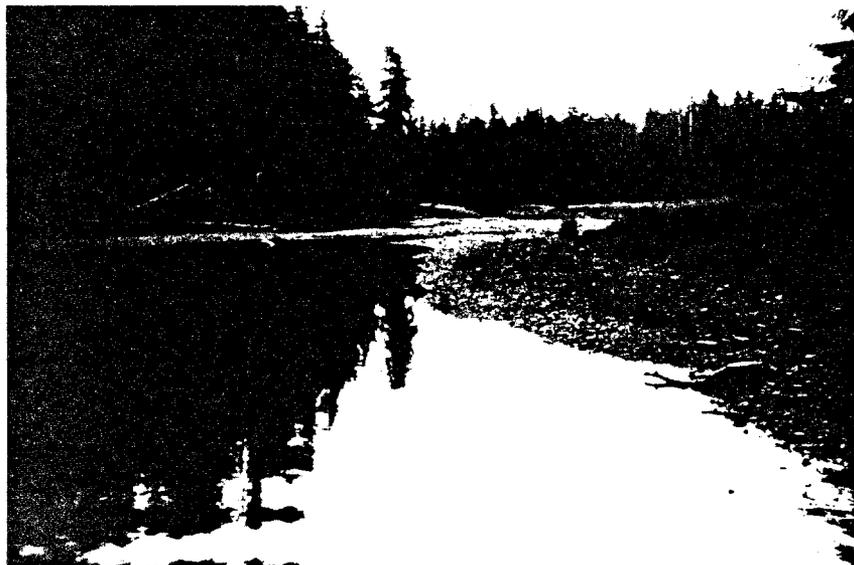
4. Downstream view of ITZ from mouth of stream.

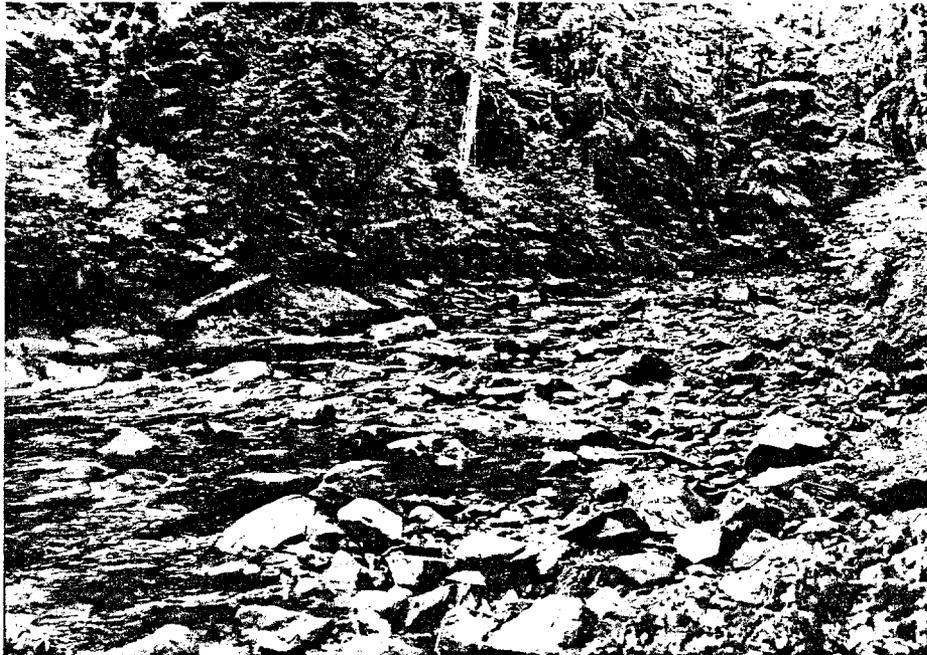
5. An abrupt substrate transition demarcates the ITZ/stream ecotone; i.e., mouth of stream.

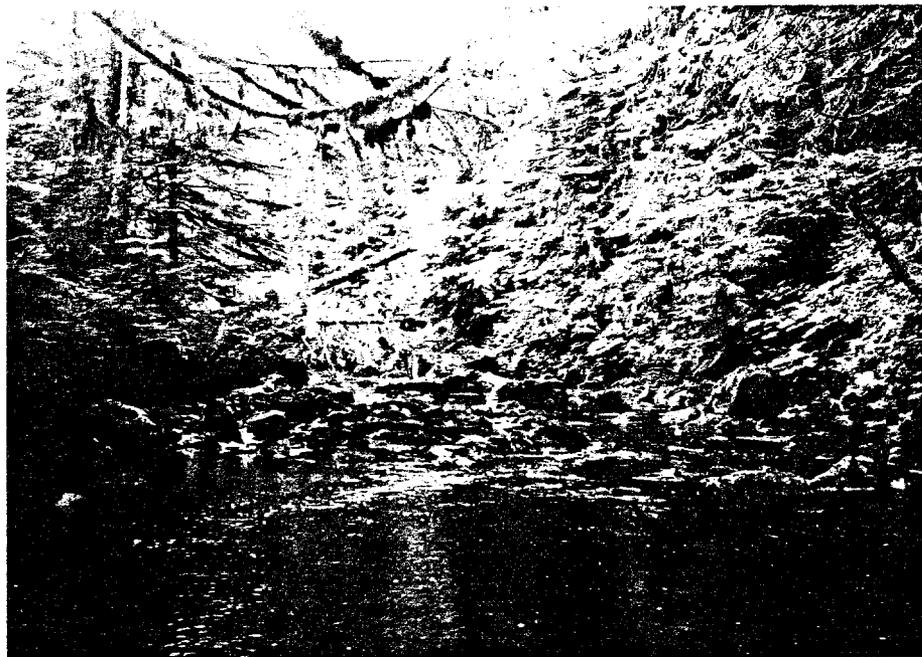
6. Channel negotiates a notch via a bedrock/boulder channel.

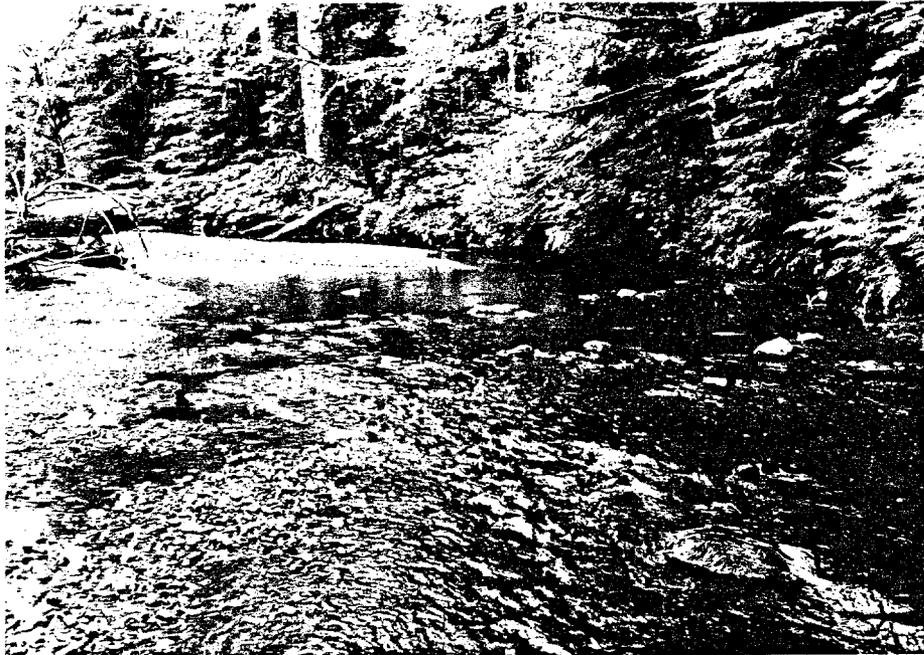
7. Above notch, channel broadens and spawning/
rearing habitat becomes common.

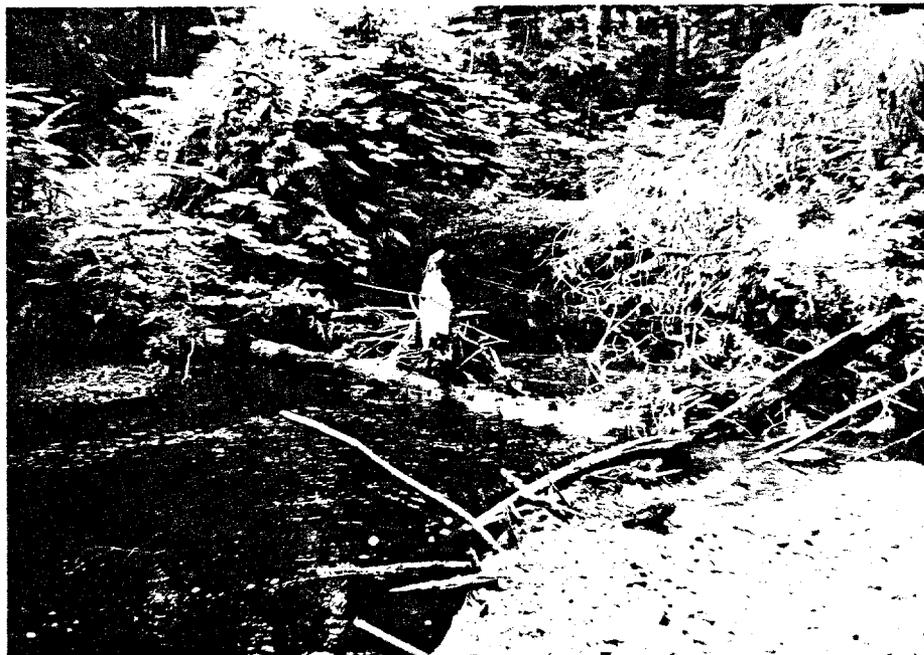
8. Section 12: Braided channels, blowdown, bank
undercutting, and accelerated bar formation
characterize this extremely disturbed section.

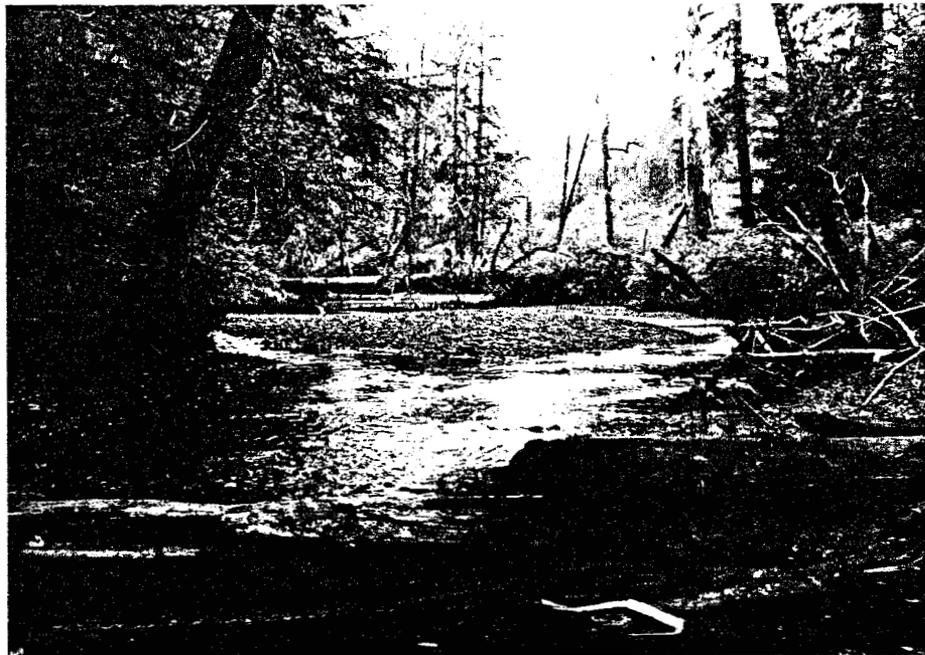
10. Section 14: Riffle over small cobble and
gravel. Good ASA and fair rearing habitat.

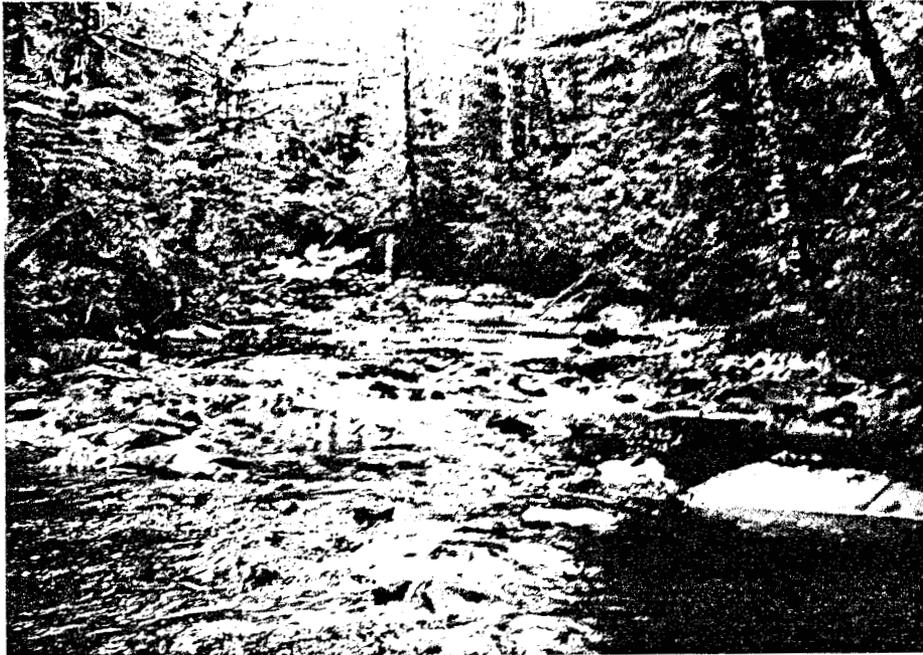
13. Stream flow over tilted bedrock in Reach V.

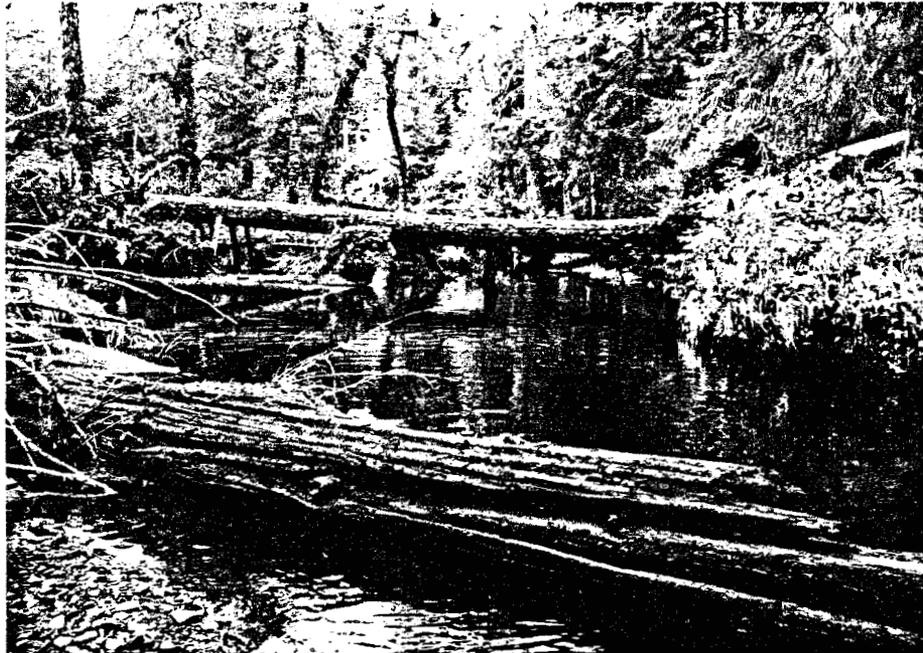
14. Survey Area "B", Section 1: Deep, slow water provides good rearing habitat just above the forks.

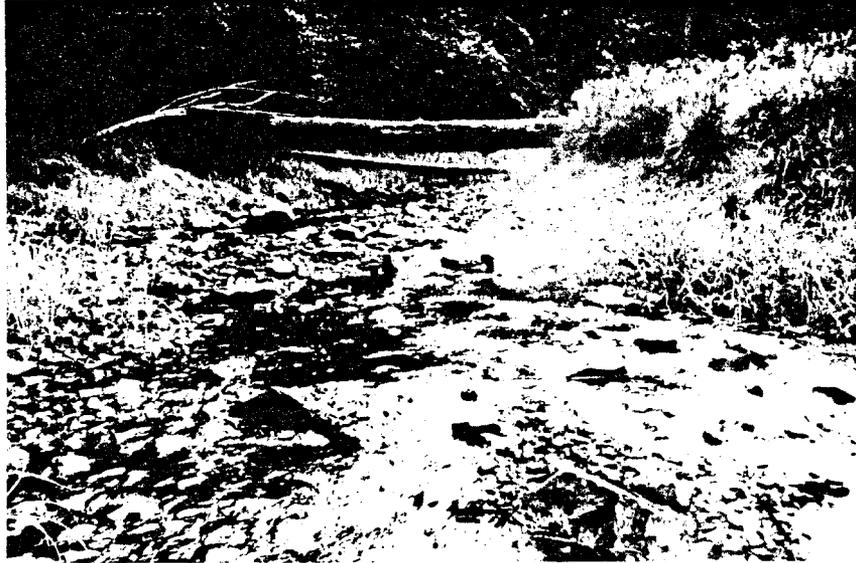
1. ITZ in grass meadow from confluence with 106-30-088.

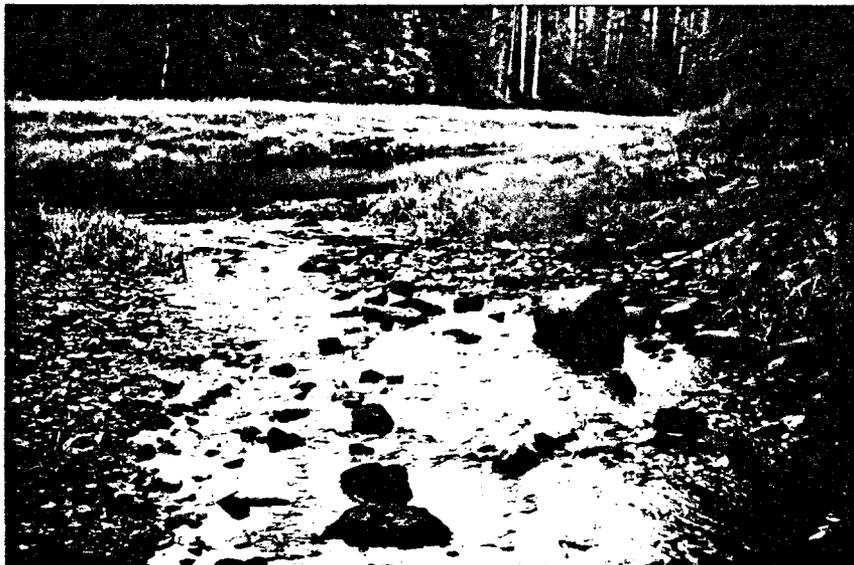
2. Downstream view of ITZ and confluence with 106-30-088.

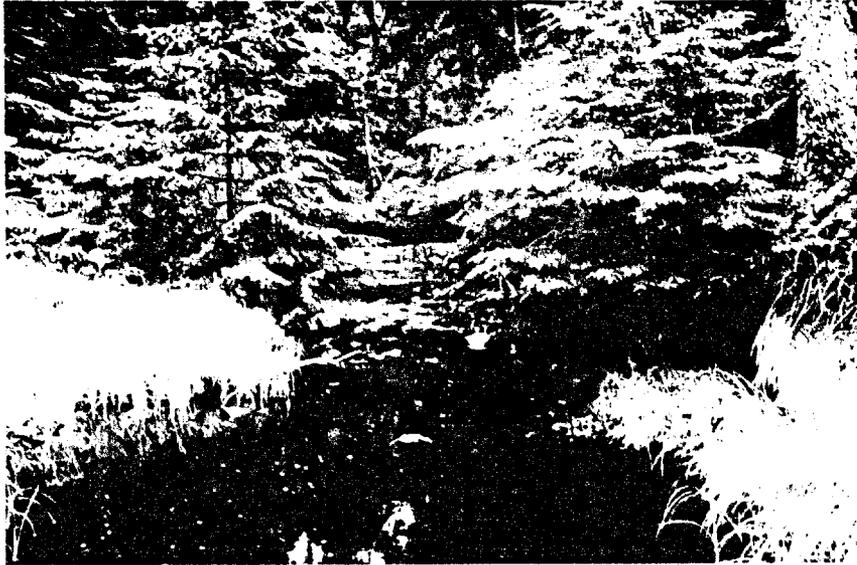
3. Mouth of stream leaving grass meadow and entering old forest cover.

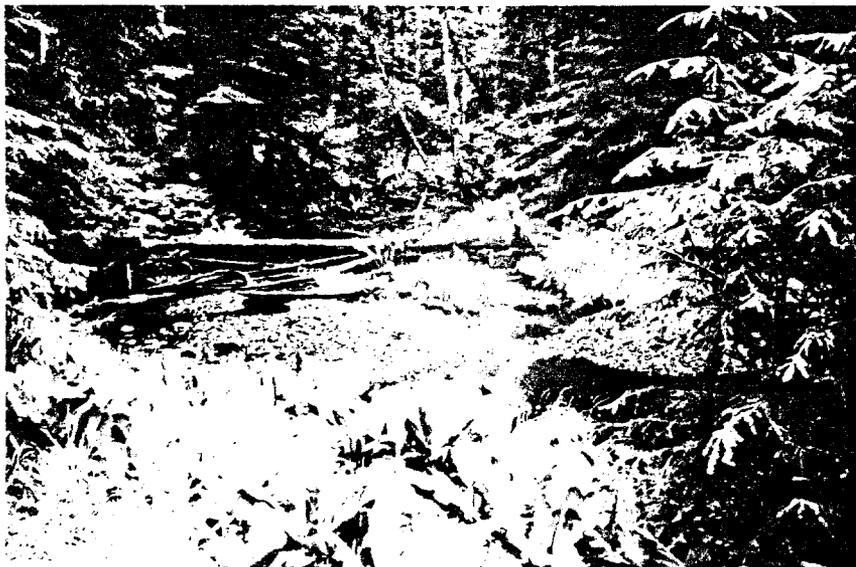
4. Representative habitat; low velocity and gradients with forbs in stream.

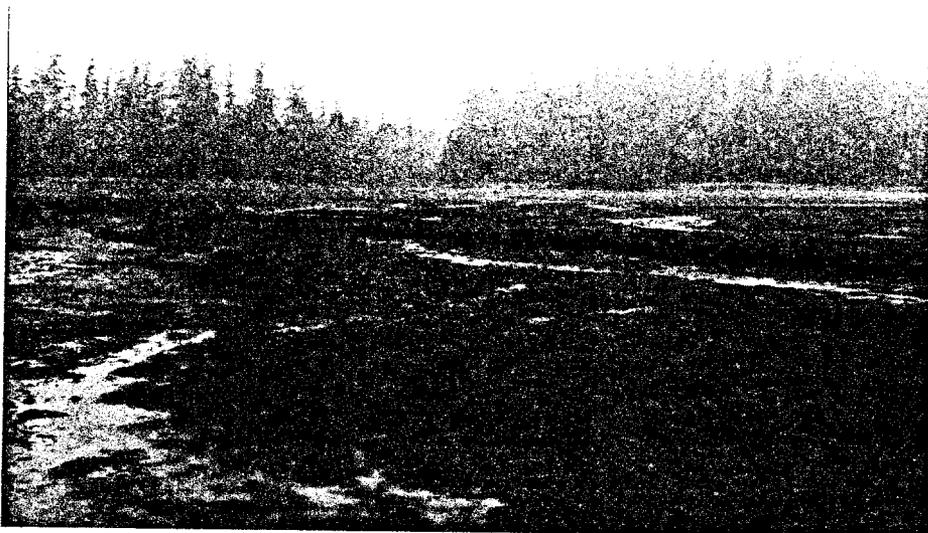
1. Lower ITZ with extensive tide flat.

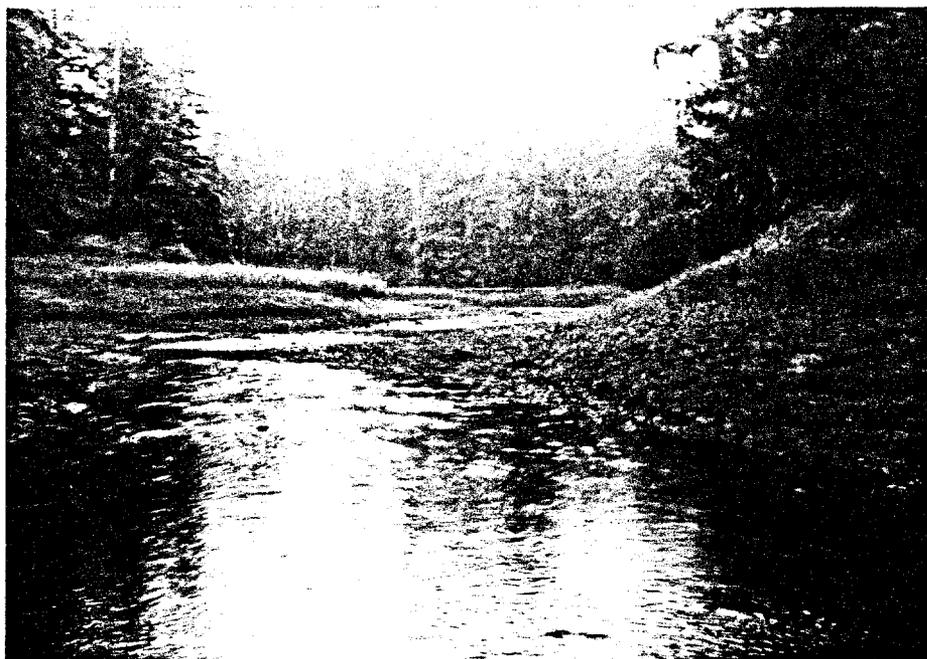
2. Upper ITZ with grass meadow as viewed from schooling area.

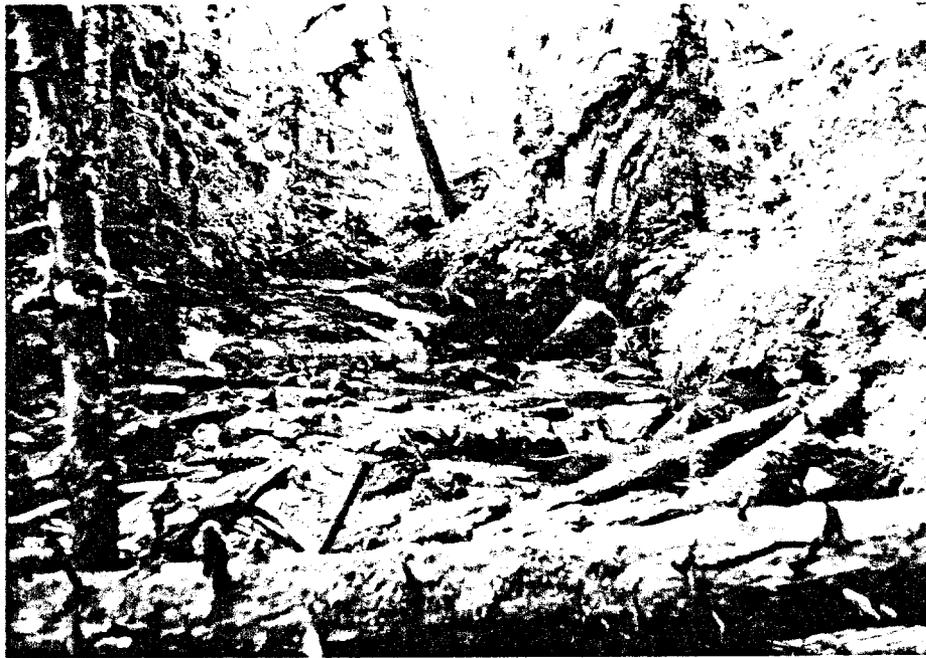
3. Mouth of stream with bedrock cascade.

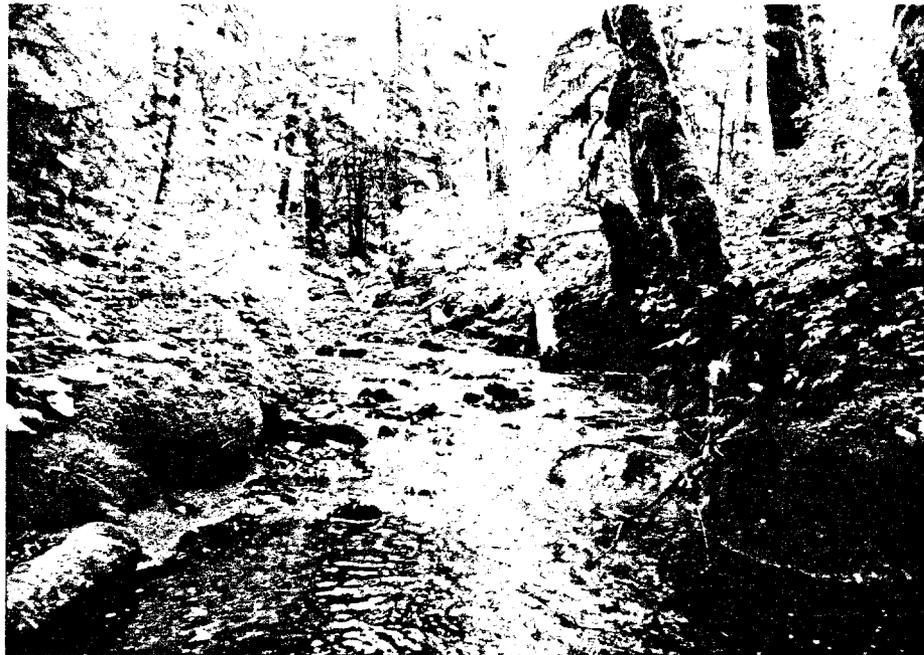
4. Representative habitat, Section 2: 0m;
Well-channelized high velocity flow over
bedrock/boulder/large cobble.

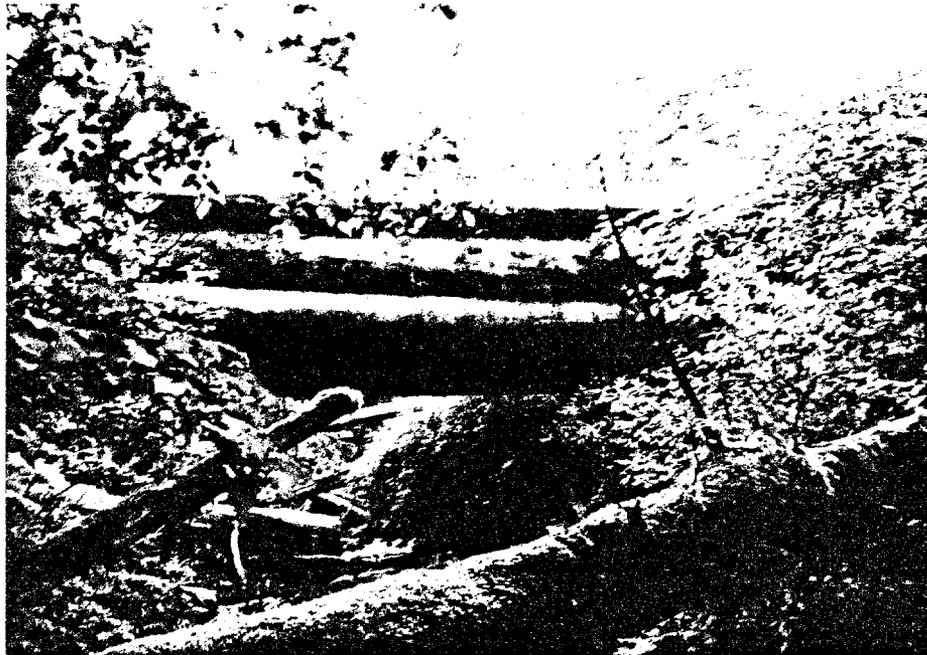
5. Log stringer bridge crossing, Section 2: 75m.

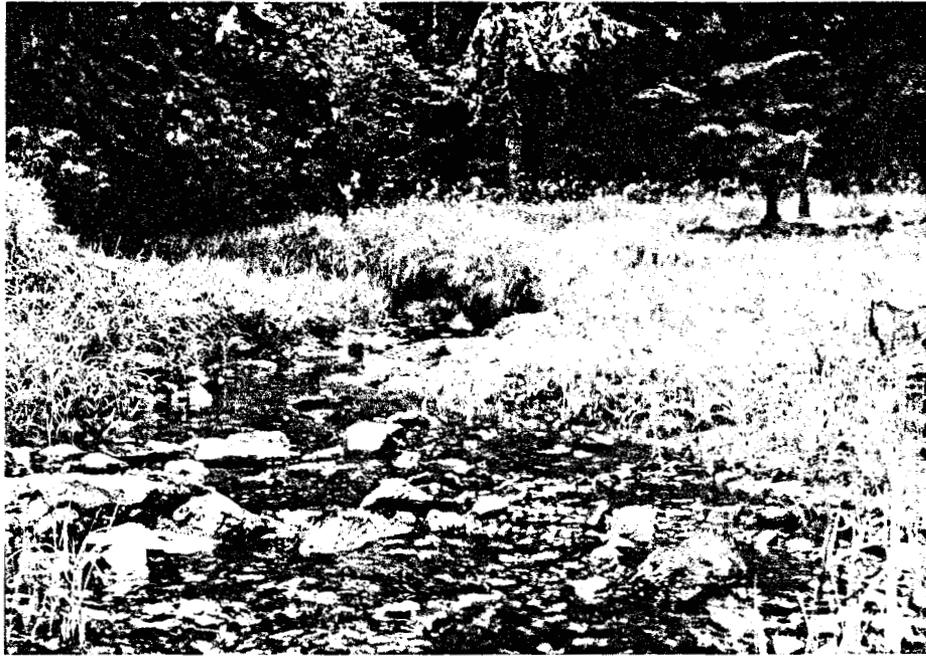
1. Mouth of stream with rearing ponds in meadows.
Shares left side IT meadow with 106-30-087.

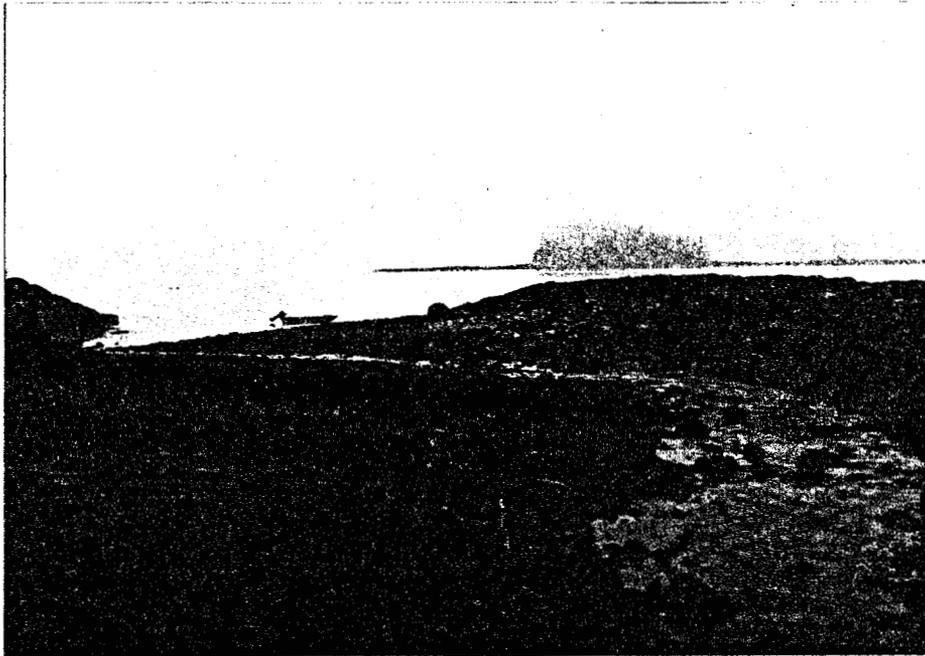
Fire Island 1

1. View down boulder strewn ITZ across Kashevarof Passage to Fire Island.

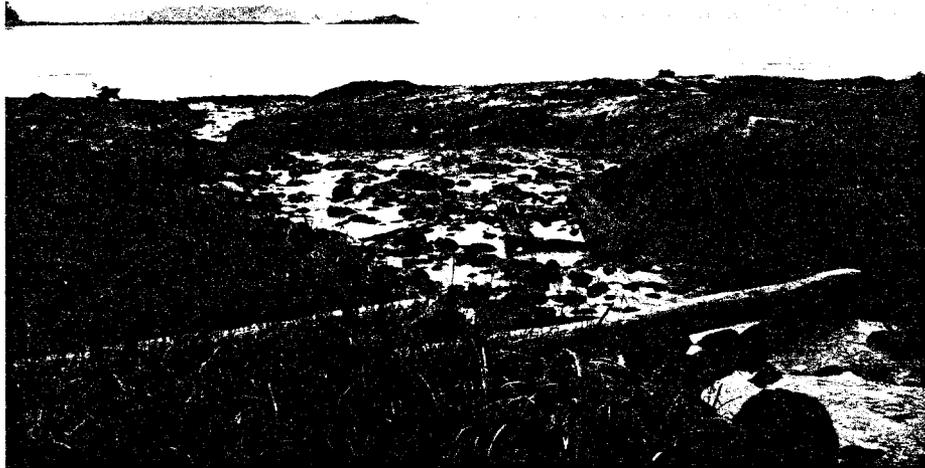
2. View down boulder strewn lower ITZ, across Kashevarof Passage to Scrubby Island.

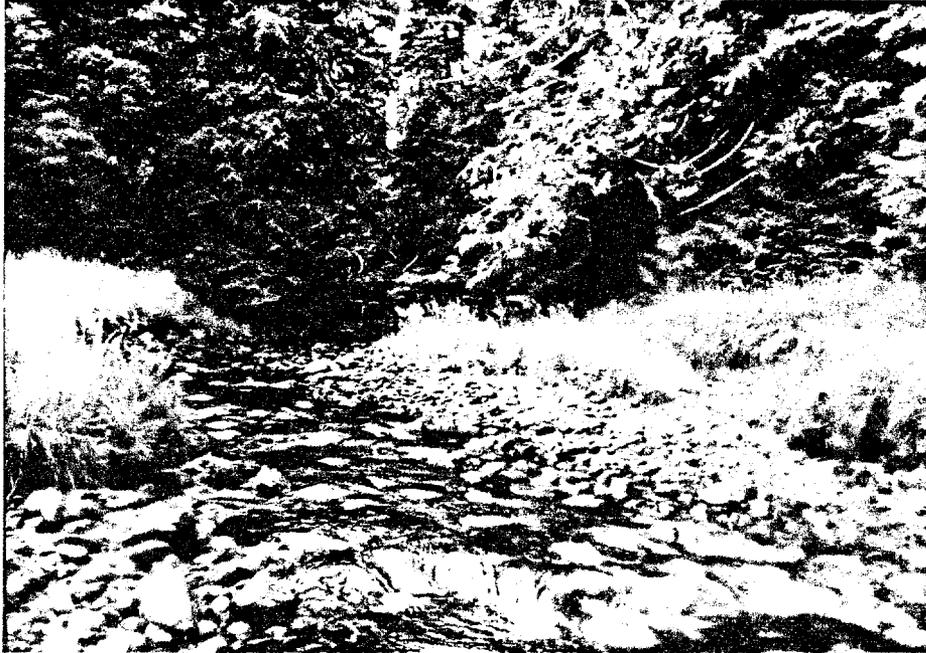
West Exchange Cove #1

1. Upper ITZ and stream mouth with flow over boulder/cobble.

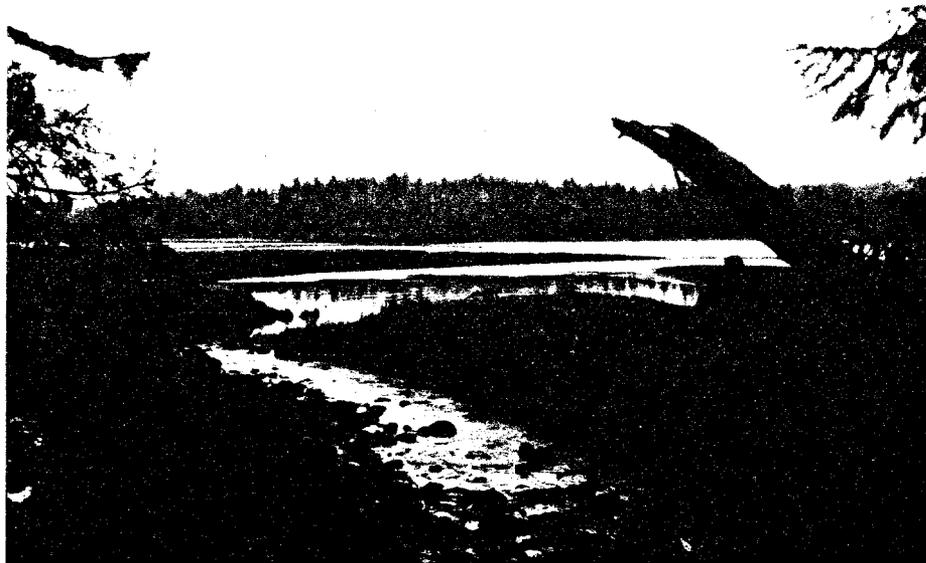
2. Downstream view of ITZ at high tide looking toward Exchange Cove.

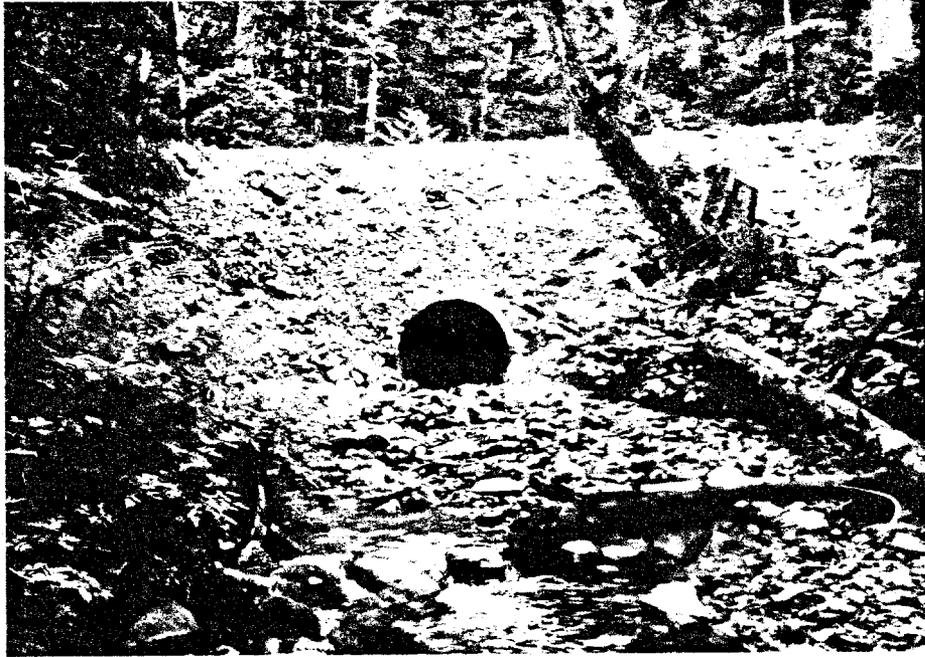
West Exchange Cove #1

This is a steep, fast mountainside stream with very little potential spawning and rearing area. Possibly, this stream could be used as a rearing area for coho fry in the first 100 meters, but none were observed at the time of the survey. The prevailing substrate is boulder/cobble. A road crossing via a culvert occurs at Section 1: 100 meters, which at high discharge levels, causes some downstream bank instability. Survey was terminated as stream heads up slope at rapidly increasing gradient.

3. Road crossing via 5' culvert, Section 1: 100m.

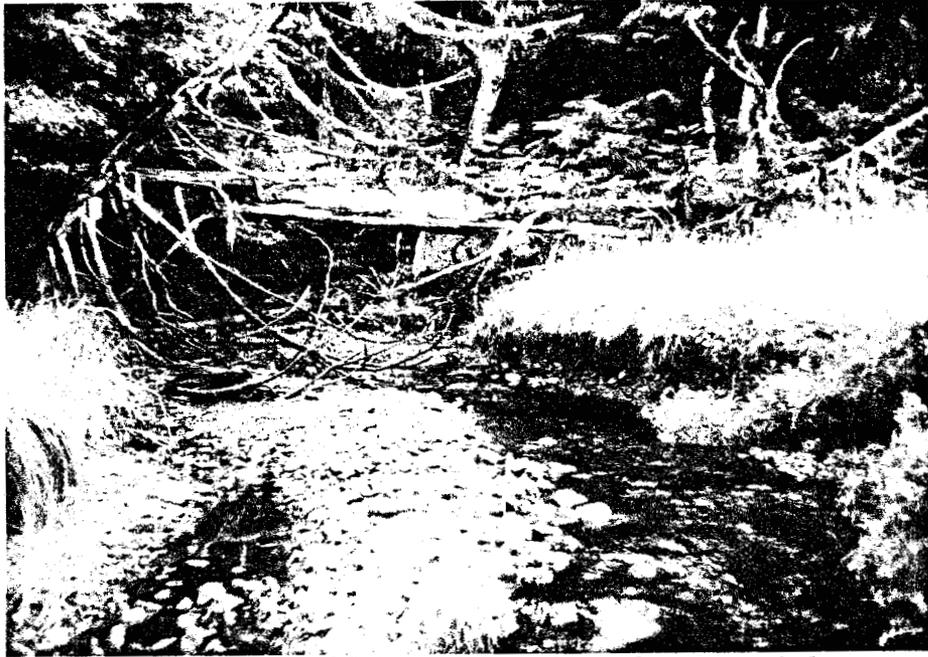
Exchange Cove West #2

1. Upper intertidal zone; copious debris and dense overhanging shrubs typify reconnoitered area.

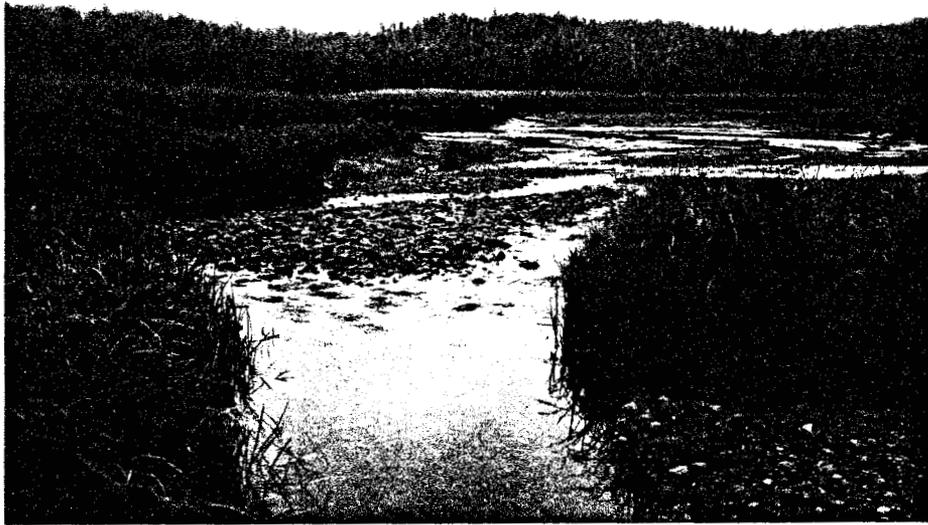
2. Sinuous intertidal slough contained one pocket of ASA and marginal rearing habitat.

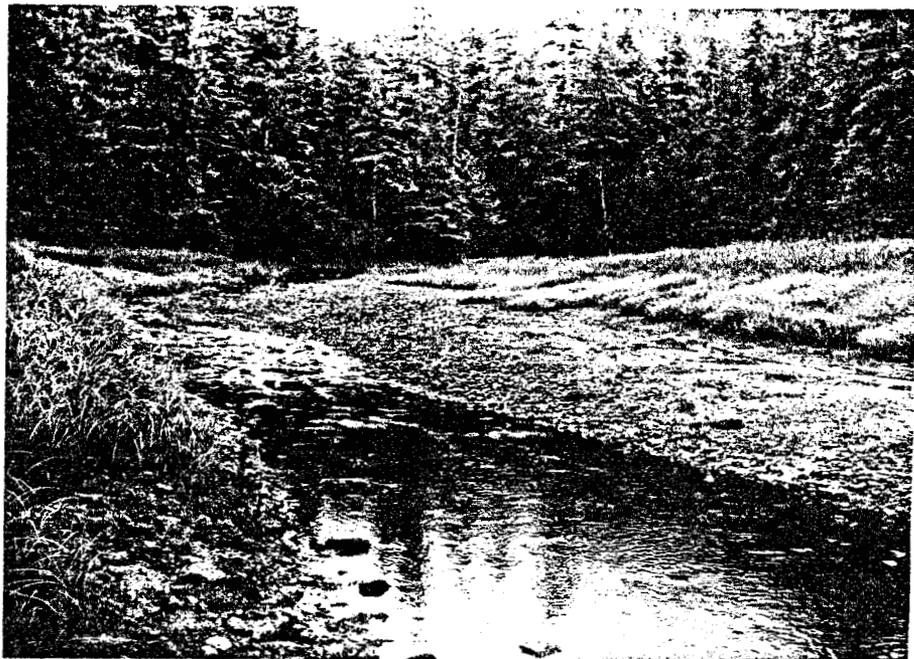
West Exchange Cove #3

1. Looking upstream toward the creek mouth. The ITZ provides excellent ASA.

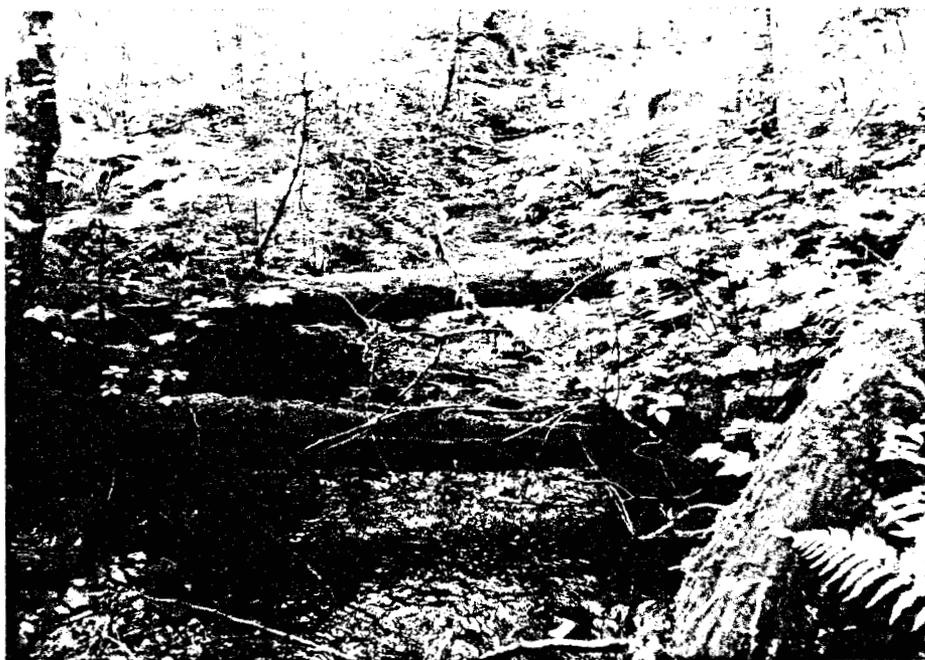
2. Section 1 contains excellent ASA and cover.

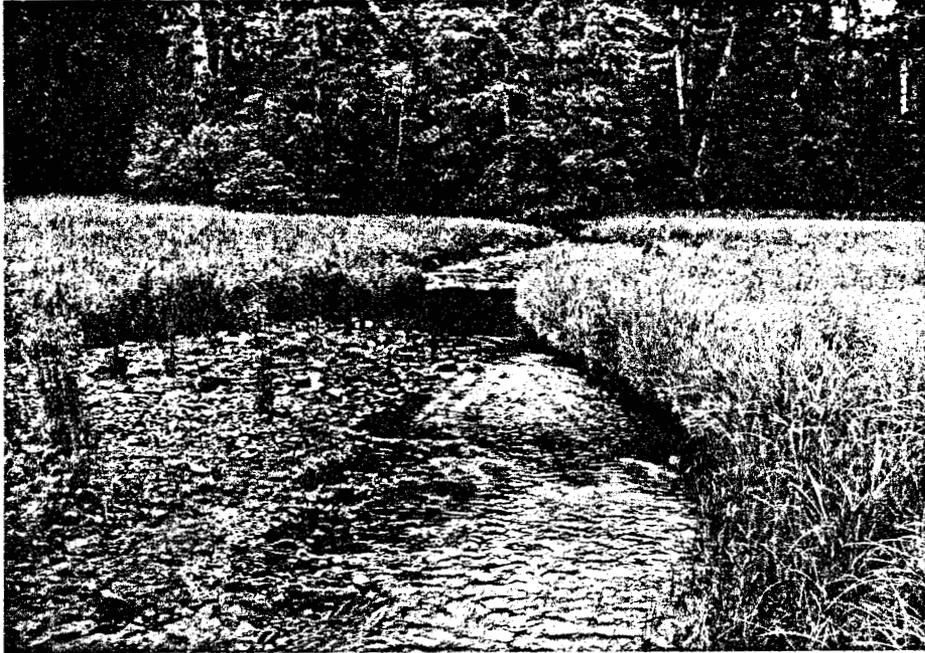
West Exchange Cove #4

1. The ITZ provides good ASA.

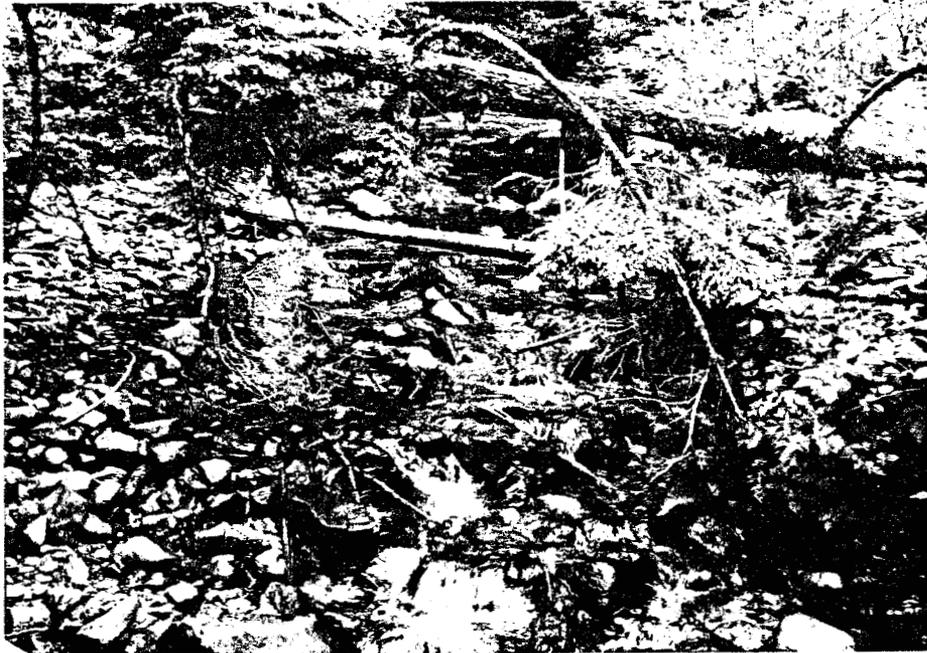
2. Cobble substrate in Section 1 creates fair ASA.
