REVISED ANADROMOUS STREAM CATALOG OF SOUTHEASTERN ALASKA

District 106

Northeast Coast of Prince of Wales Island

Subdistricts 106-30 and 106-10

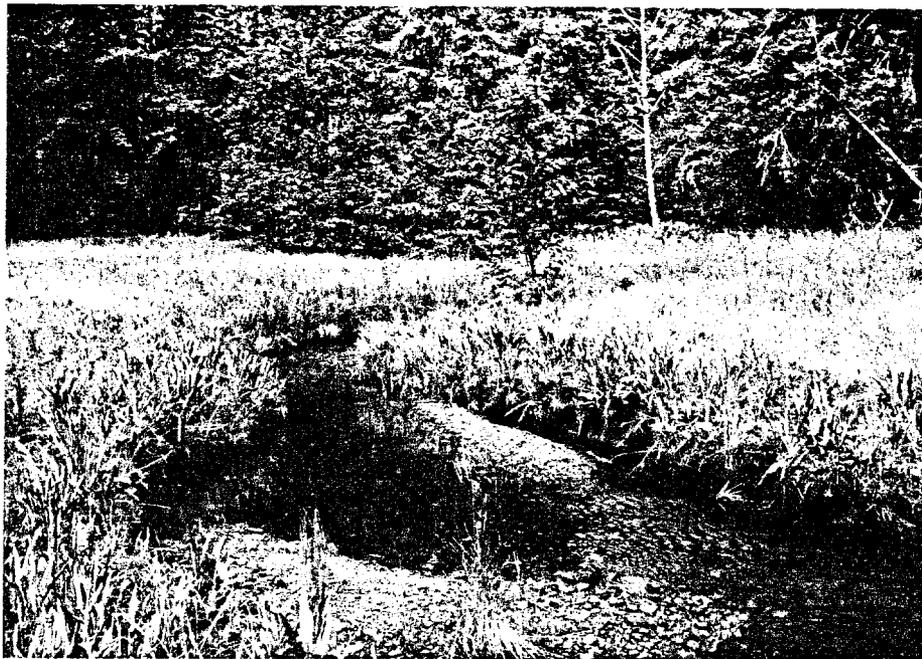
West Exchange Cove #5

1. The ITZ looking toward the creek mouth. Intertidal ASA is limited due to sandy substrate.

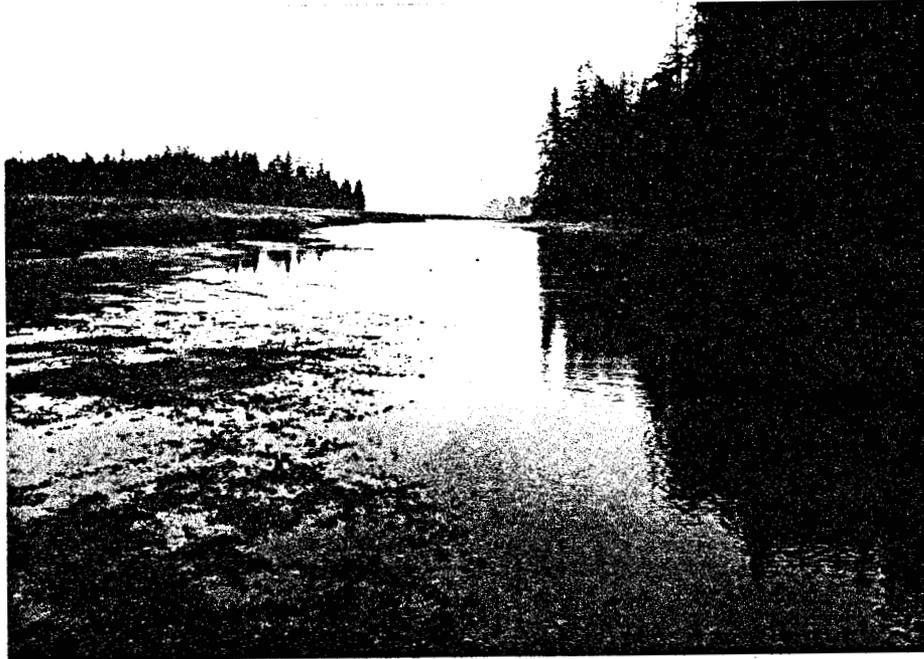
Exchange Creek

1. The ITZ looking downstream from Section II.

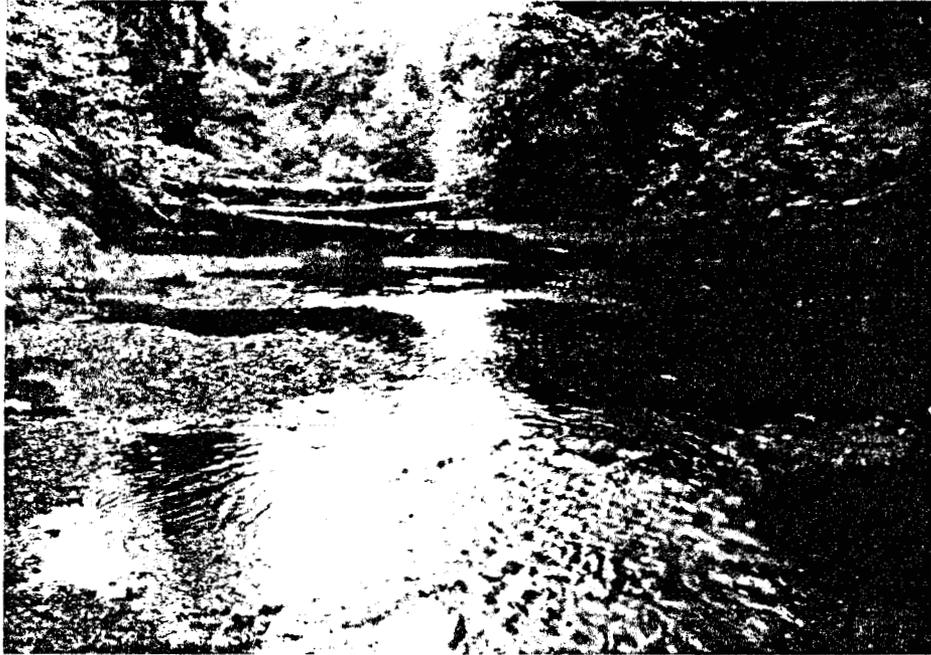
Exchange Creek

3. A shallow, wide channel with massive blowdown in the background of Section 4.

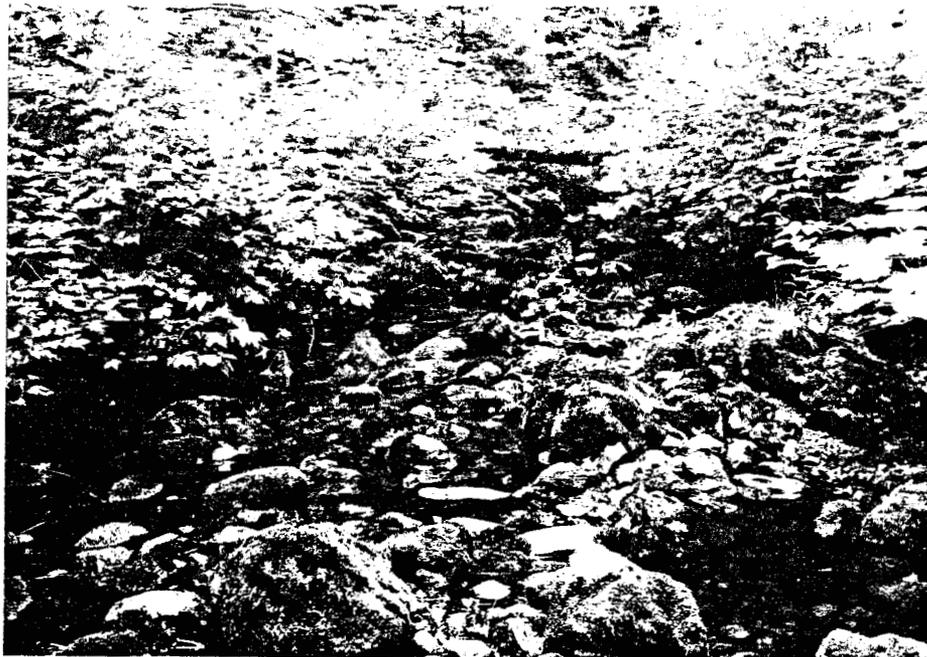
4. Moderate gradient and large cobble substrate of Section 8.

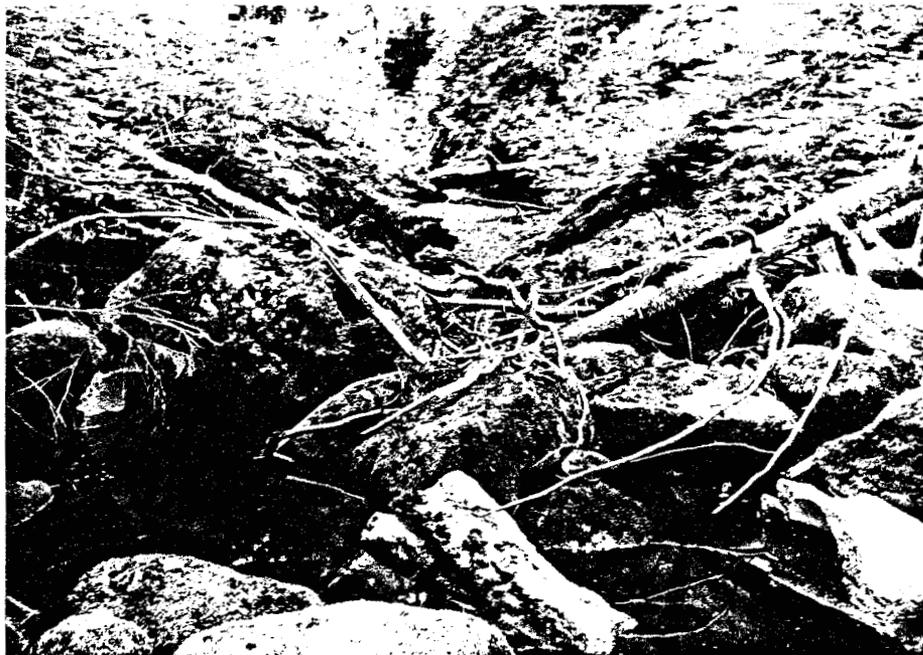
6. A low flow barrier is created in Section 9 when flow seeps through the gravel.

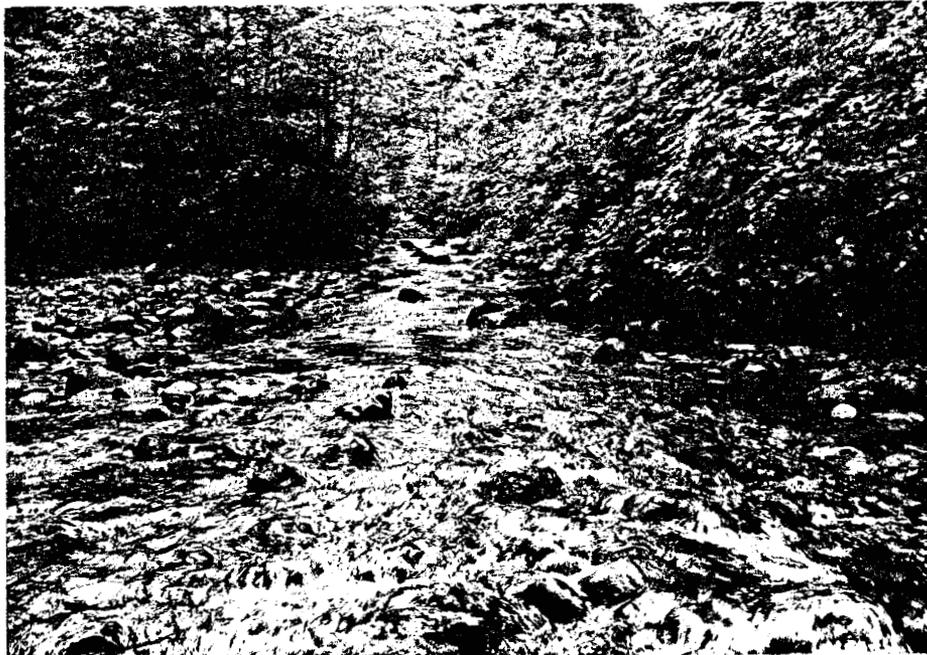
8. Mouth of Survey Area "B".

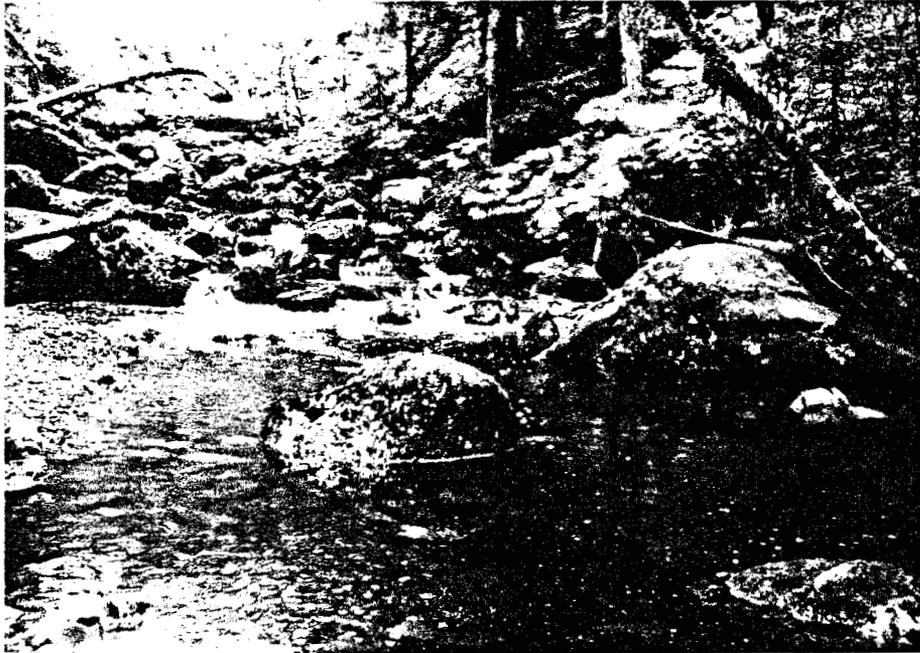
Exchange Creek
Survey Area "B"

9. Large boulders and bedrock dominate the substrate in Section 3.

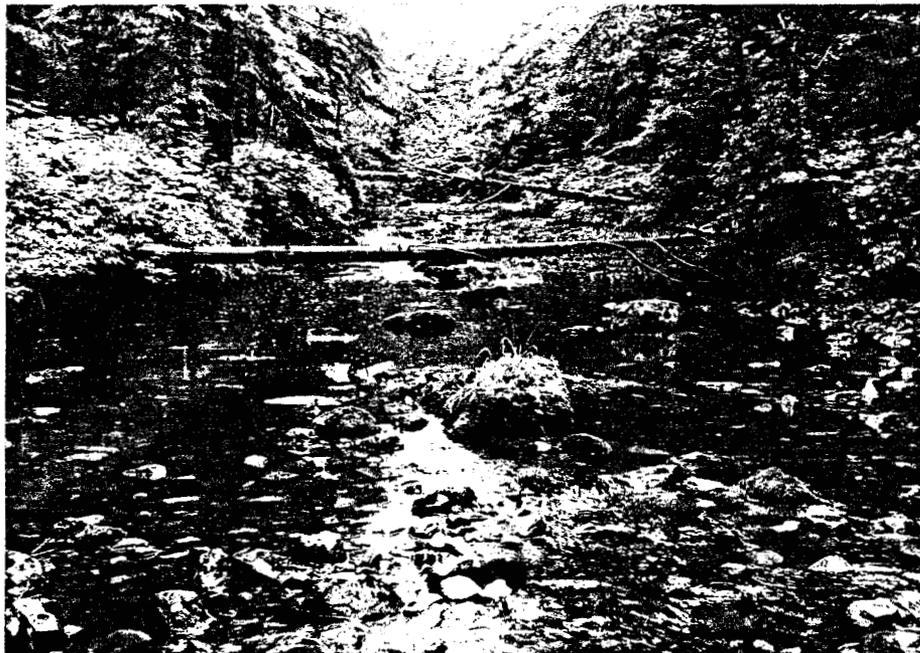
10. Gradient becomes moderate in Section 5. ASA and rearing habitat improve.

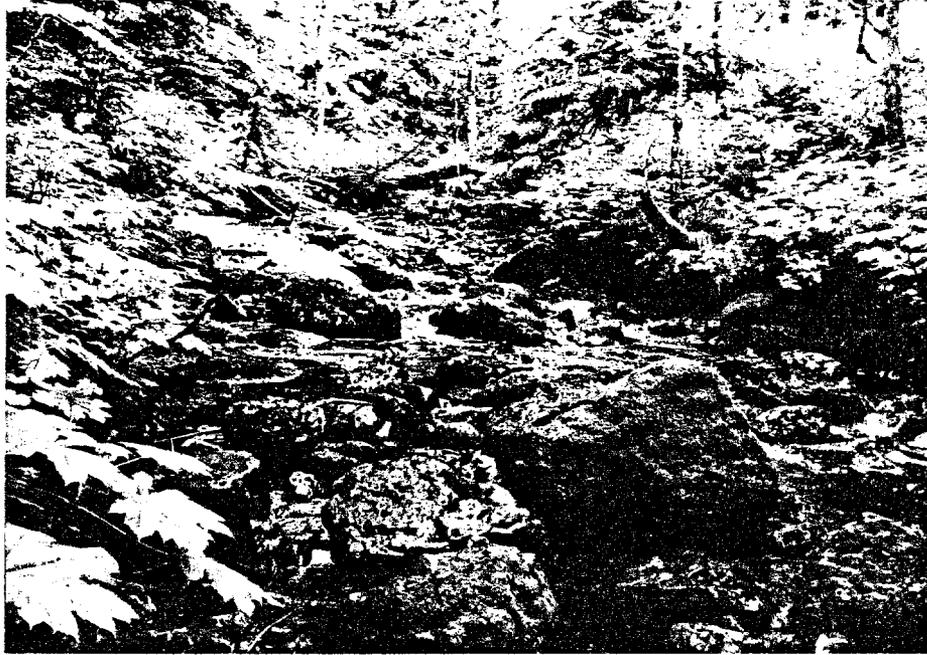
Exchange Creek
Survey Area "B"

11. Fish habitat quality diminishes with increased gradient in Section 11.

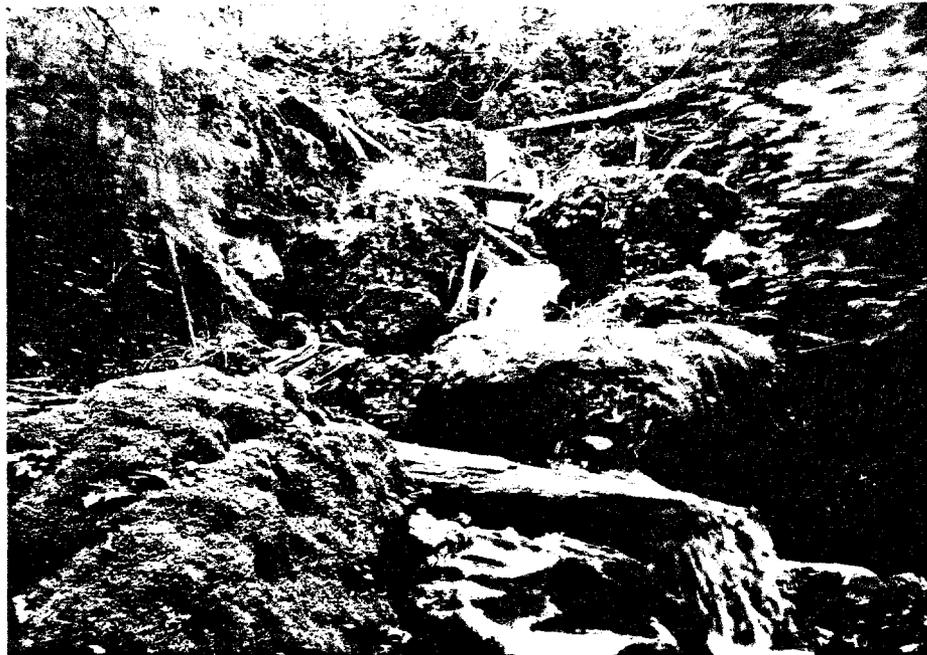
12. This survey terminates at a 2 m barrier falls (background) at the end of Section 11.

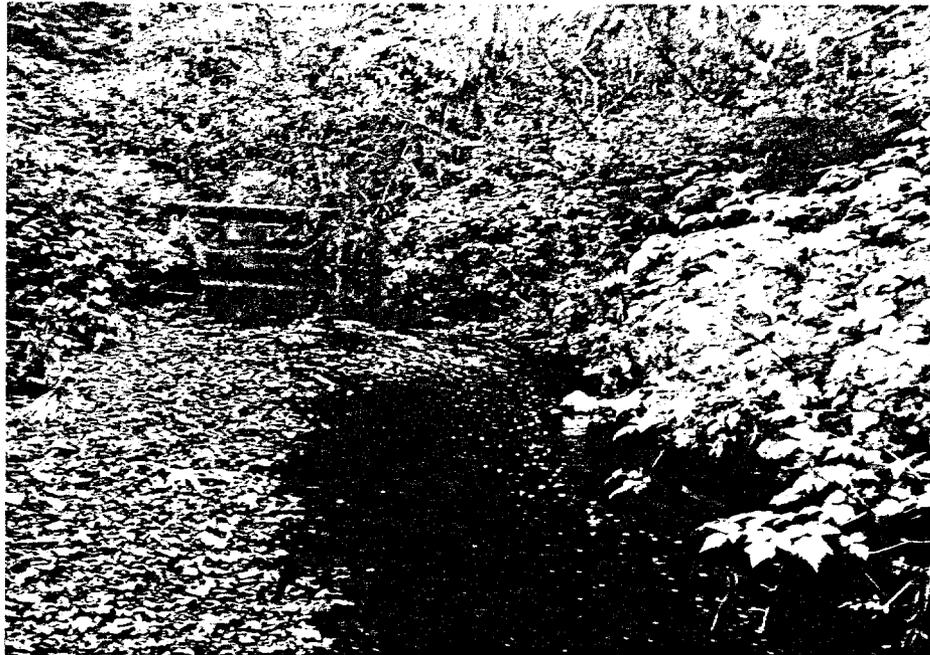
16. Section 2: 0m; Good rearing cover with patchy ASA.

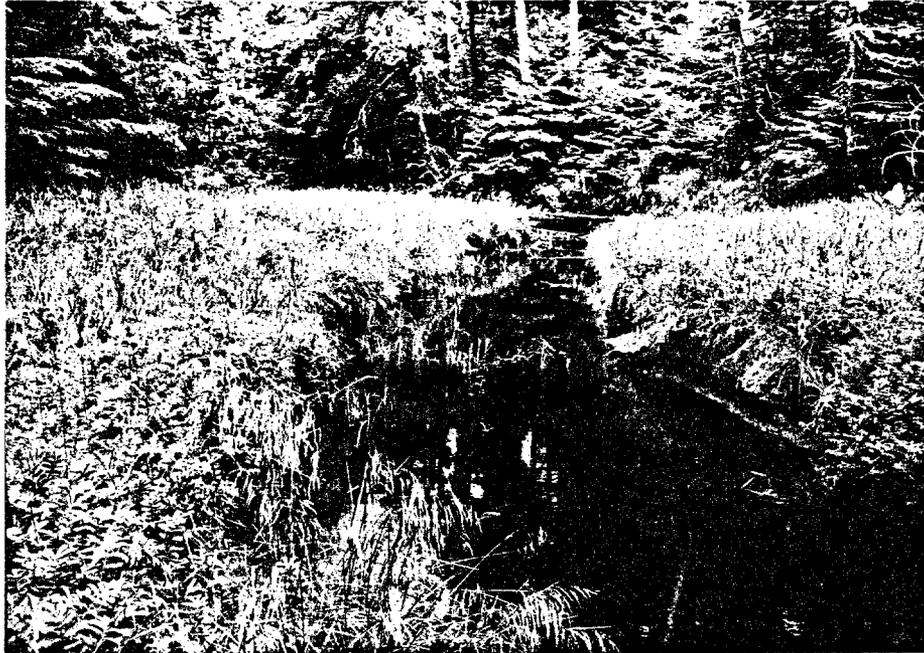
Exchange Cove Head #2

1. The ITZ looking downstream toward the confluence with Exchange Cove Head #1. Substrate is composed almost entirely of sand and muck.

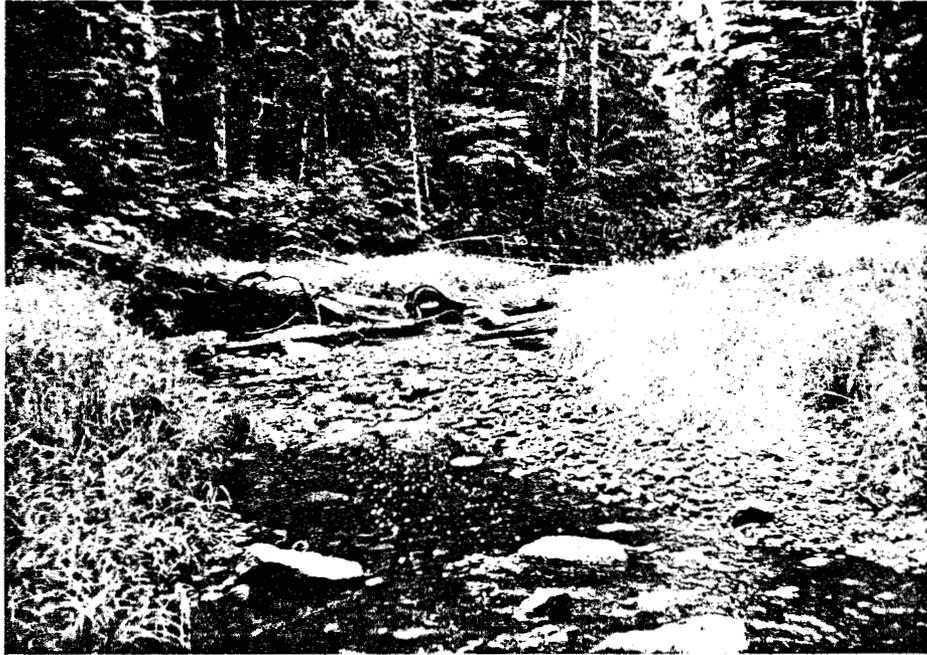
Exchange Cove East #3

1. The bulk of available rearing and spawning habitat is concentrated near the mouth.

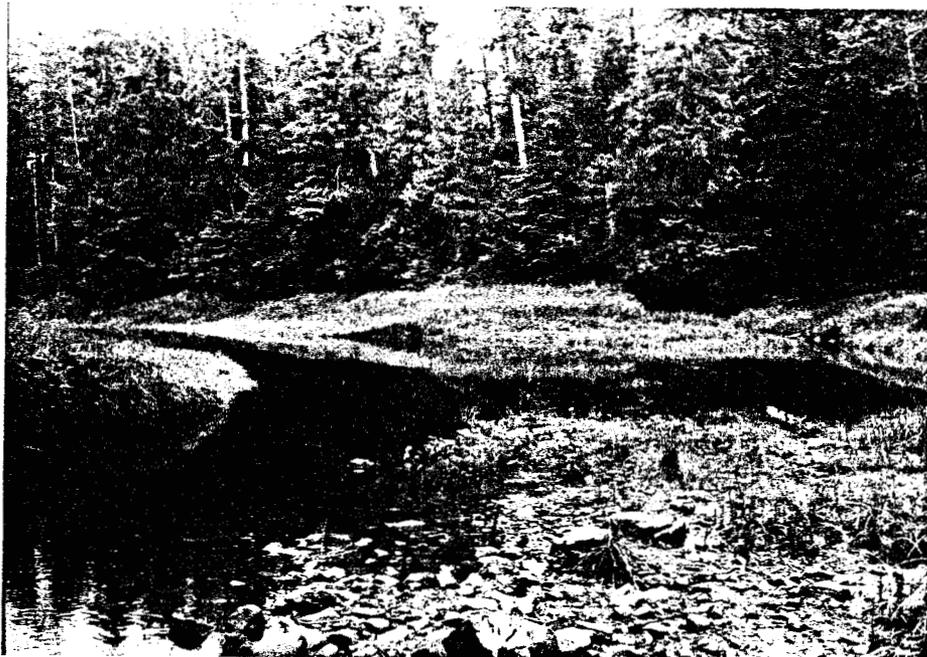
2. This moderately sized, muskeg influenced stream empties into the head of a tidal lagoon.

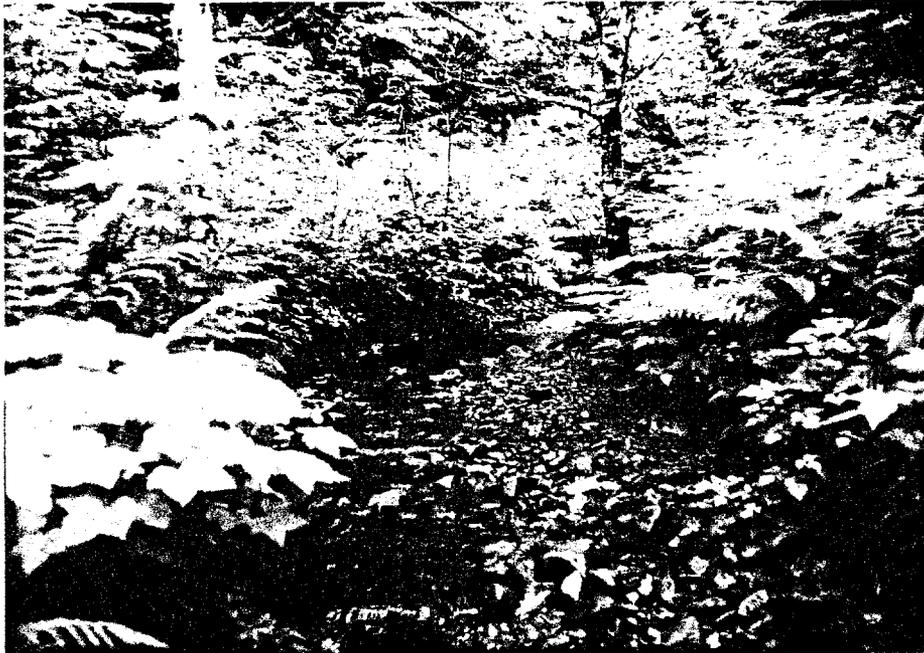
Exchange Cove East #3

3. Increased channel sinuosity and bank undercutting, reduced gradient, extensive pooling, and muskeg seeps typify Reach 2.

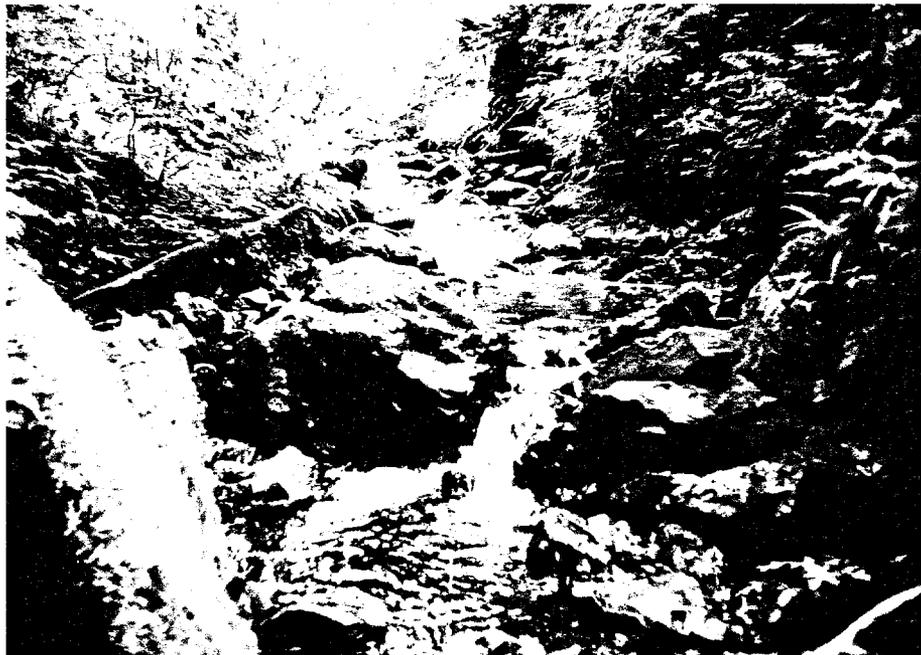
4. Lack of habitat negated additional surveying. Reconnaissance revealed channel gradients exceeding 10% and nearly continuous bedrock cascades.

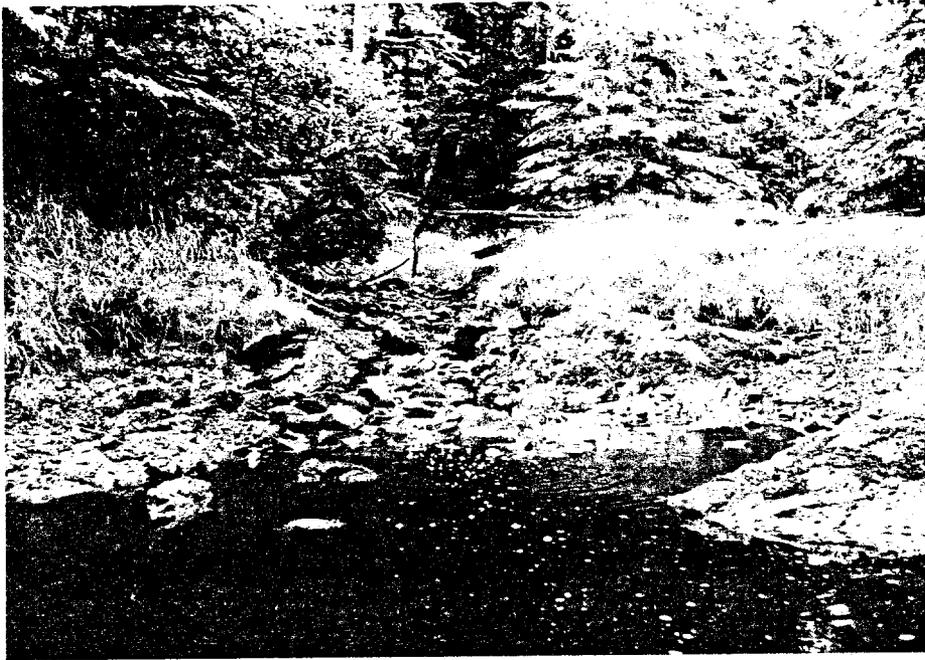
1. IT bedrock riffles drain this beaver/muskeg system.

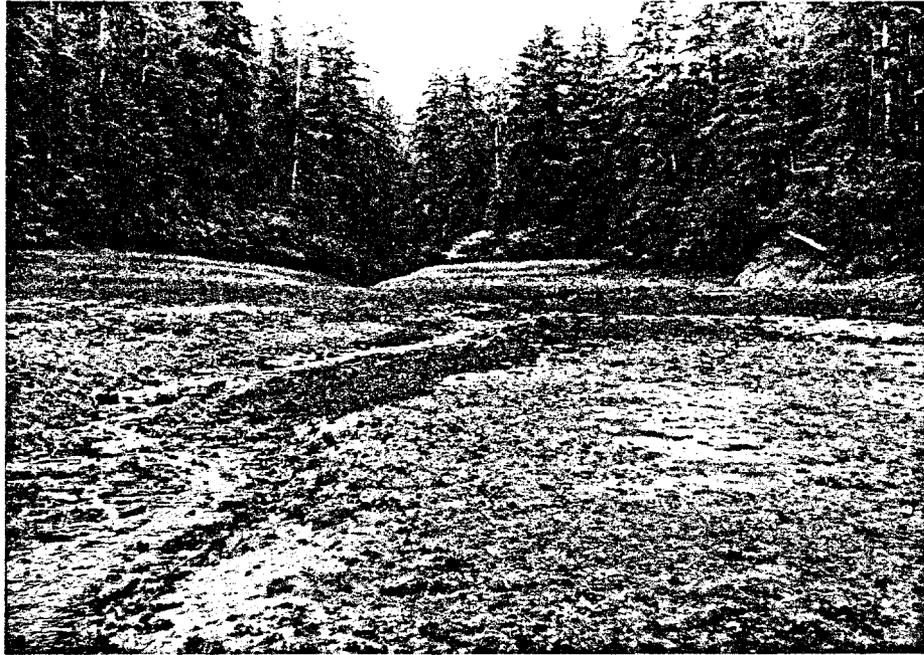
1. ITZ at low tide.

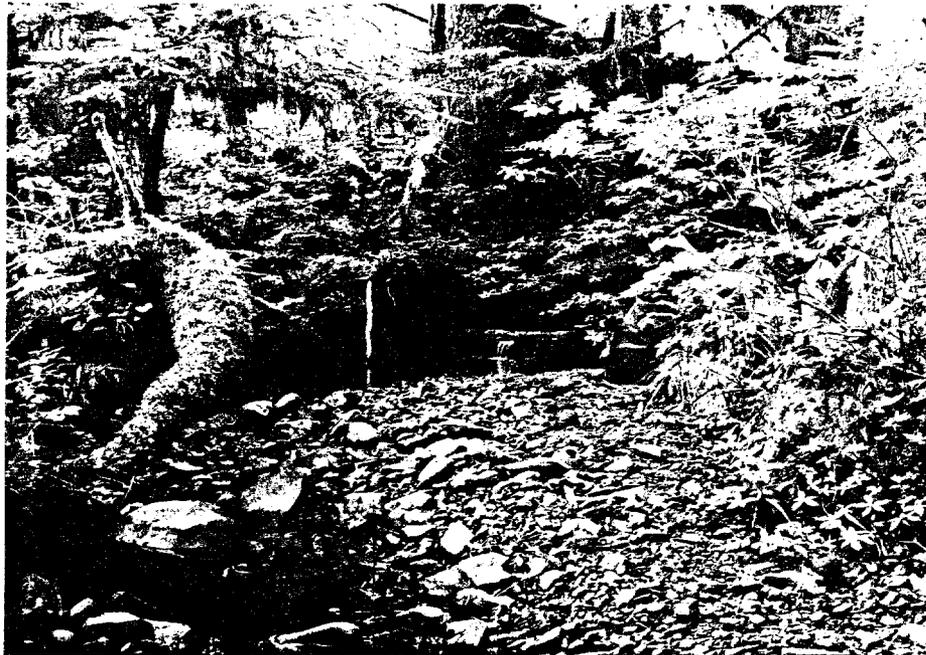
2. Mouth of stream with boulder/cobble substrate.

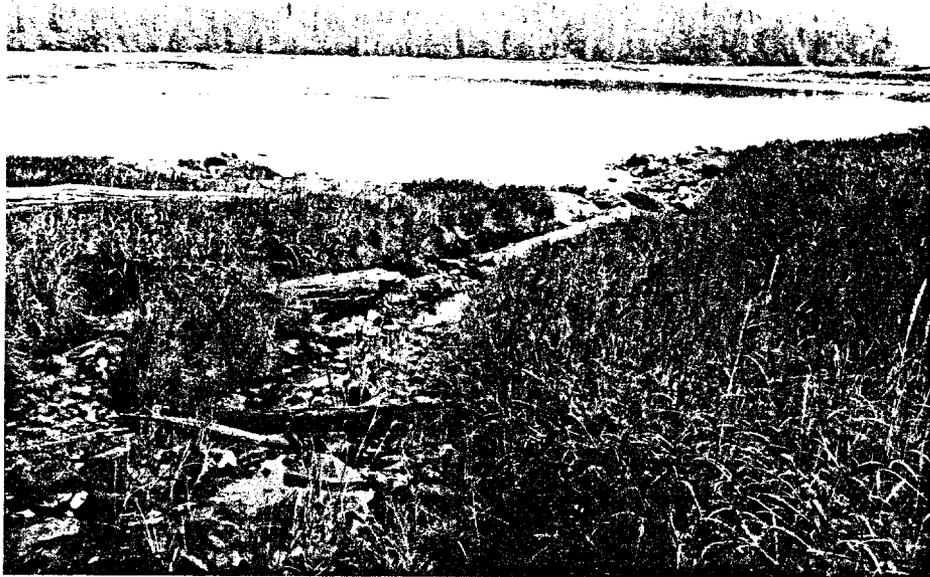
1. Downstream view of lower ITZ outlet from rearing pond.

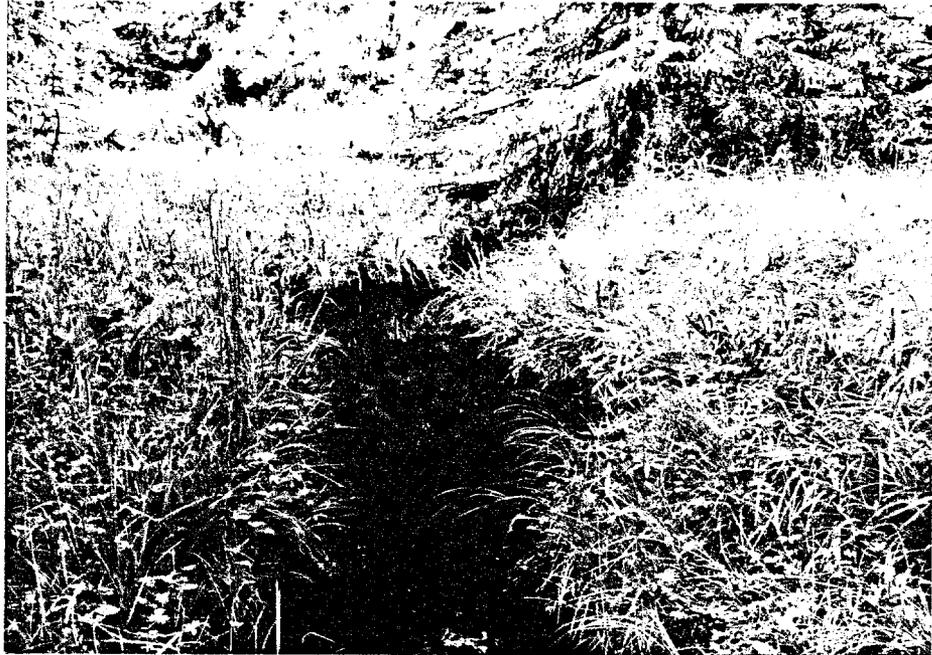
3. Stream is rearing slough through grass meadow.

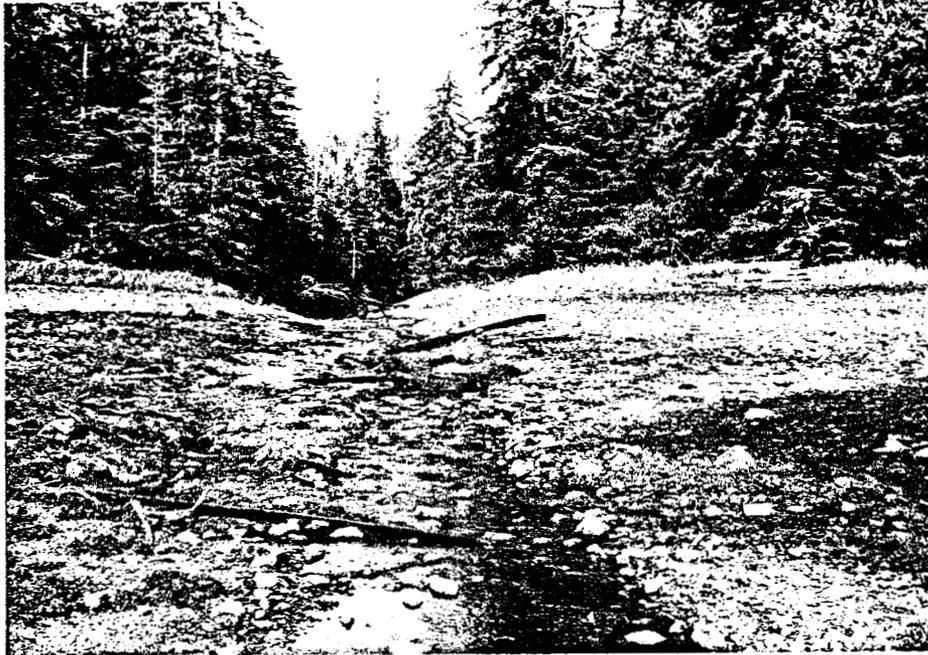
1. ITZ and mouth of Whale Pass #5.

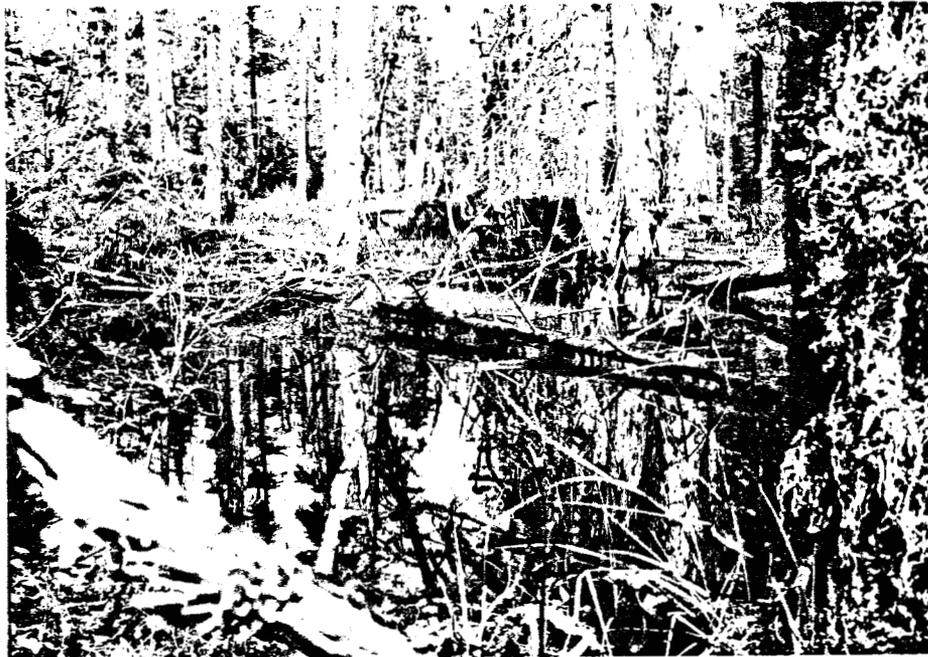
2. Beaver pond from beaver dam, Section 1: 130m.

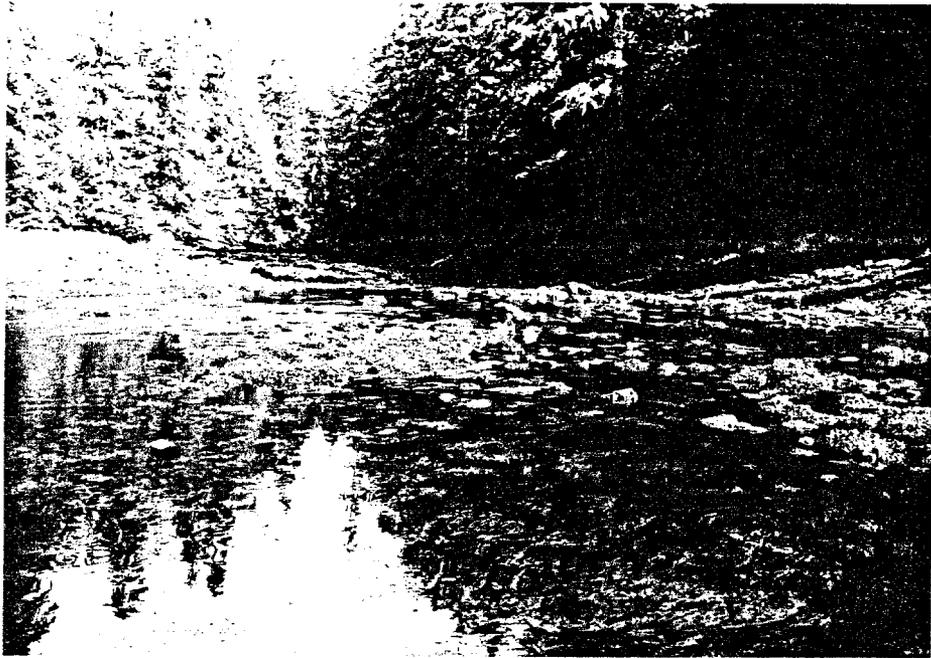
1. The ITZ looking at the stream mouth.

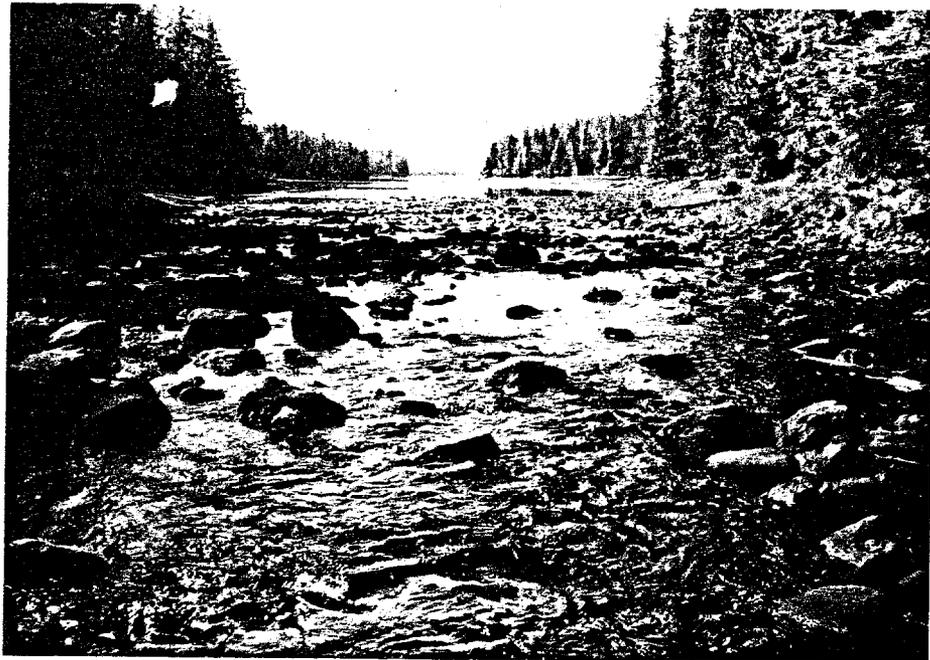
2. The ITZ looking downstream from the stream mouth.

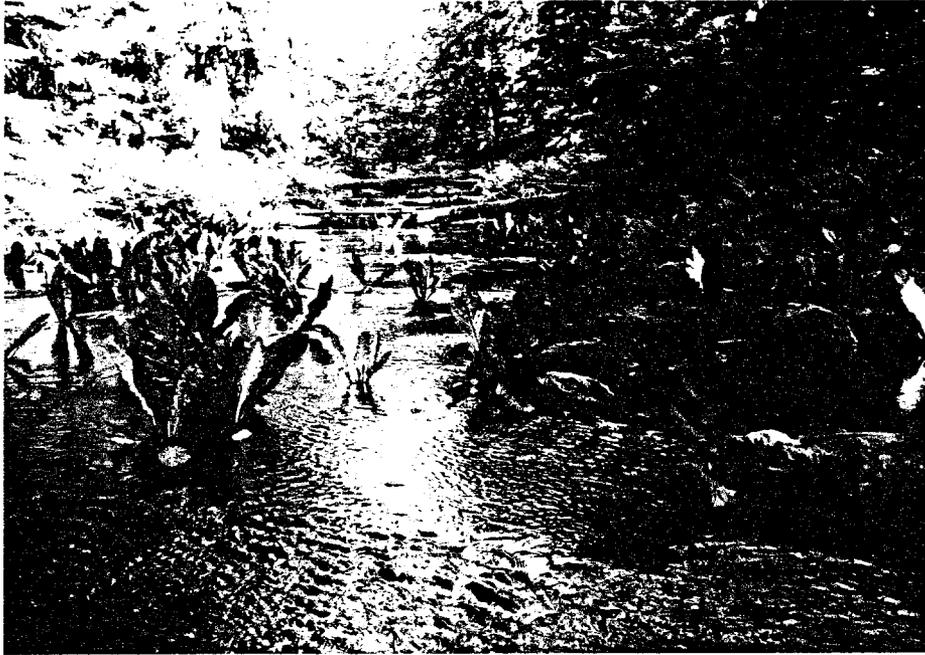
3. Forbs growing in shallow, wide channel of Section 1.

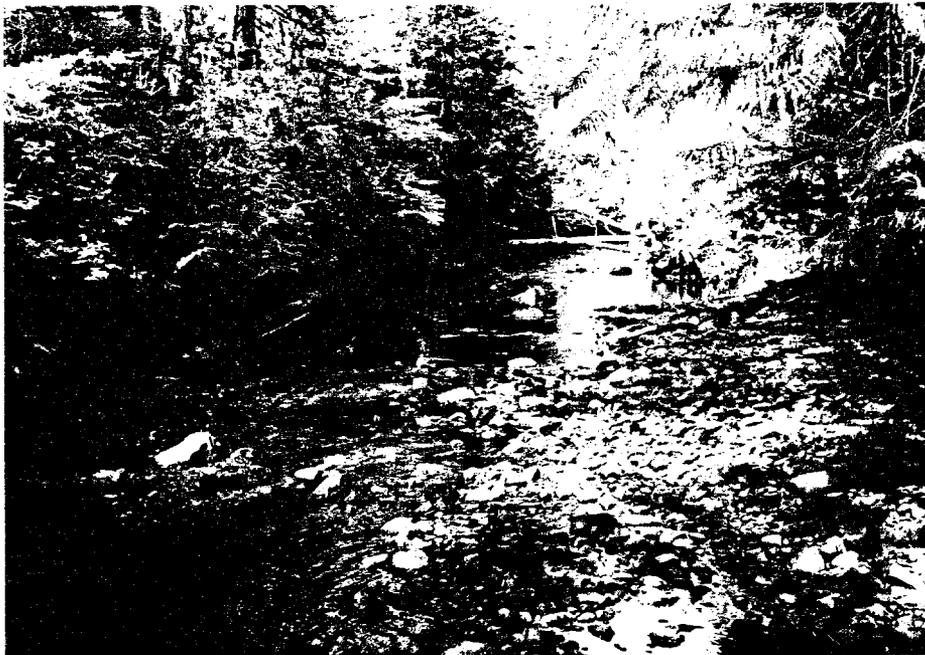
6. Section 6: Low gradient and good ASA just above the cascade.

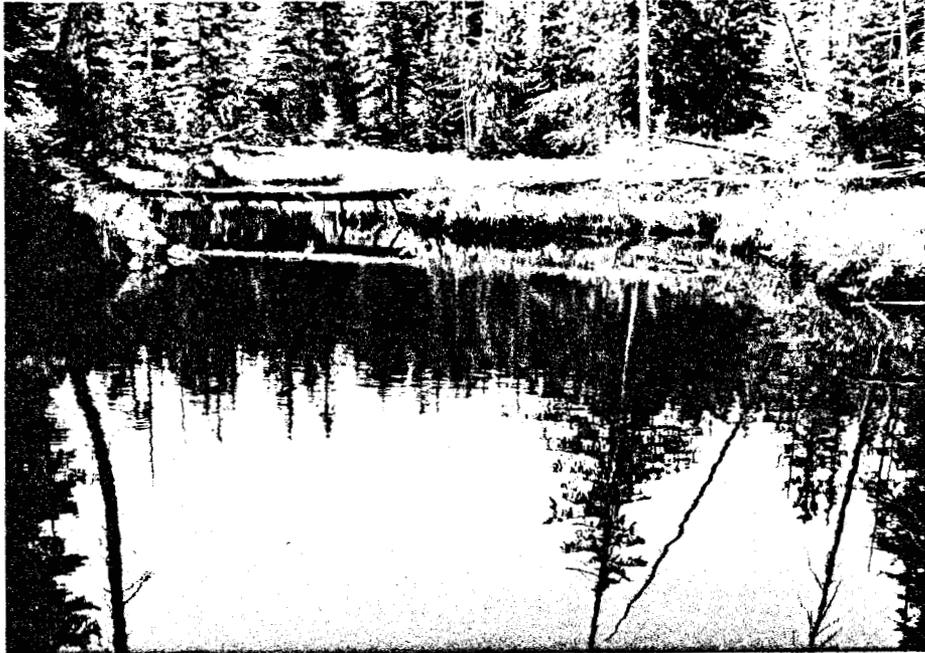
7. The stream becomes sinuous and slough-like in Section 9.

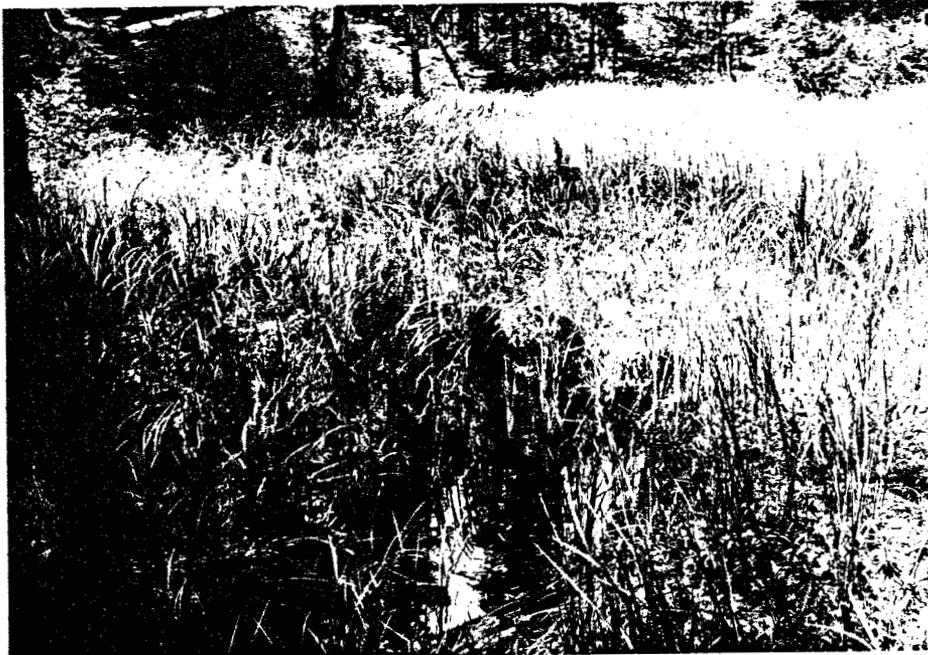
8. A small tributary enters Section 10.

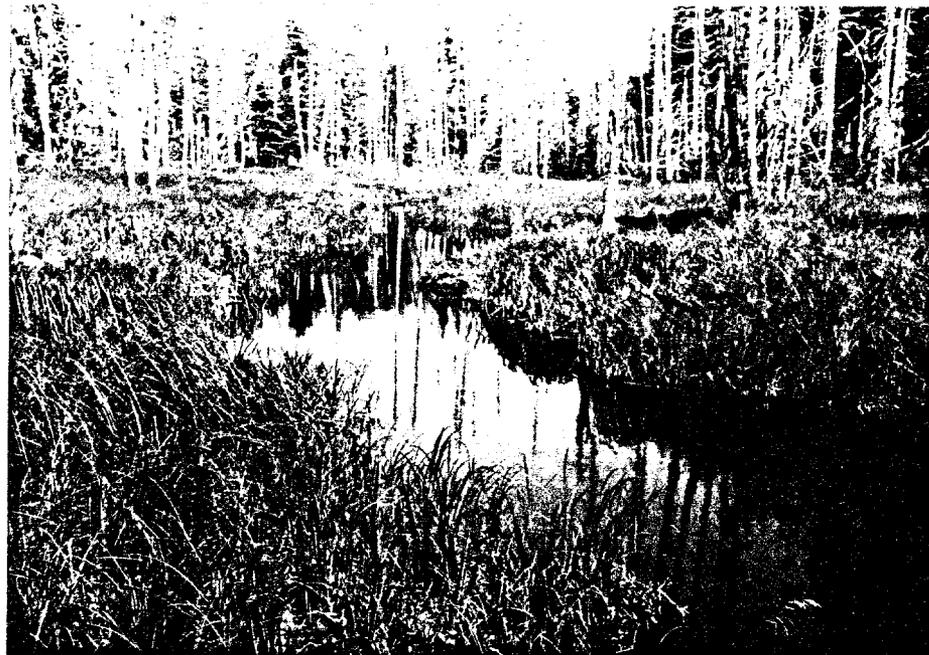
10. Survey Area "B": Section 4 is a channelized beaver system which travels through a wide, grassy floodplain, similar to Section 2 & 3.

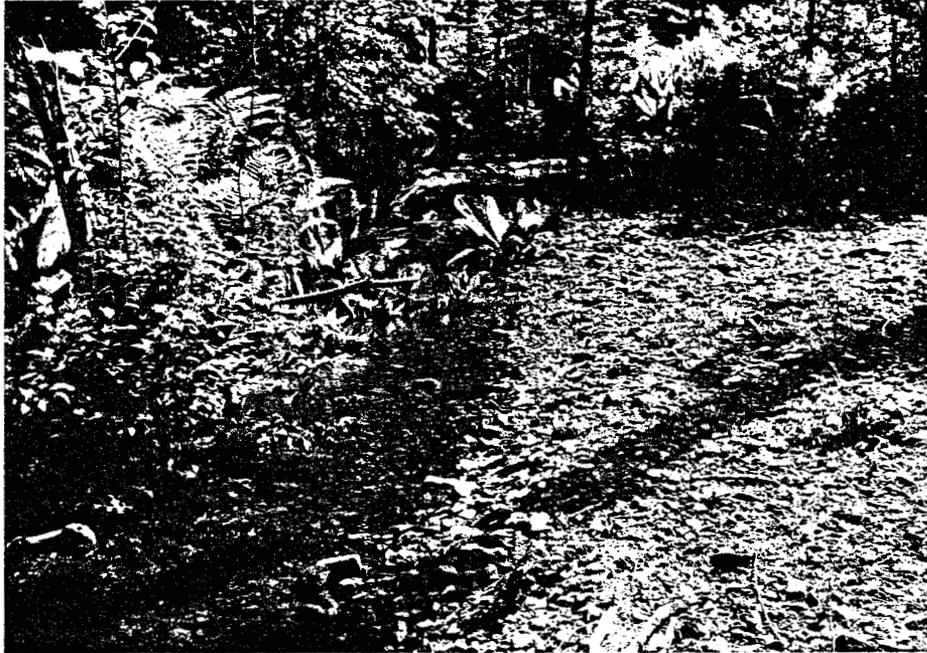
11. Survey Area "B": The stream enters a fringe of trees in Section 5. ASA improves with an increase in gradient and small cobble substrate.

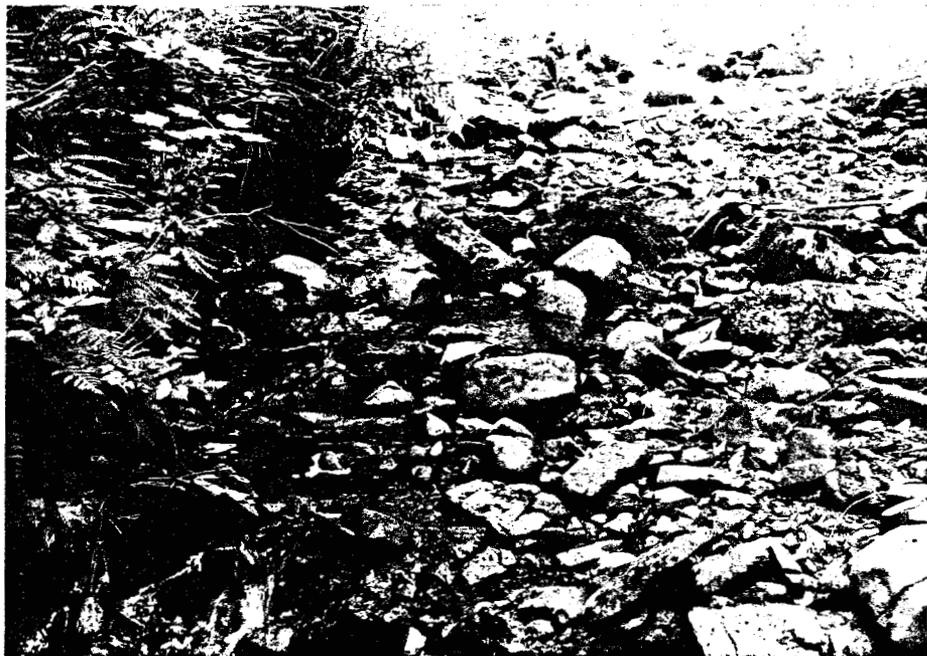
12. Survey Area "B": An abrupt gradient increase occurs as the stream enters a V-notch in Section 6.

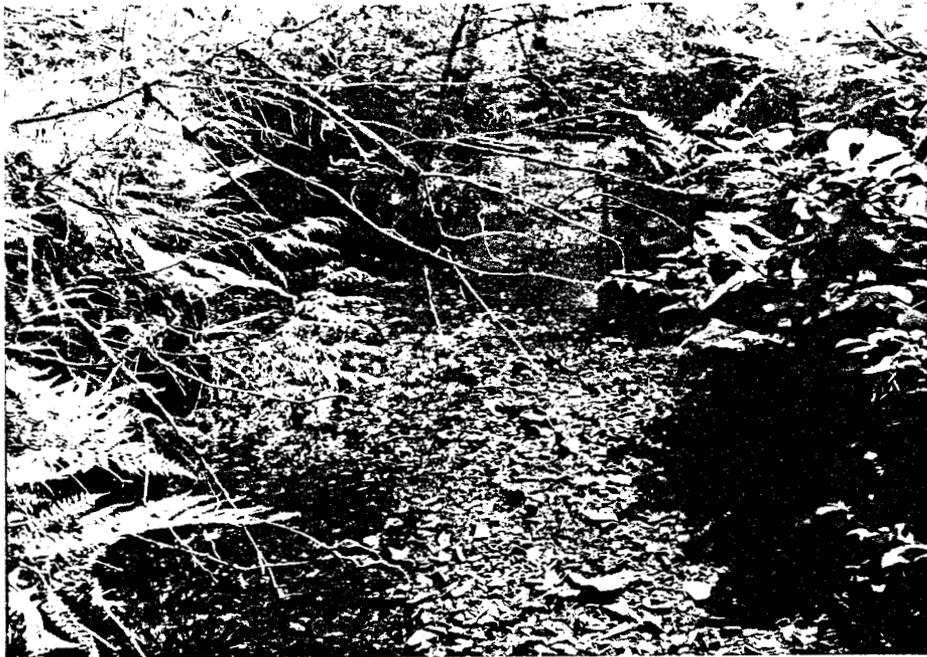
14. Survey Area "C": Section 2 has increased gradient and good ASA, as the stream travels through a transitional zone between floodplain to forest.

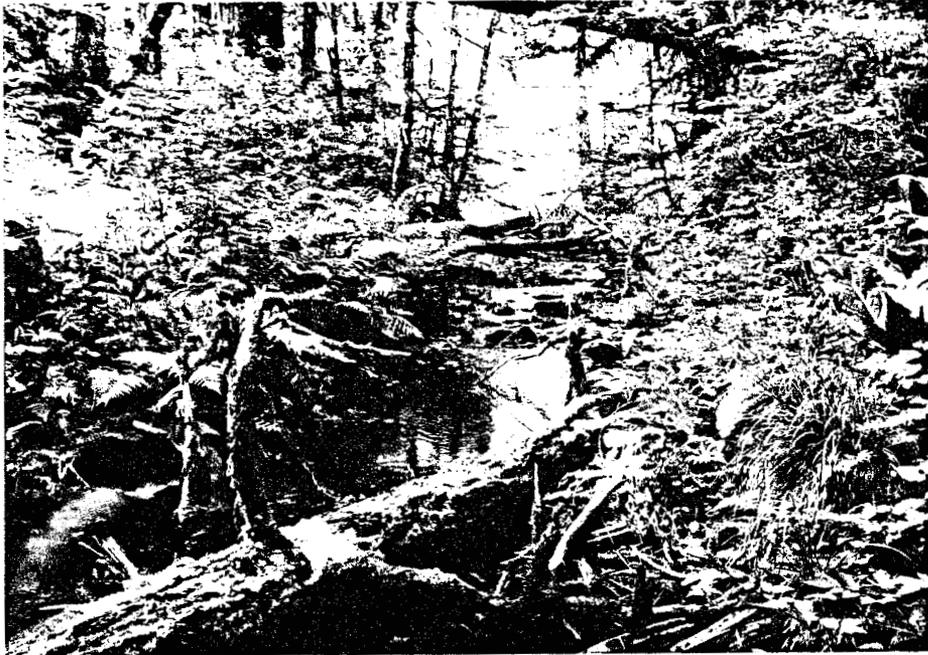
15. Survey Area "C": The stream enters the forest at Section 3.

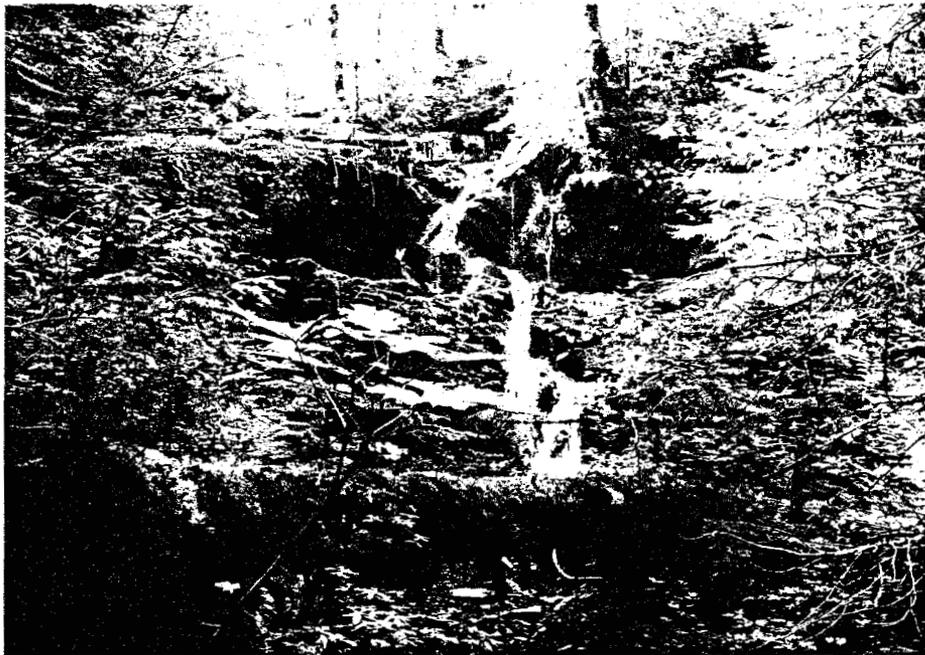
16. Survey Area "C": An 8 m barrier falls at the end of Section 3.

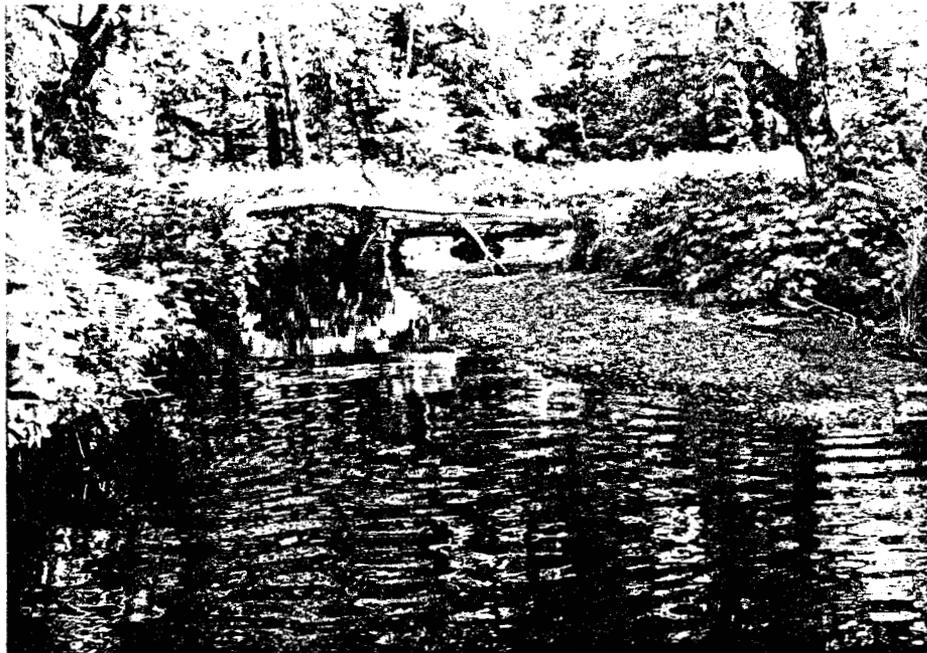
18. Survey Area "D". Large pools in Section 1 provide excellent rearing habitat.

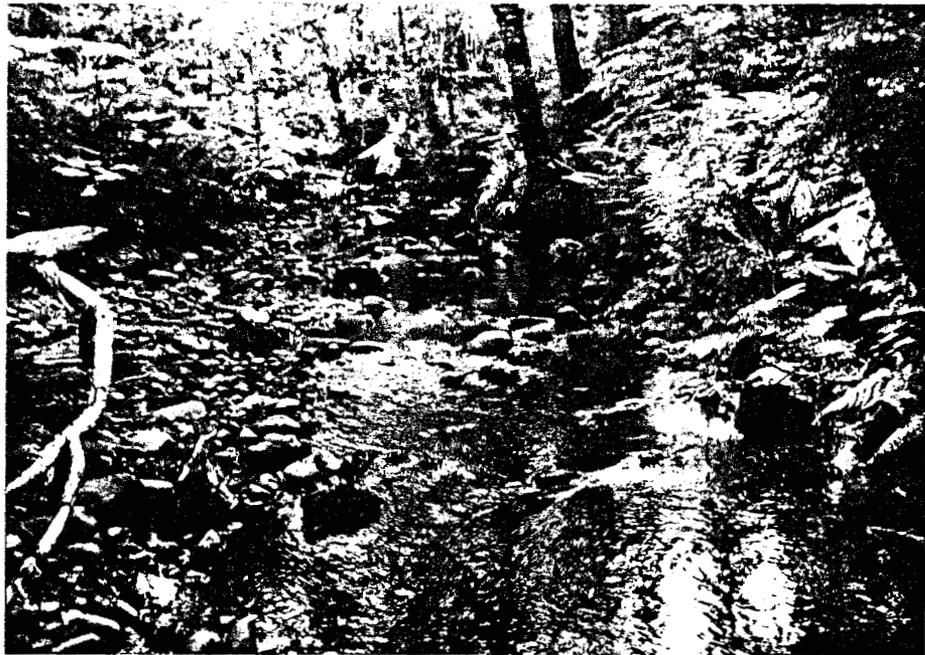
20. Survey Area "D-1": Large cobble substrate
in Section 2.
