REVISED ANADROMOUS STREAM CATALOG OF SOUTHEASTERN ALASKA

District 106

Northeast Coast of Prince of Wales Island

Subdistricts 106-30 and 106-10

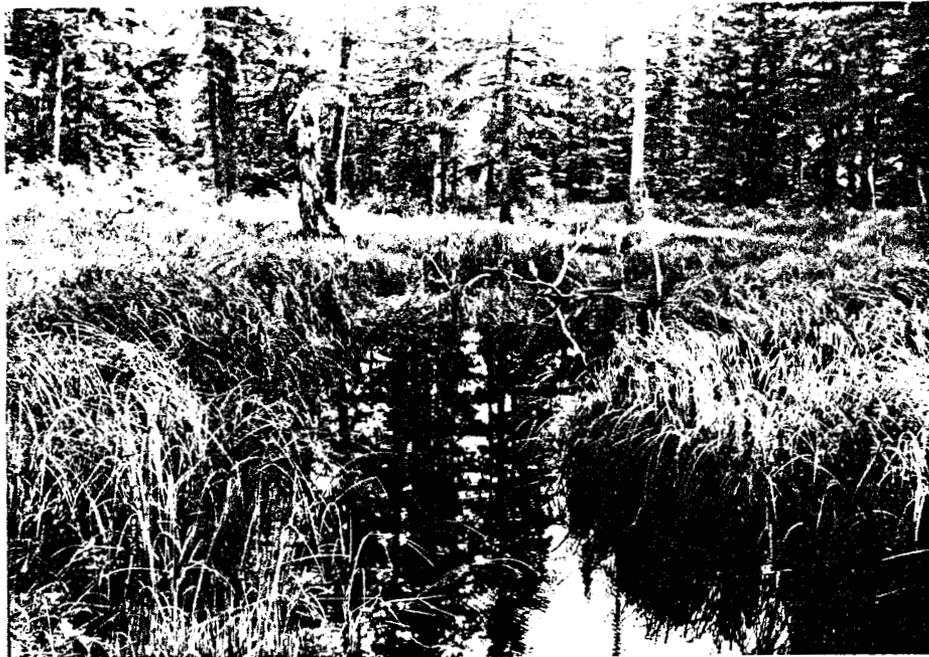
22. Survey Area "D-2": Section 1 is sinuous, traveling through a wide, grassy floodplain.

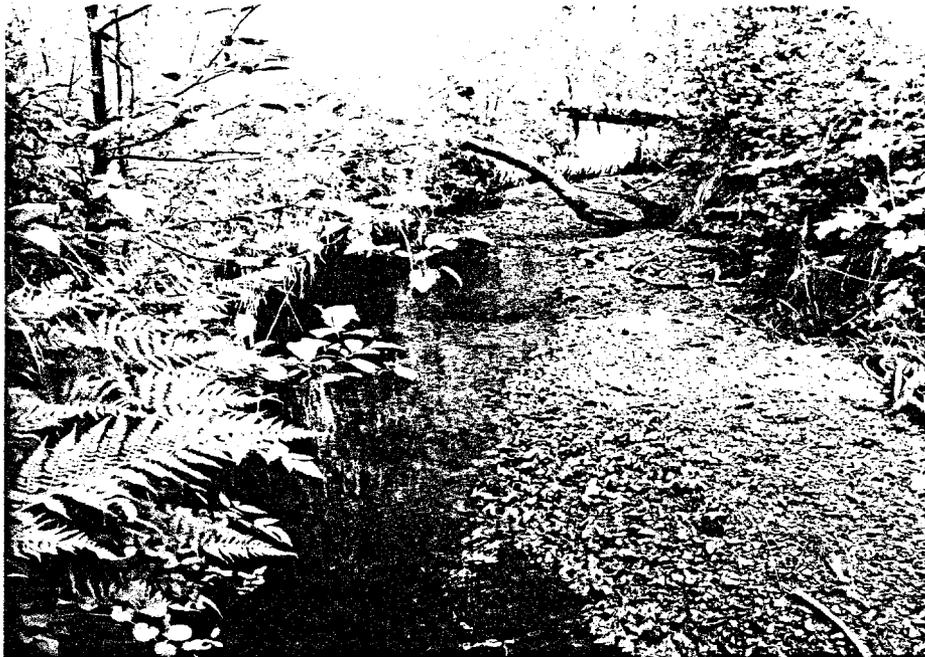
23. Survey Area "D-2": Section 2 contains intermittent regions of gradient providing some ASA.

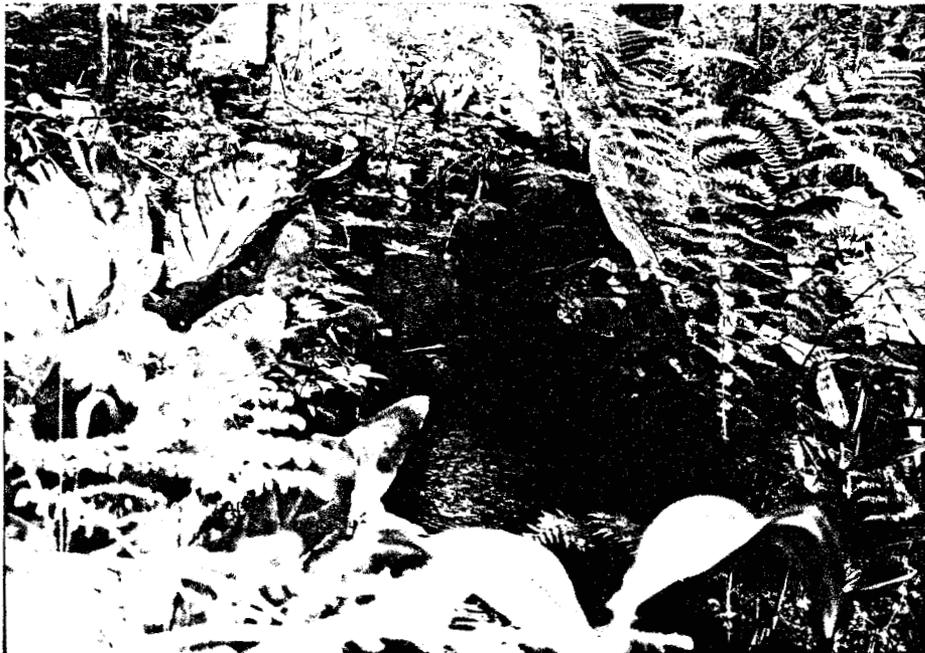
28. Survey Area "F": This small stream has dense riparian cover.

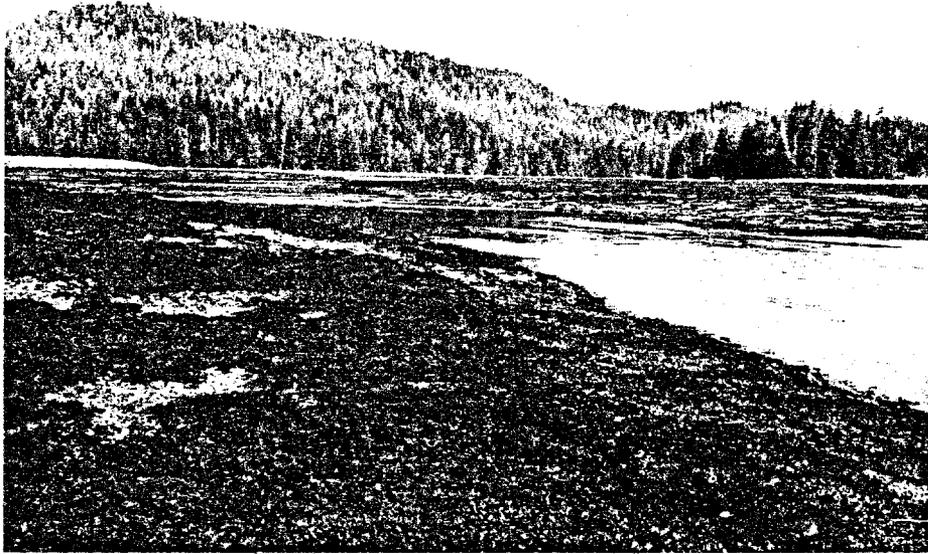
The lower ITZ is primarily a large mud flat with heavy fines in the cobble substrate of the stream channel. Large populations of mussels and clams were observed here, as well as considerable amounts of aquatic vegetation (rockweed, Ulva spp., etc).

1. Lower ITZ at low tide.

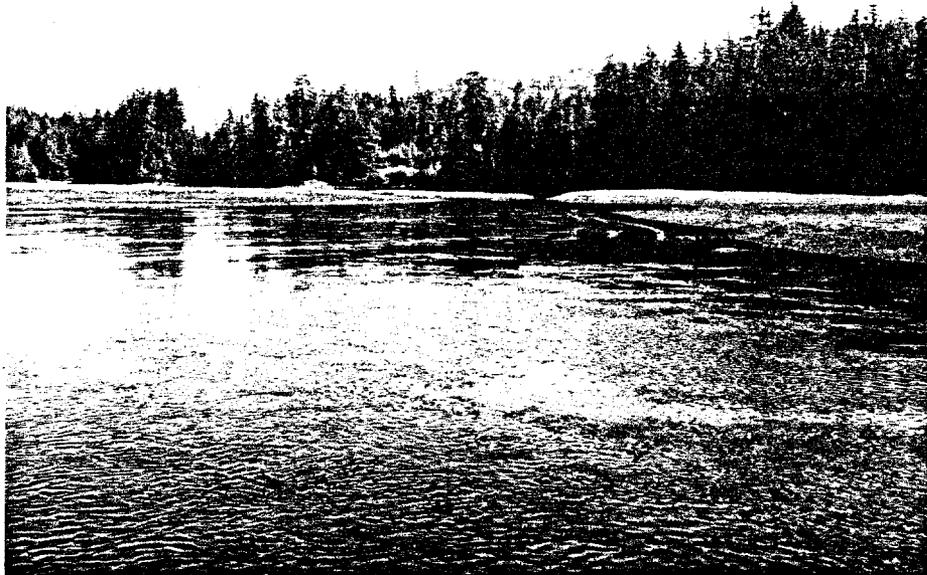
2. Middle ITZ in grass meadow with heavy concentration of fines. Adjacent road visible (middle right of photo).

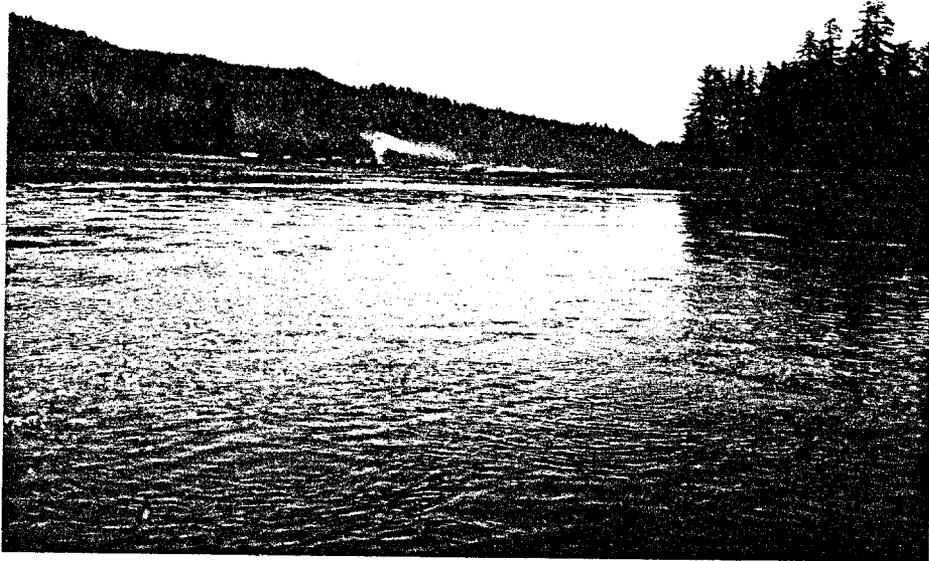
3. Downstream view of ITZ with Whale Pass logging camp in background.

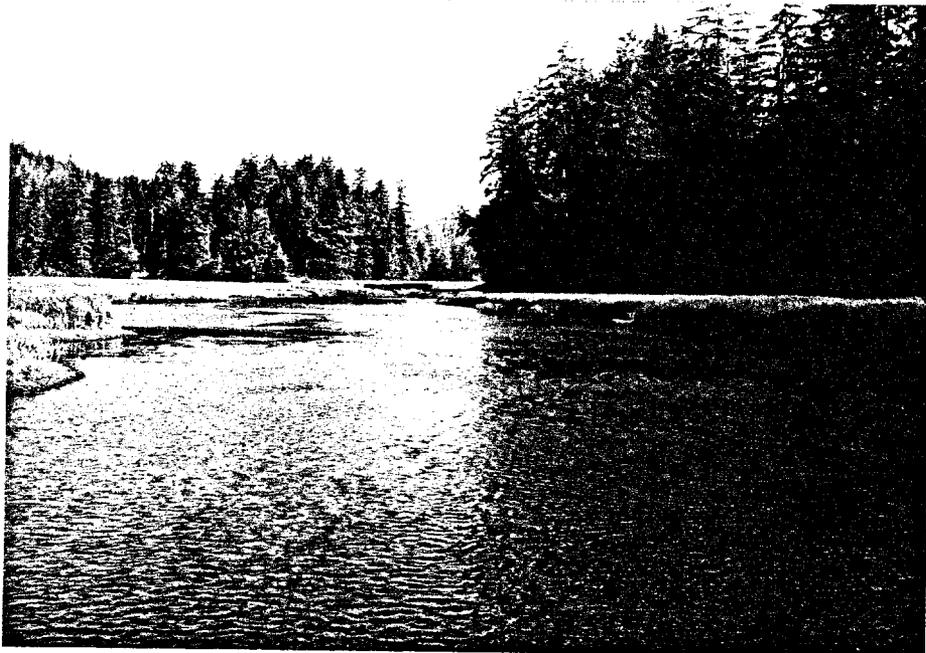
The upper ITZ has excellent gravel riffles which seemed significant enough to warrant sectional survey (Reach I). This 400 meter stretch is excellent pink and chum spawning area with shallow riffle over loose gravel. Large amounts of coho fry were observed in this area. The bridge crossing is a bi-span log stringer bridge with a footing on an island. The aborted first bridge crossing is located at Section 2I: 65m. The old ADF&G weir site is located at Section 4I: 100m. After this point the stream channel narrows and the ITZ ends.

4. Upper ITZ with good spawning riffle; log stringer bridge crossing.

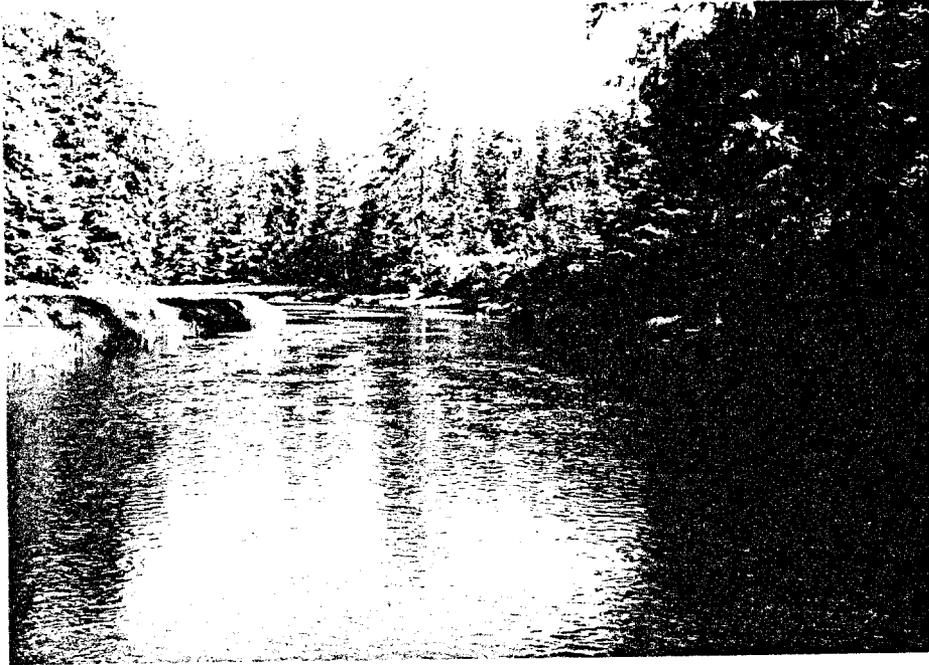
5. Excellent spawning riffle in ITZ above bridge crossing.

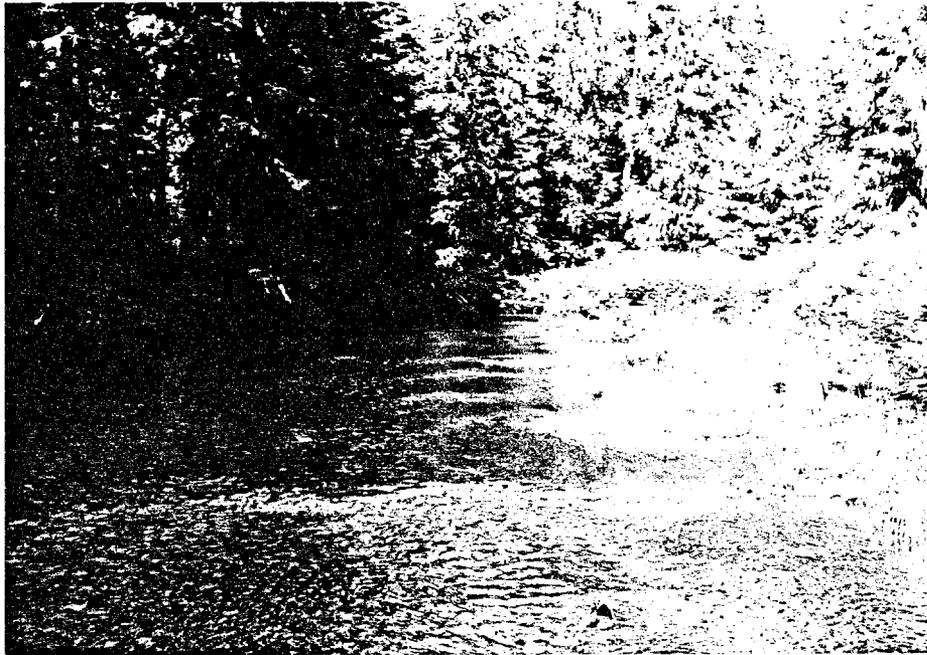
The stream channel widens as gradient and velocity decrease. Substrate size diminishes to cobble/gravel with heavy sand deposition. Best ASA is located on gravel areas flanking the cobble main channel. Two significant tributaries enter in this Reach; Survey Area "B", Section 4: 55m, and Survey Area "C", Section 9: 50m. Both streams have good ASA with overhanging streambank vegetation. Again the stream narrows and substrate size increases. Heavy concentrations of coho and trout fry were observed, especially behind numerous instream logs.

7. Reach 3: Section 4: 20m; Excellent ASA in gravel riffle.

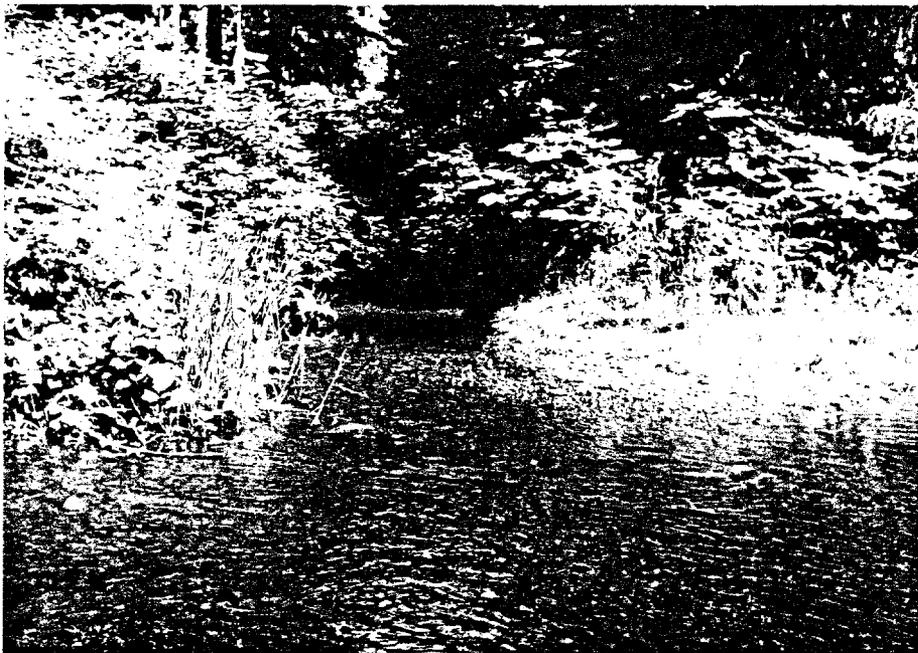
8. Mouth of Survey Area "B"; tributary entering main stem at Section 4: 55m.

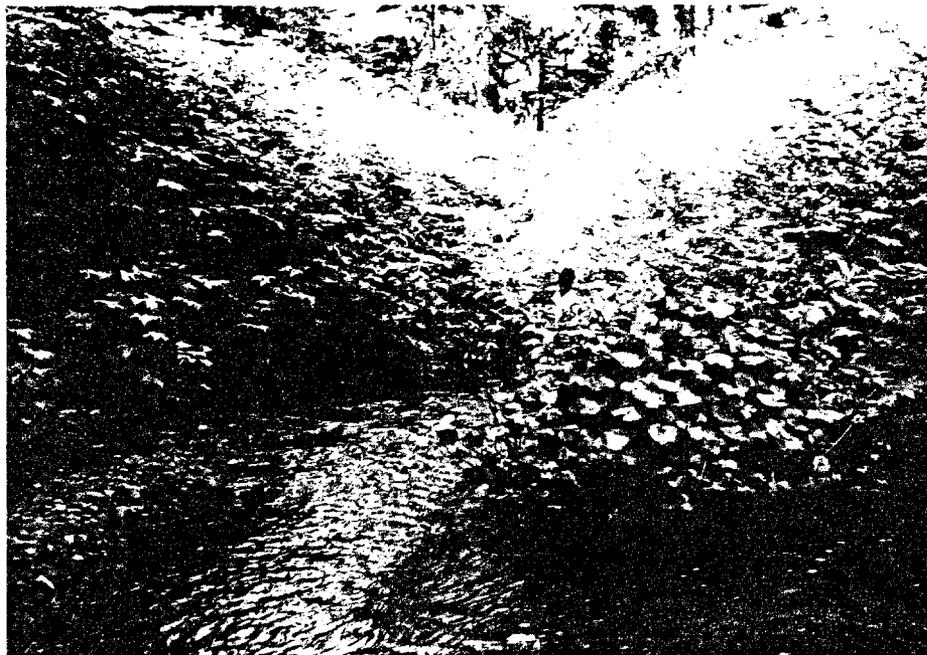
This tributary also has good loose gravel with almost complete salmonberry cover. Flowing through a spruce flat, the stream has good ASA, rearing, and heavy concentrations of coho fry. After 390m, the gradient starts to increase and by 450m, no fish were observed.

9. Mouth of Survey Area "C"; tributary entering main stem at Section 9: 50m.

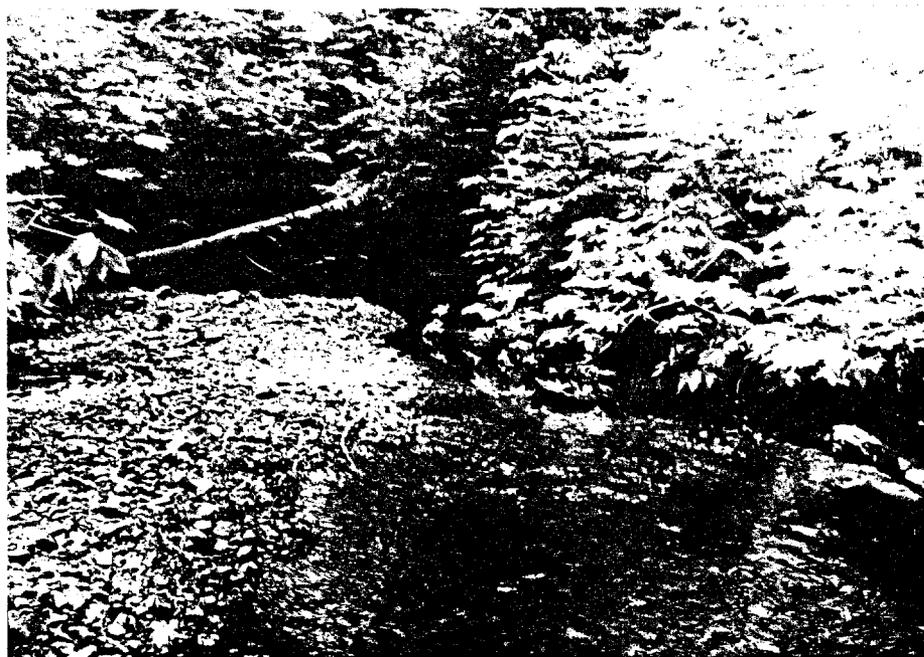
10. Section 2: 0m; Survey Area "C"; gravel riffle with salmonberry cover.

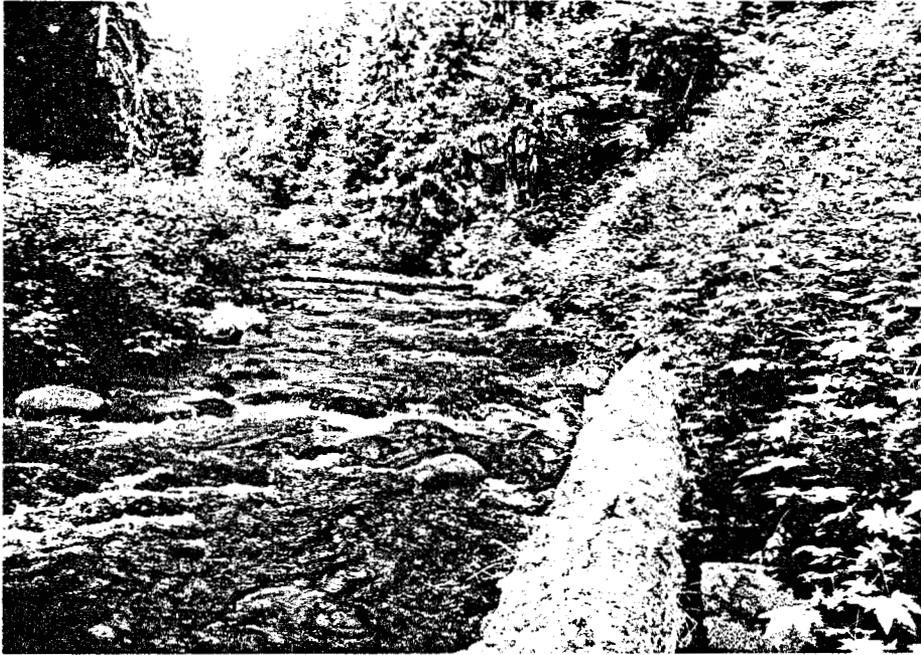
This reach is characterized by high velocity flow over boulder/cobble substrate between steep banks with little fish habitat. Small populations of trout fry were observed and very few coho fry. Areas of blowdown with associated soil slumps are scattered through the Reach.

11. Reach 4: Section 16: 0m; Channelized, high velocity flow over boulder/cobble.

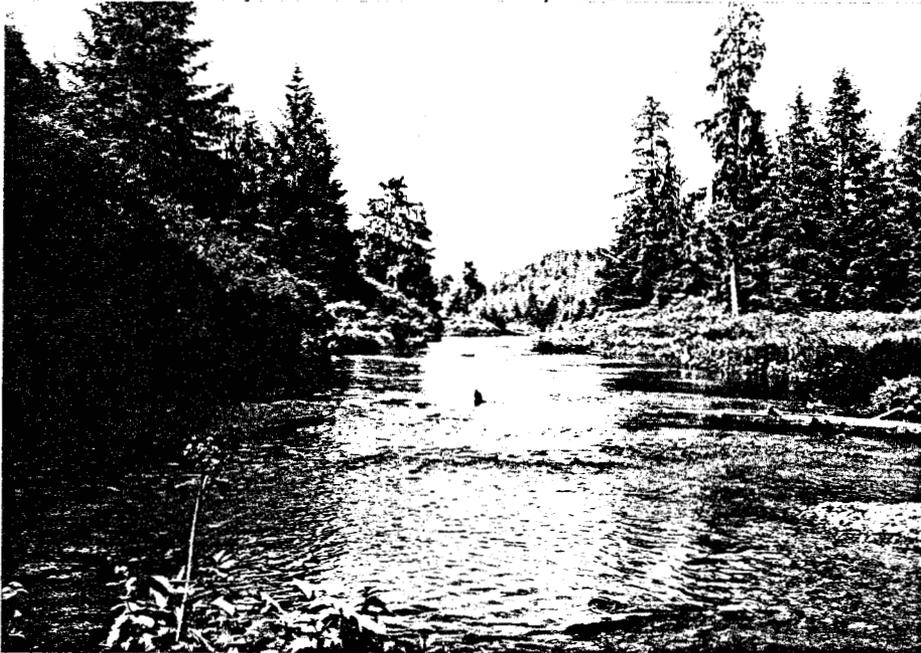
At Section 19: 0m, the stream characteristics change sharply. The stream channel becomes wide and shallow as the gradient and velocity decrease. The substrate is predominantly gravel with little instream debris. The entire Reach is within an old unit, completely cut to the banks with no canopy of streamside cover whatsoever. A continuous sheet of "slime" covers the substrate. The water temperature jumps up to 20°C (68°F). Large concentrations of coho and trout fry were observed in this temperature sensitive area. Isolated soil slumps are located within the unit.

12. Reach 5: Section 19: 0m; Wide shallow flow over gravel wholly within unit with no canopy cover. Water temperature; 10°C.

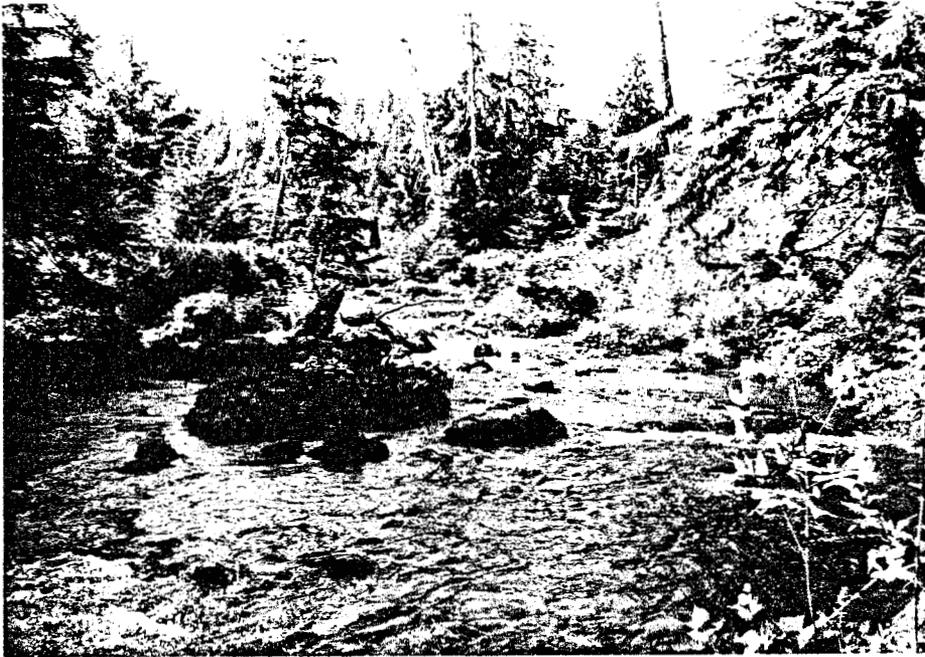
13. Reach 6: Section 26: 30m; Stream flow over boulder/
cobble within unit.

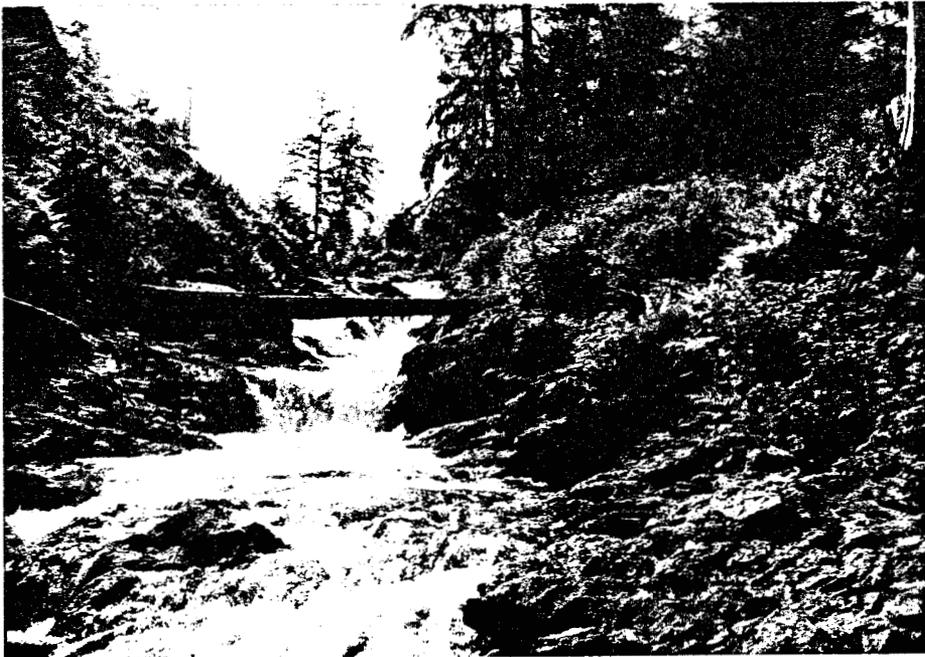
14. Reach 6: Section 31: 50m; Staircase succession
of cascade/falls 30 meters in total height over
bedrock.

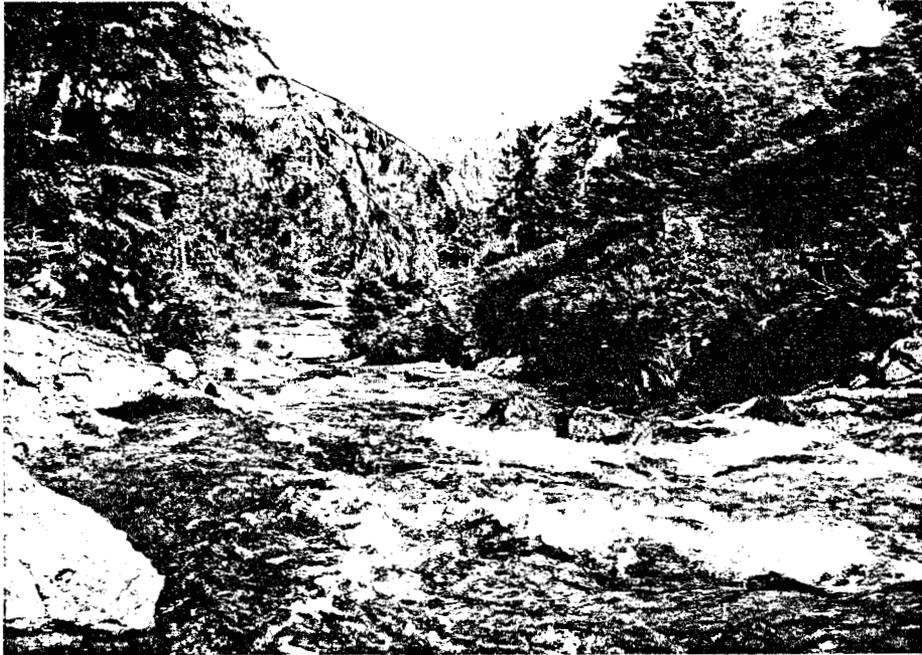
15. Downstream view from falls at Section 31: 50m; with large drop evident. Units present on both banks.

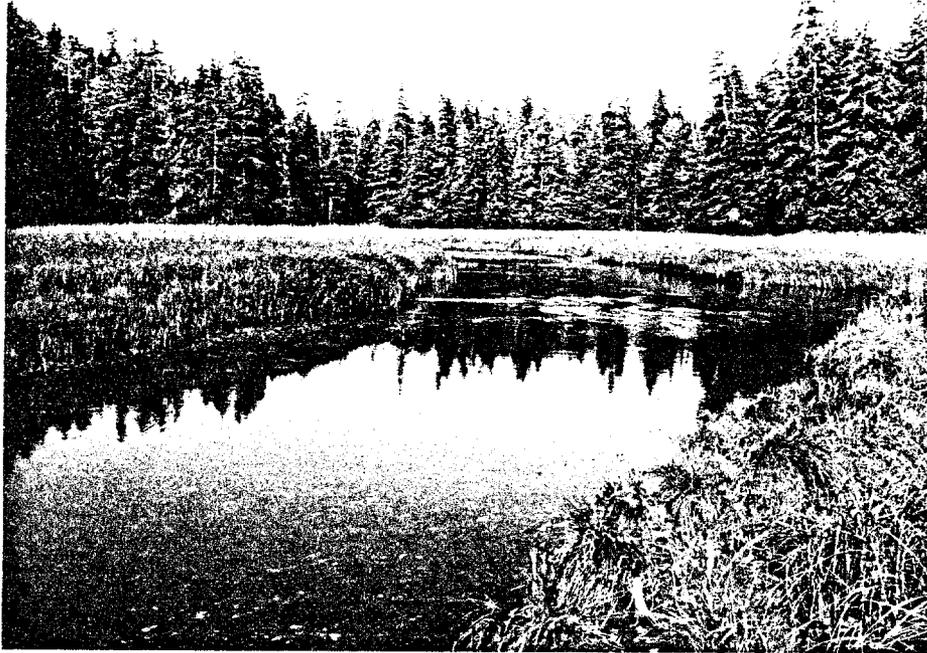
1. Upper ITZ forms an extensive, productive estuary. Channel enters timber left center.

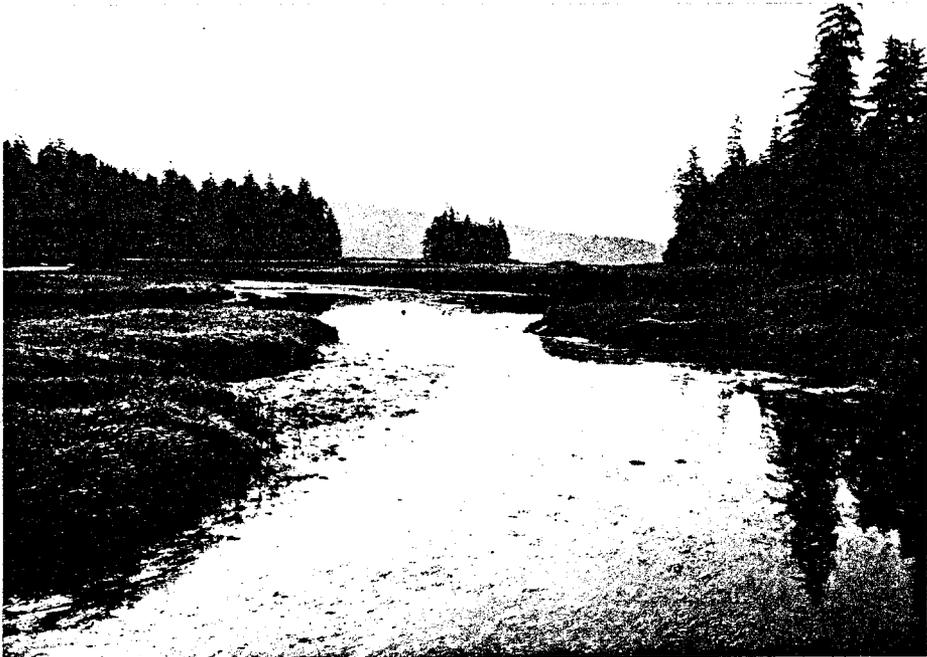
2. View of extensive estuary to Whale Pass. The ITZ provides excellent rearing habitat, however, abundant interstitial fines reduces ASA.

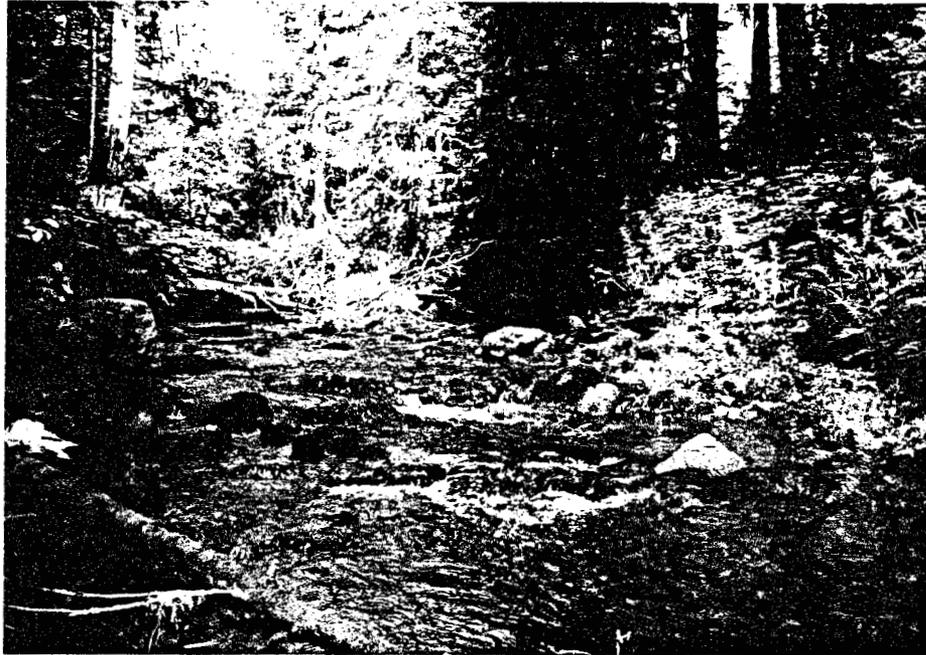
3. Section 1: The ITZ ends approximately 75 meters above a bridge crossing and the habitat type is predominantly boulder riffles.

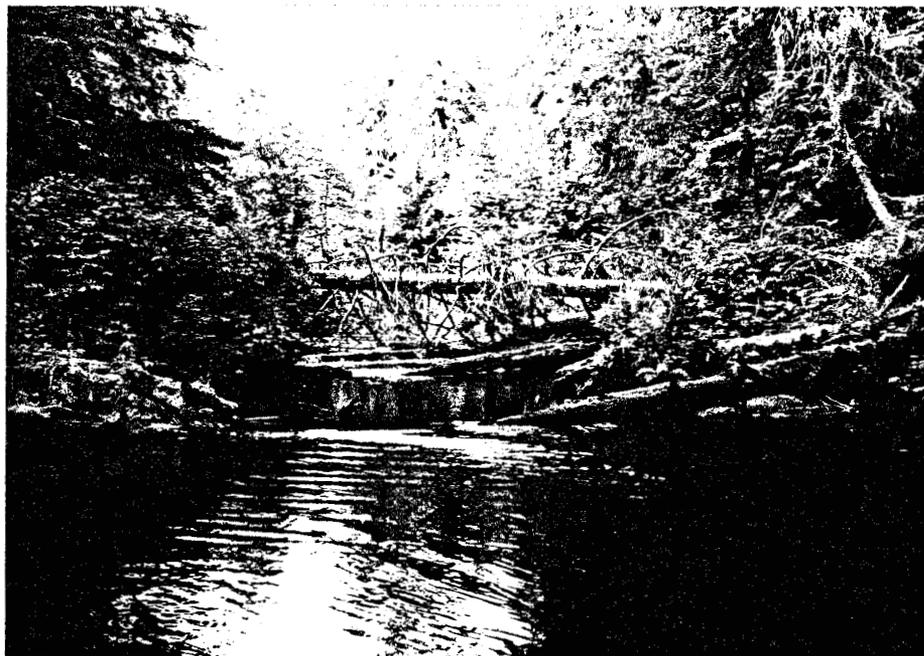
4. Section 3: Channel broadens and copious blowdown provides good rearing cover.

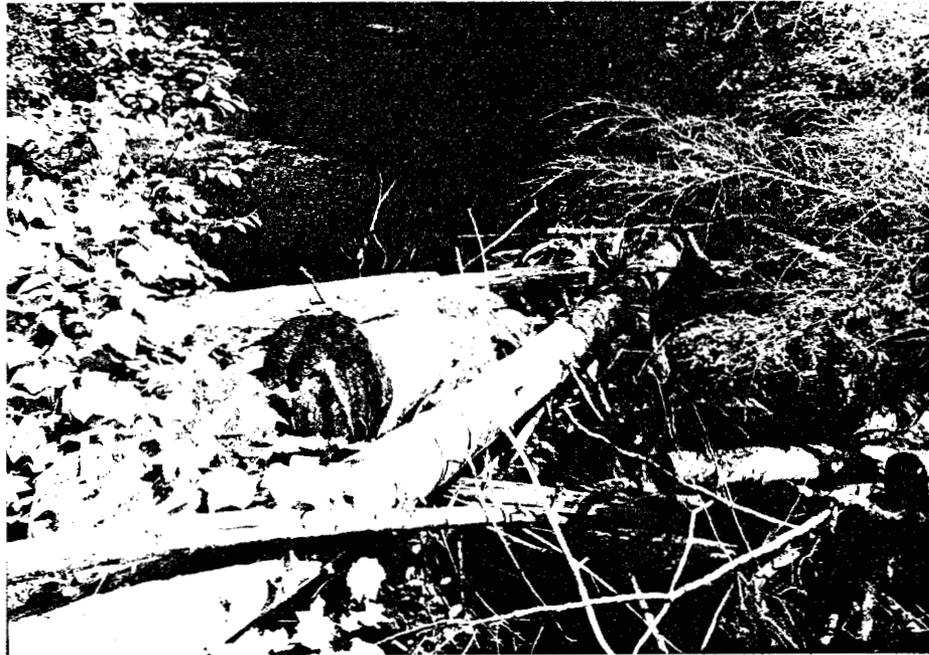
6. Section 10: Debris jam represents a potential low flow barrier.

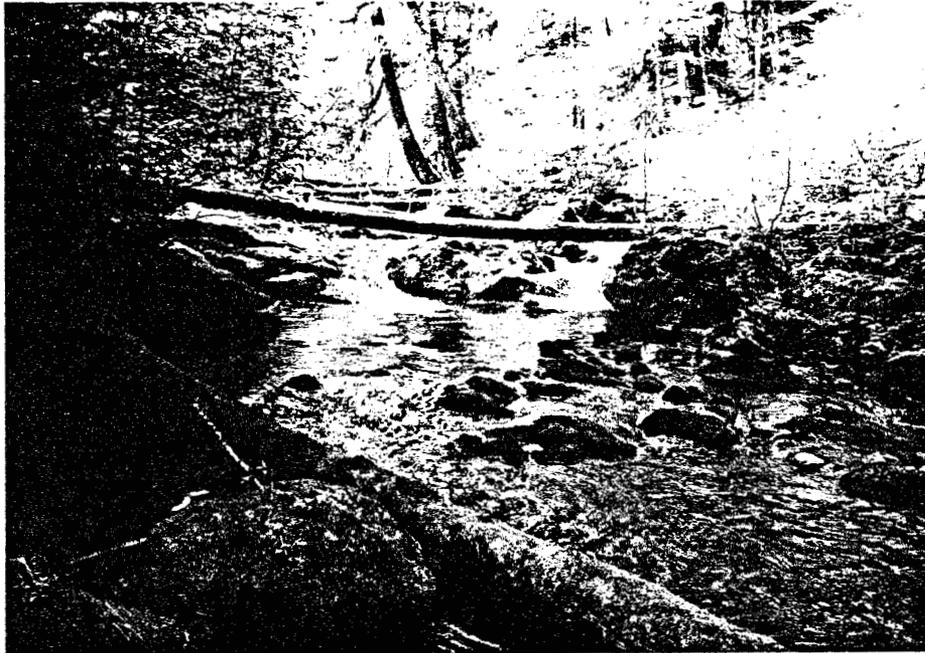
7. Section 15: Channel negotiates a V-notch via boulder/bedrock cascades.

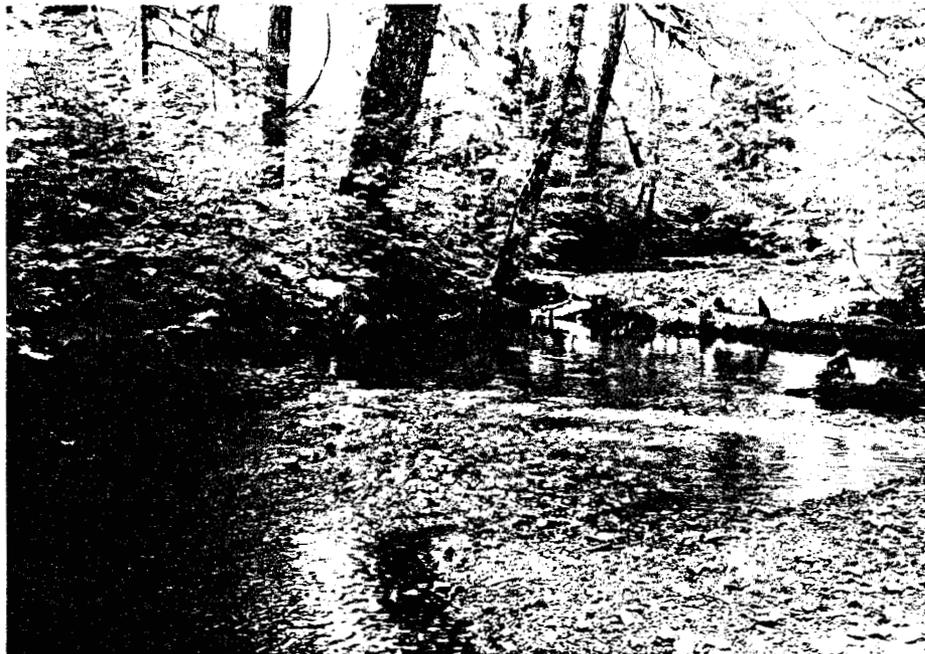
8. Section 23: Between V-notches gradient is reduced and gravel/cobble riffles provide excellent ASA.

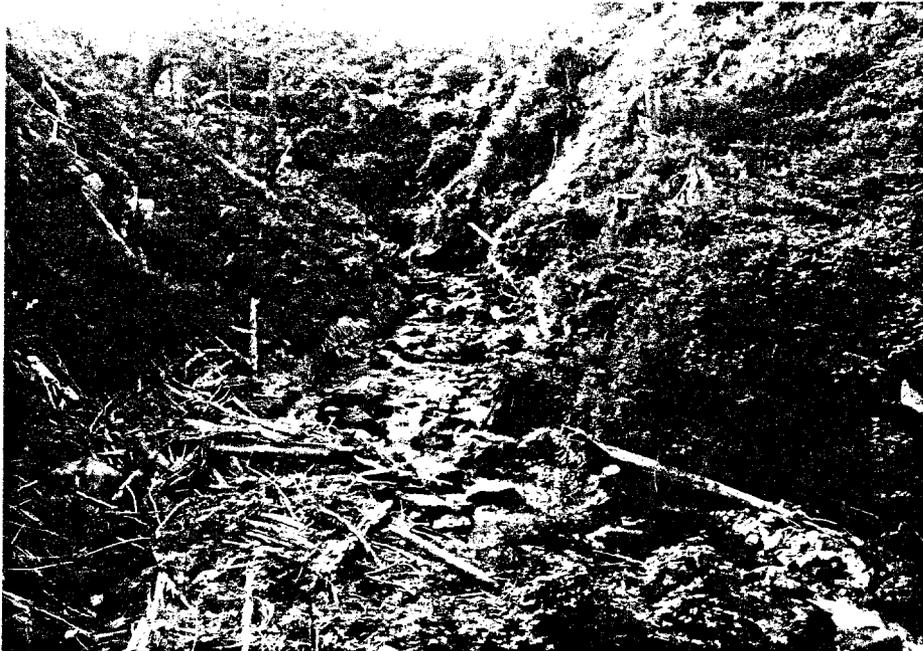
10. Reconnaissance above barrier falls revealed continuous boulder cascades, a steep narrow V-notch, and extensive clearcutting of the upper watershed.

Reconnaissance above barrier revealed continuous boulder cascades; a steep, narrow V-notch, and extensive clearcutting of the upper watershed. No fish or habitat were observed.

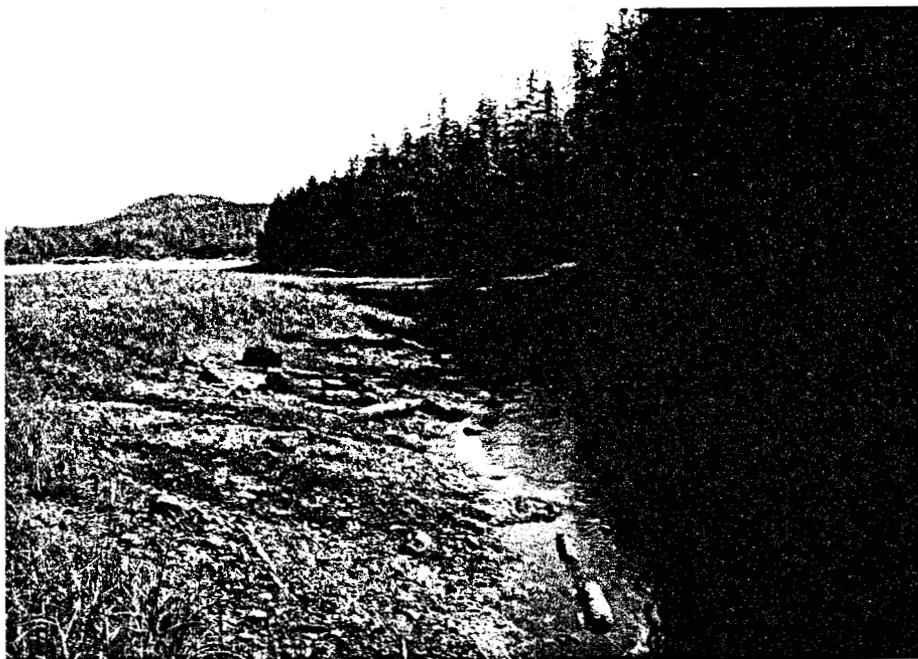
1. An extensive ITZ drains into a lagoon providing excellent holding and rearing habitat.

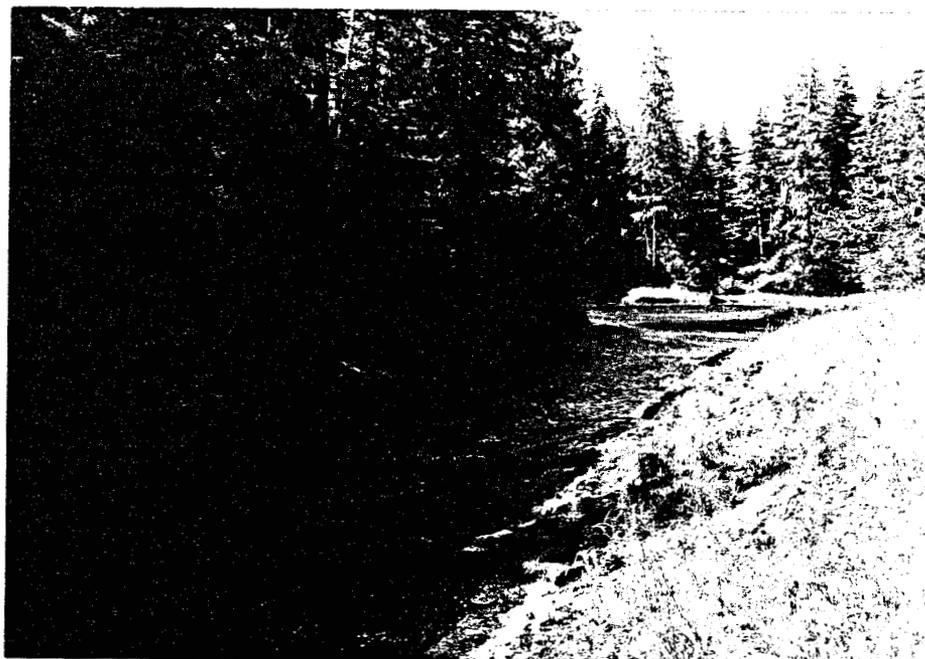
2. View of mid ITZ. The bulk of PS spawning occurs below this point and a migration barrier occurs approximately 150 m upstream.

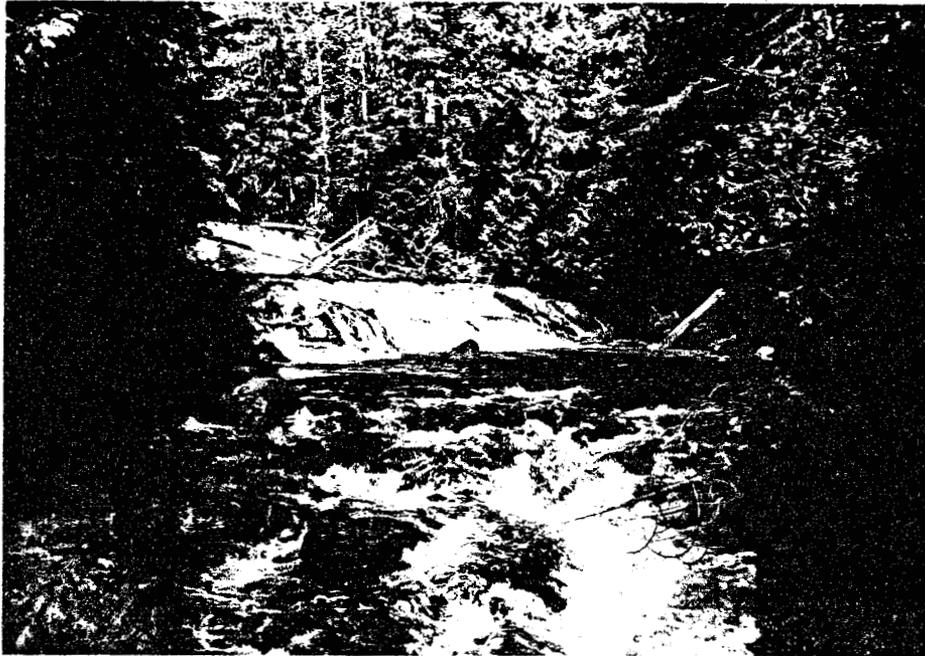
Neck Creek drops 87 vertical feet from Neck Lake to the ITZ, a distance of approximately 500 meters. Three sets of barrier falls were encountered, the first of which delineates the extent of the ITZ. No fish or ASA were observed during the survey and rearing habitat was marginal, being confined to peripheral boulder pools. Escapement records indicate historical ITZ use by pink salmon, however, at time of survey (i.e. tidal stage) no ASA was observed. No enhancement or rehabilitation recommended.

3. Section 1: The ITZ ends at the base of these 5 and 7 vertical meter bedrock barrier falls.

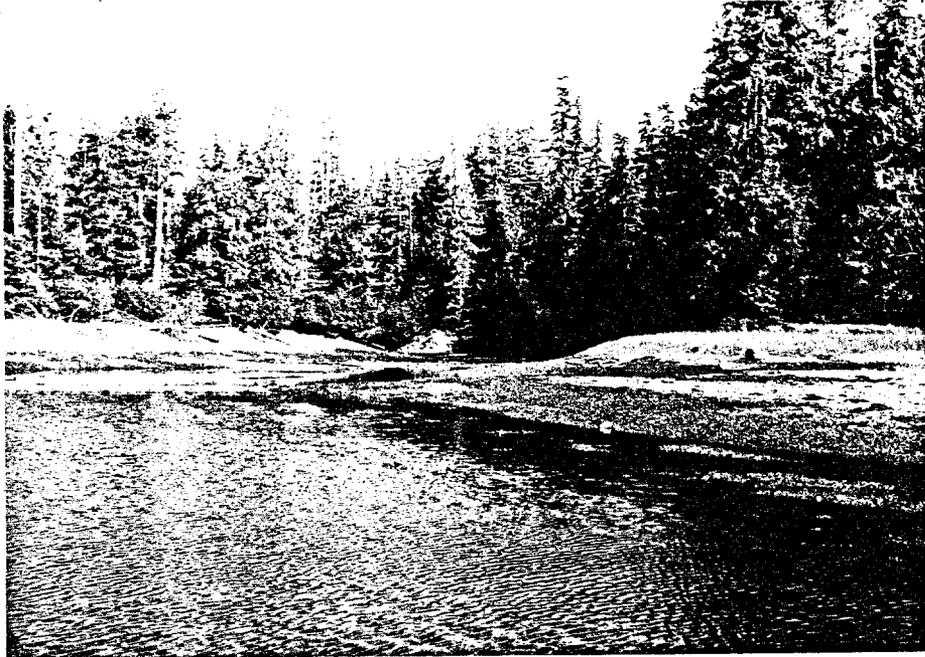
1. ITZ with pool.

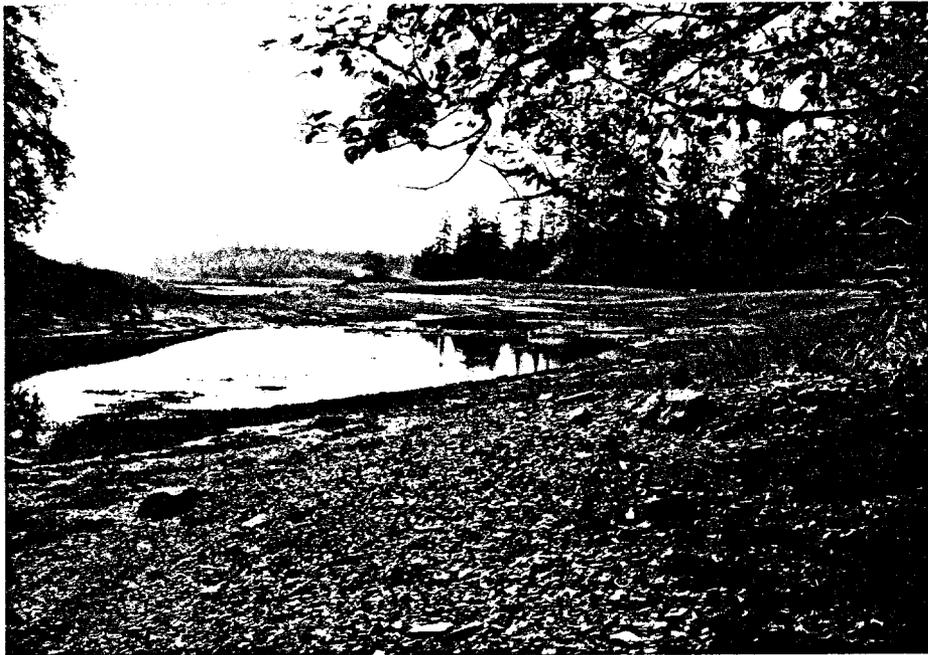
2. Downstream view of ITZ with pool looking toward Whale Pass.

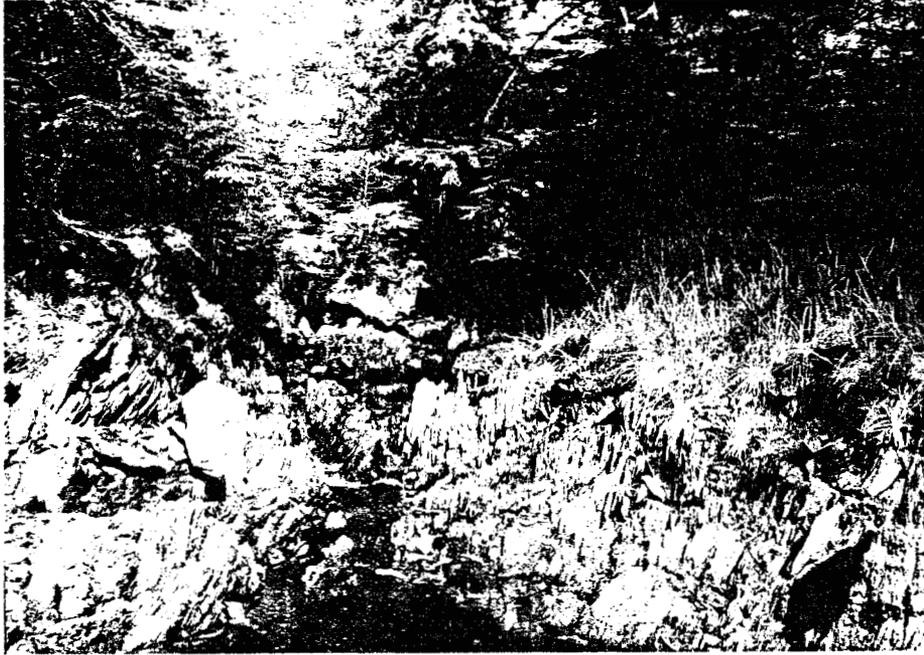
3. Angular bedrock of stream mouth.

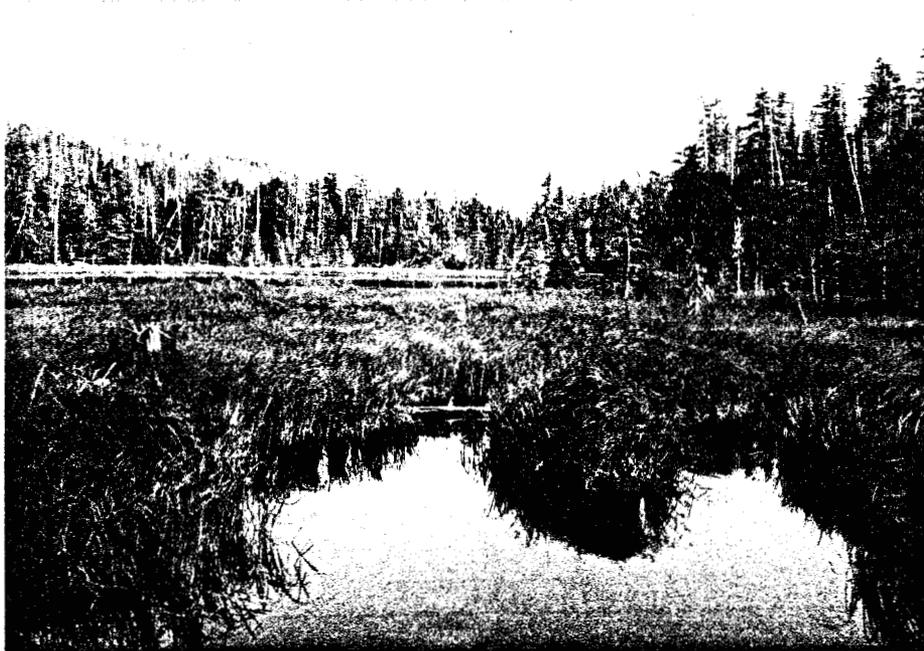
4. Beaver pond area.

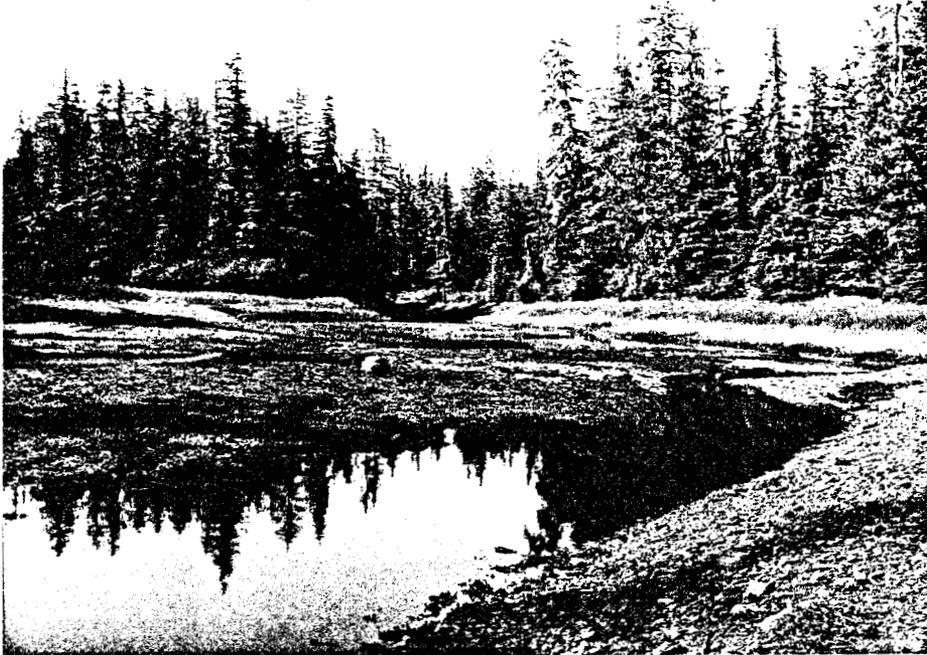
1. Lower ITZ of Whale Pass #3.

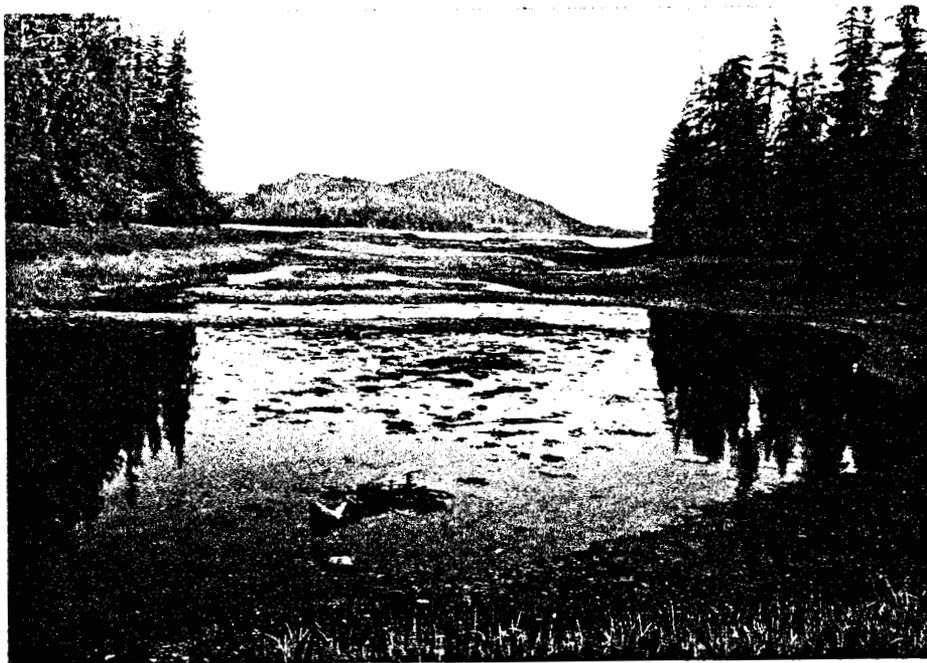
2. Downstream view of lower ITZ with rearing pond.

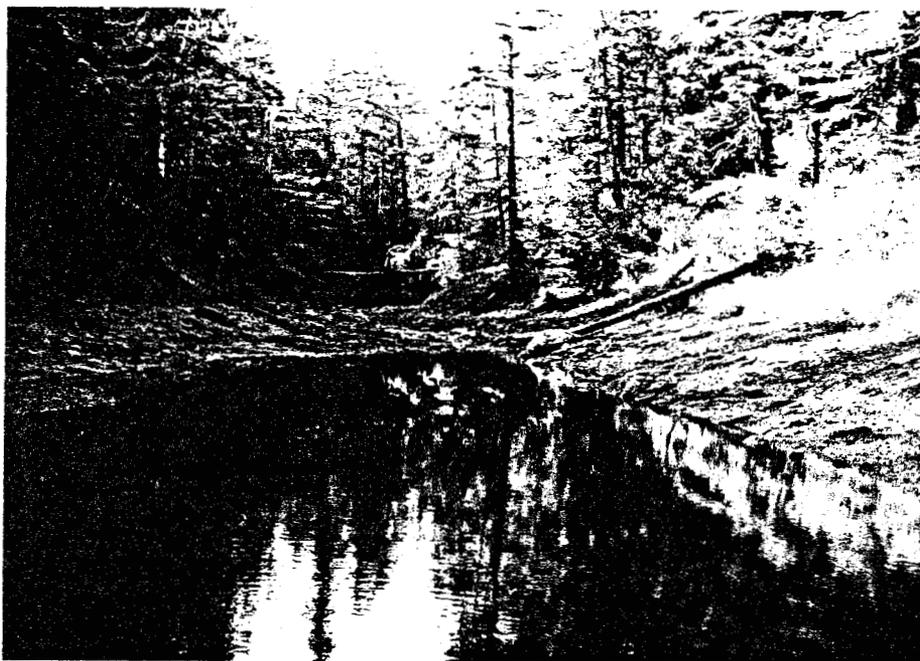
3. Upper ITZ and mouth of stream.

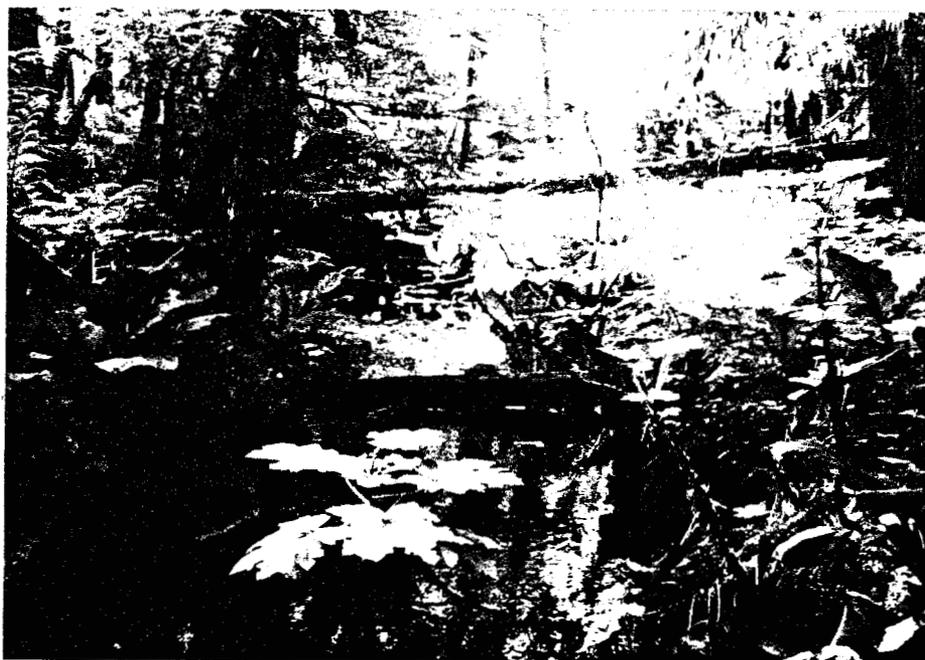
4. Low velocity, meandering habitat of Section 2.
