REVISED ANADROMOUS STREAM CATALOG OF SOUTHEASTERN ALASKA

District 106

Northeast Coast of Prince of Wales Island

Subdistricts 106-30 and 106-10

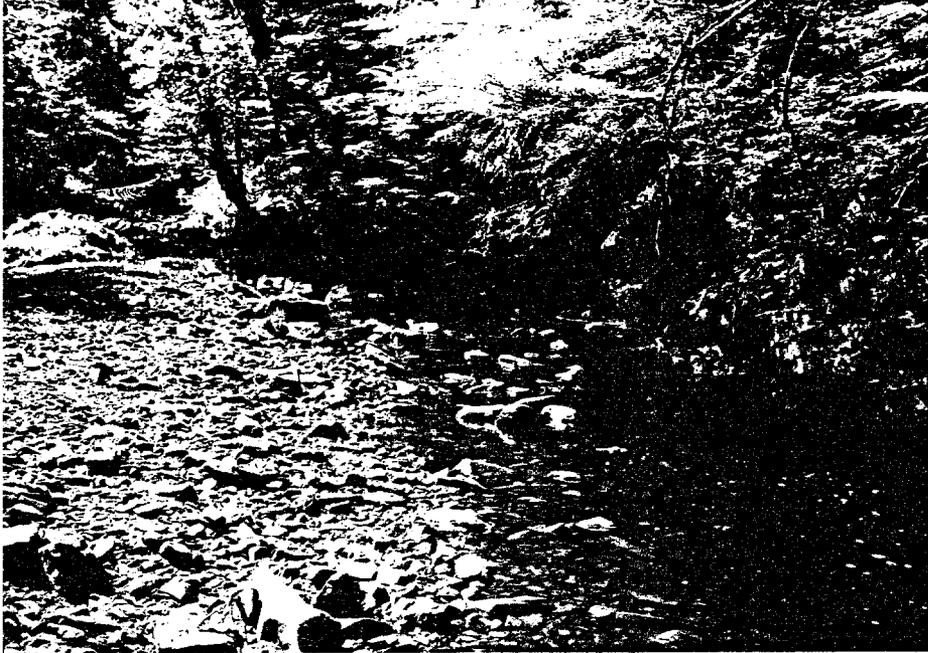
5. Section 9: Good fish habitat just above the falls.

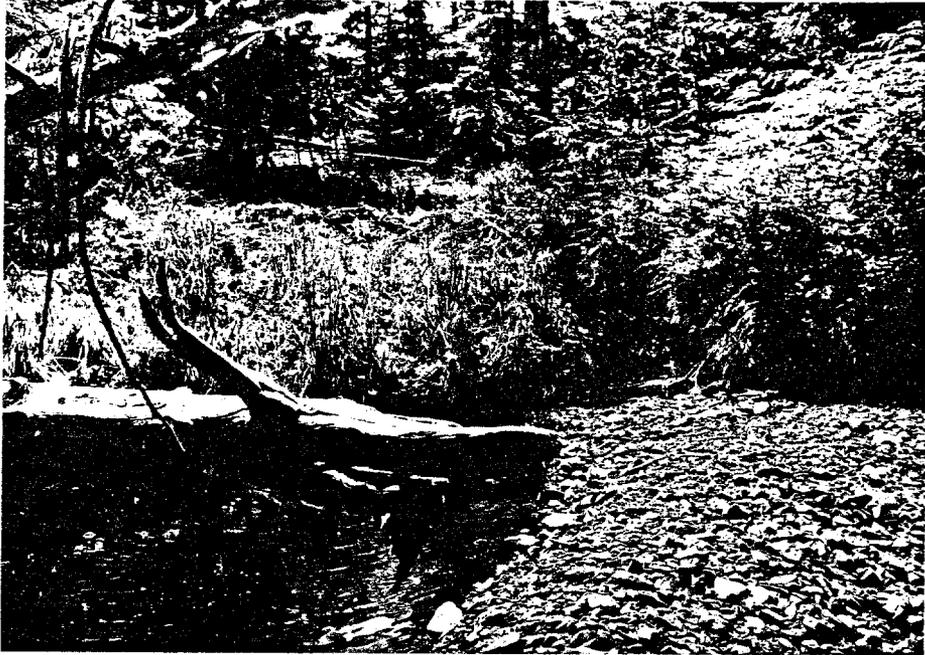
7. A large beaver system enters the left bank of Section 16.

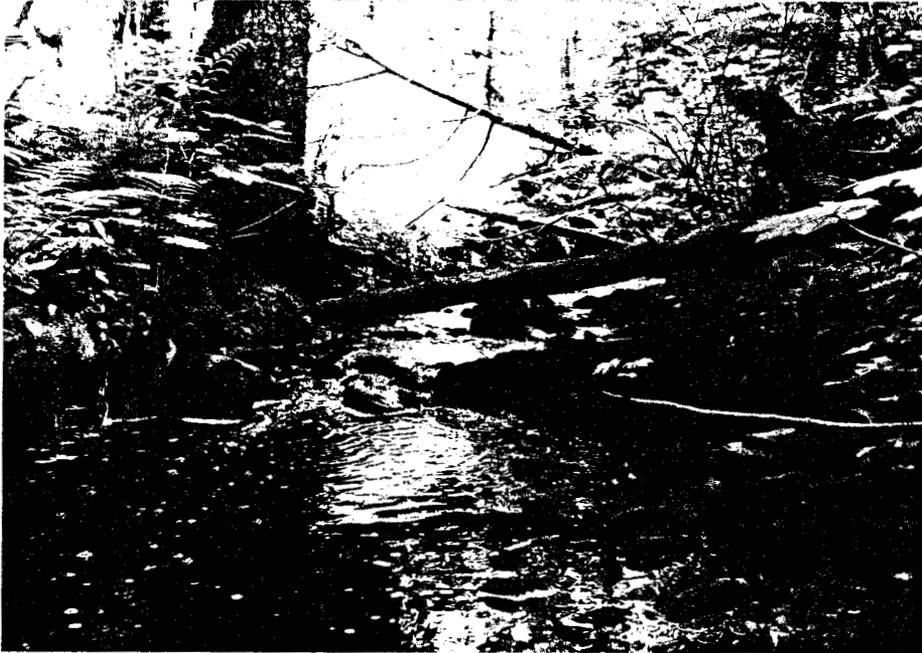
2. Substrate consists largely of large cobble, boulder and bedrock.

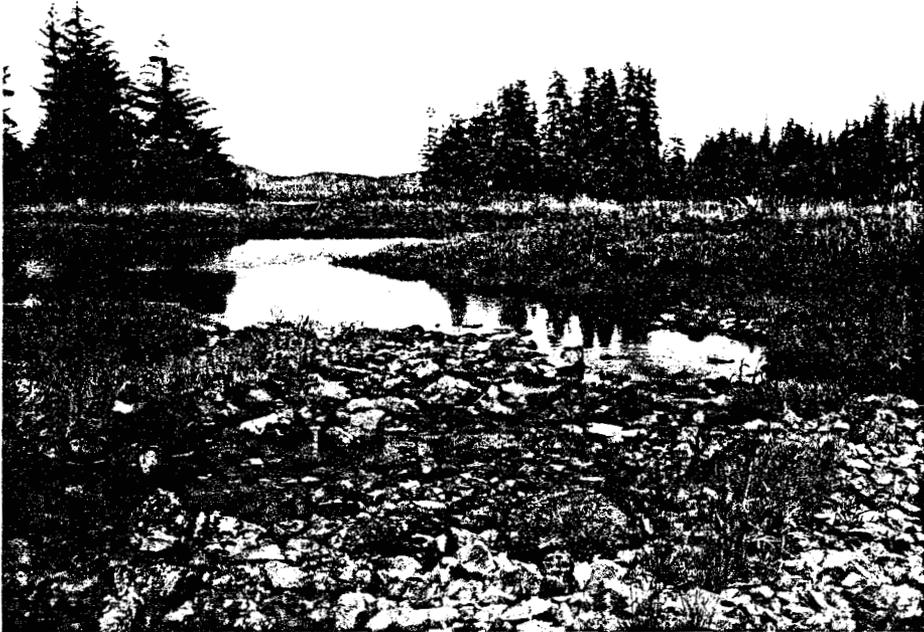
1. Interface of the boulder strewn upper ITZ and a small tidal lagoon.

ITZ: Survey was performed near high tide. A bedrock cascade delineates the upper extent of the ITZ and fractured bedrock/boulders typify that portion of the ITZ visible at time of survey. 12 SS fry were observed rearing in peripheral bedrock pools. An extensive, revegetated clearcut extends to both banks (Photo 1 and 2).

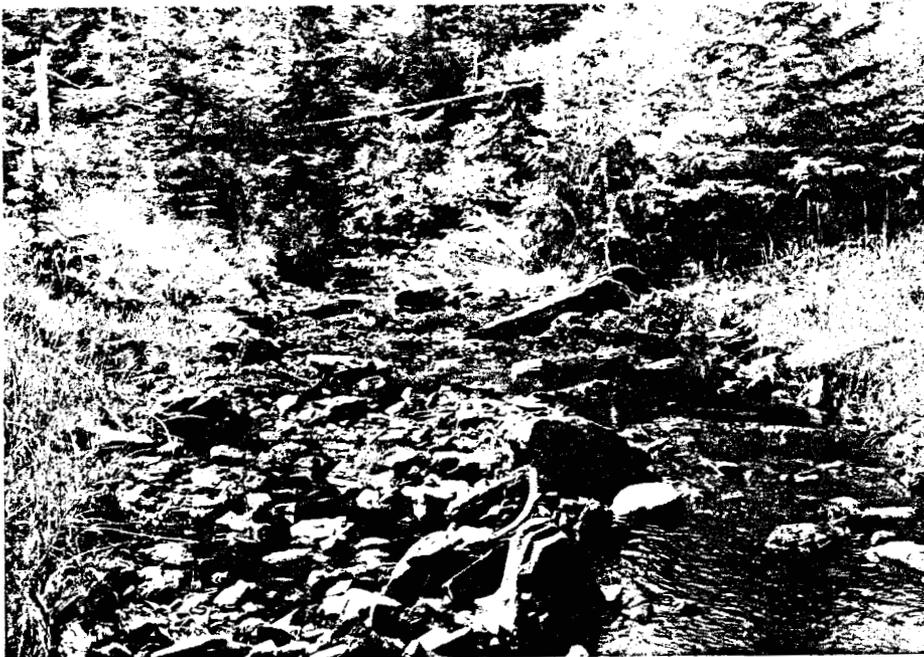
2. The upper ITZ is characterized by bedrock chutes and boulder riffles. A clearcut unit extends to both banks.

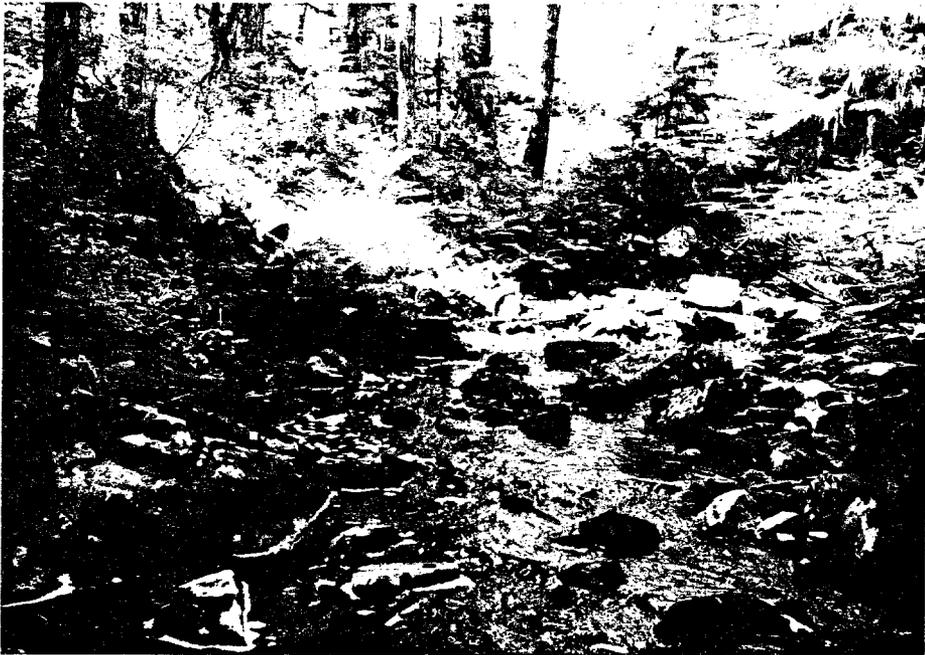
4. Bedrock/boulder cascades characterize section. Fisheries habitat limited to isolated rearing in peripheral pools.

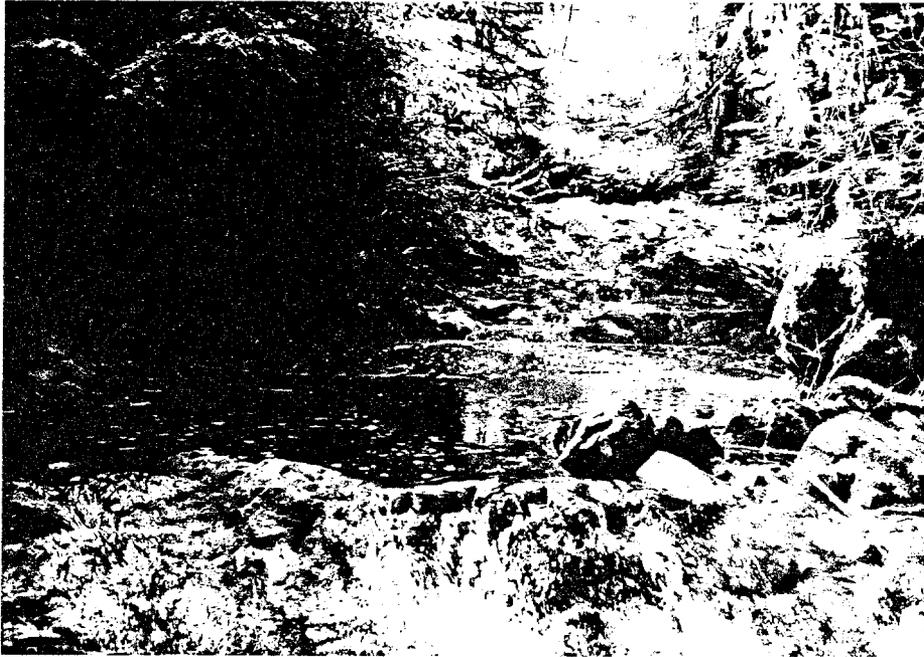
5. Bedrock cascades located at the junction of Section 3 and Section 4 represent a potential low flow/velocity migration barrier.

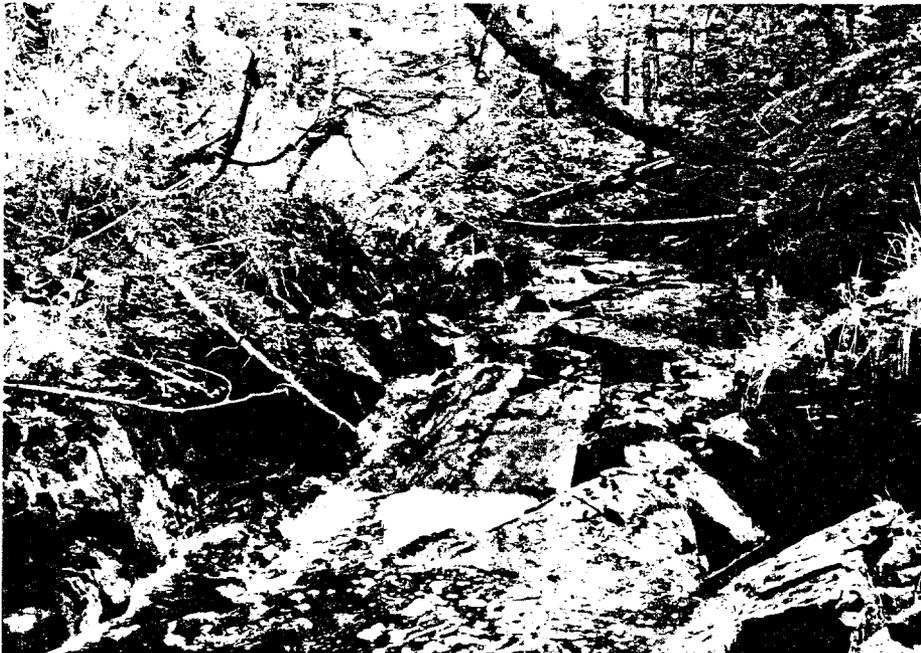
6. Steep channel gradients, lack of ASA, and marginal isolated rearing negated additional surveying.

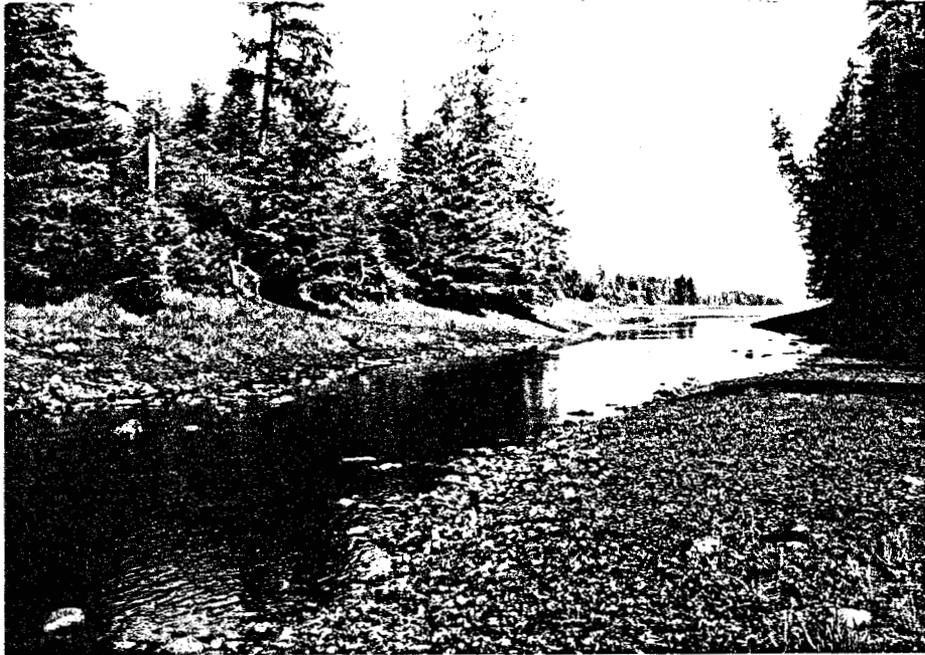
1. View down lower ITZ toward Whale Pass. An extensive revegetated clearcut extends along a portion of the right bank.

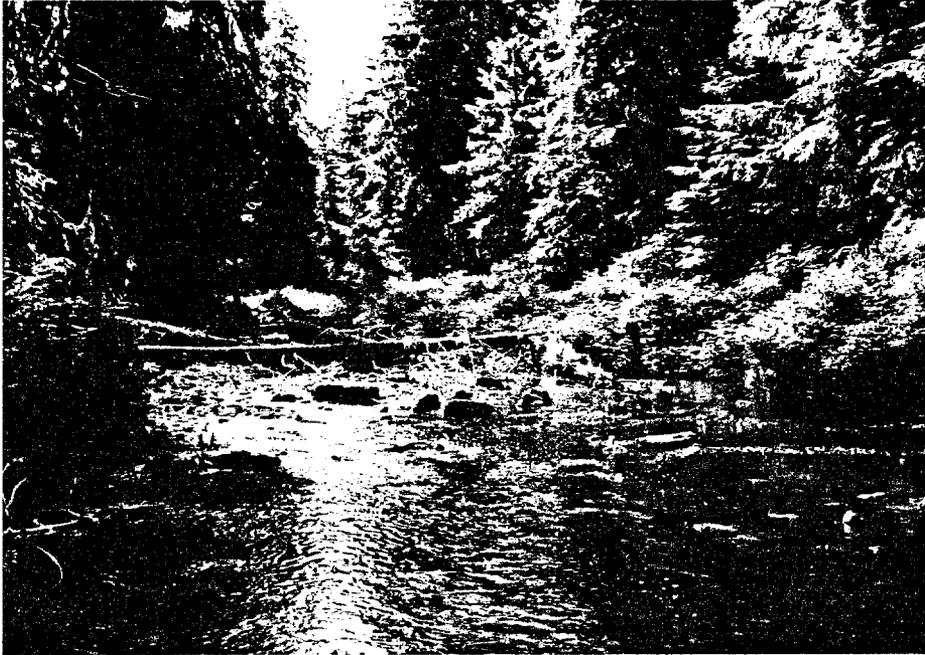
3. Section 3: Cobble riffles provide moderate spawning habitat. Abundant instream moss and skunk cabbage attest to typically low, stable summer flows.

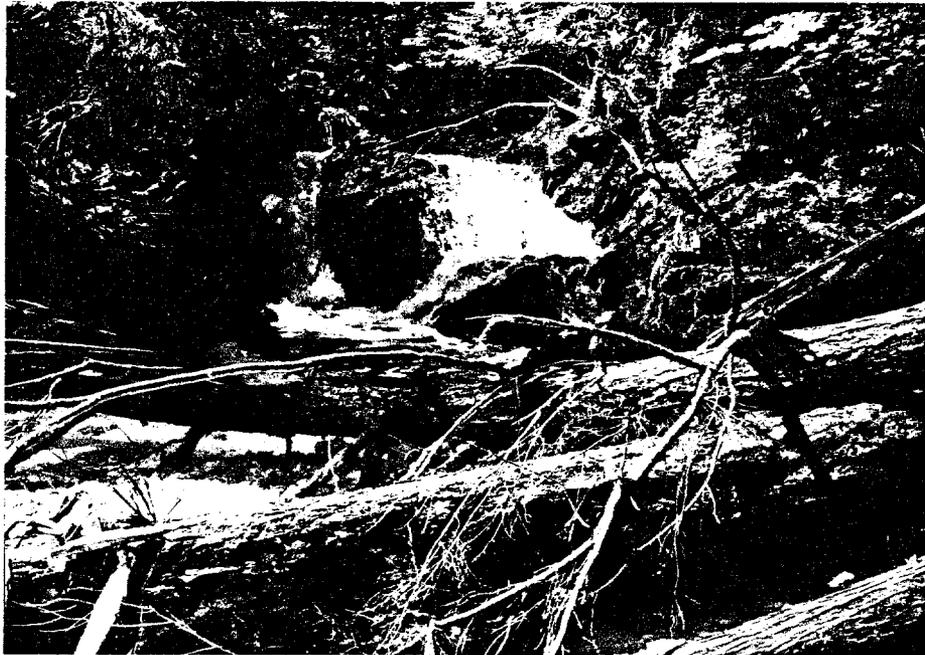
4. Section 1: A 4.0 vertical meter bedrock falls represents a height and velocity barrier. A debris jam demarcates the extent of an extensive "mid-channel" bedrock outcrop.

- Section 4: 50m; Less than 1.0 cfs muskeg drainage enters channel via the left bank. No fish or habitat observed.
- Section 5: Isolated blowdown along right bank.
- Section 6: Localized sideslope failure along left bank.
- Section 7: 0-68m; Channel diverges around brush-covered island. 45m; Survey Area "B" enters the main stem via the left bank.
- Section 8: Bedrock/boulder channel diverges around a large bedrock outcrop "headed" by an extensive logjam and culminates in a 4.0 vertical meter barrier falls (photo 4).

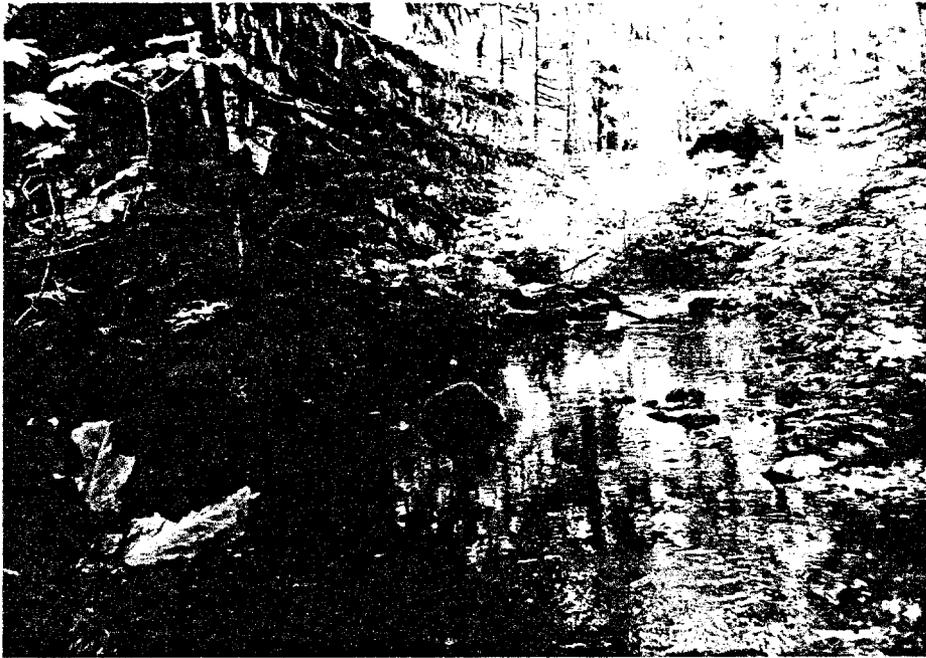
1. Section 1: Gravel riffles, debris pools, undercut banks, and copious overhanging vegetation provide excellent spawning and rearing habitat.

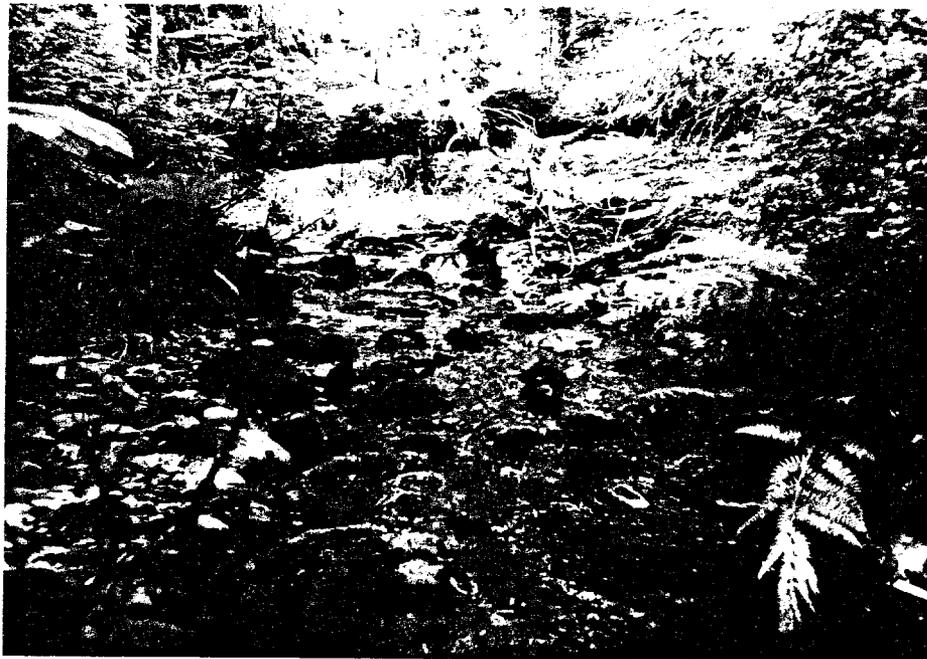
2. Section 4: Reach 2 is characterized by increasing sinuosity, gradient and the incidence of large cobble and boulders.

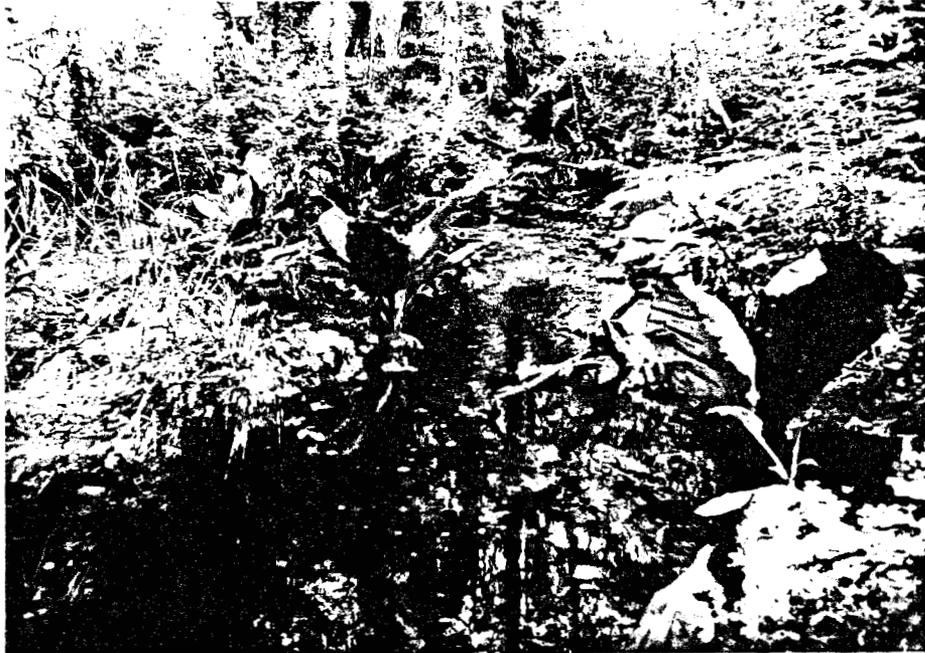
3. Section 9: Increasing sinuosity and undercut banks, reduced gradients, instream skunk cabbage, and "muskeg banks" typify Reach 3.

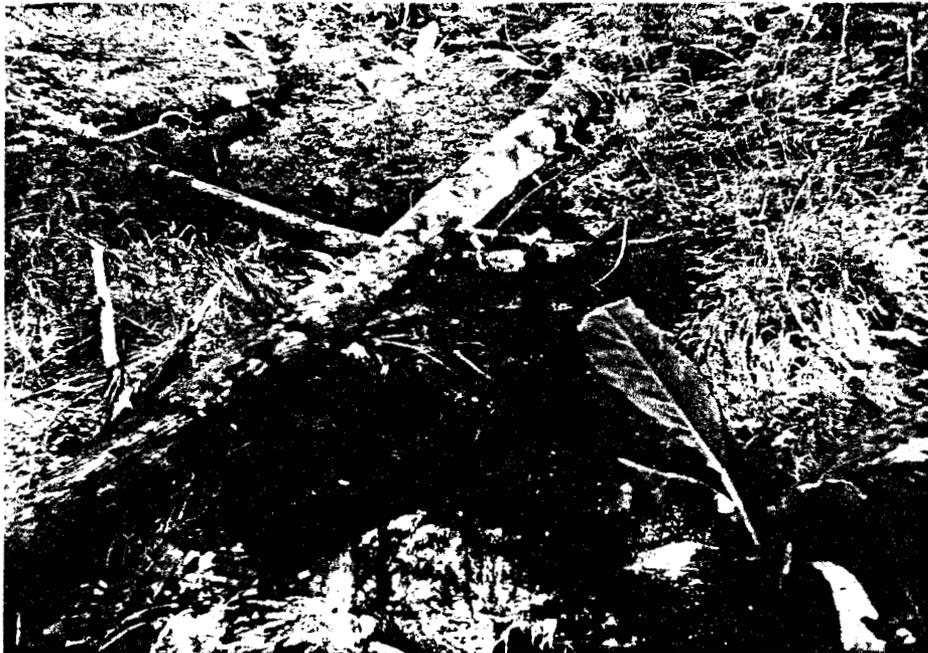
4. Reconnaissance: Narrow, sinuous seep fed channel provides rearing habitat in the form of dark, debris pools. Spawning substrate was isolated.

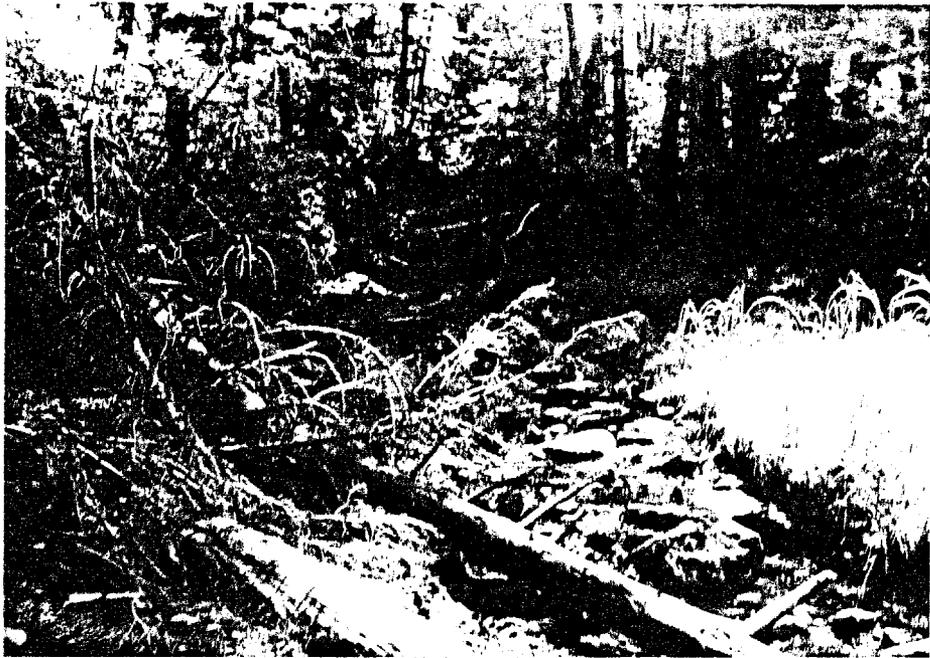
1. Mouth of stream with boulder substrate and debris.

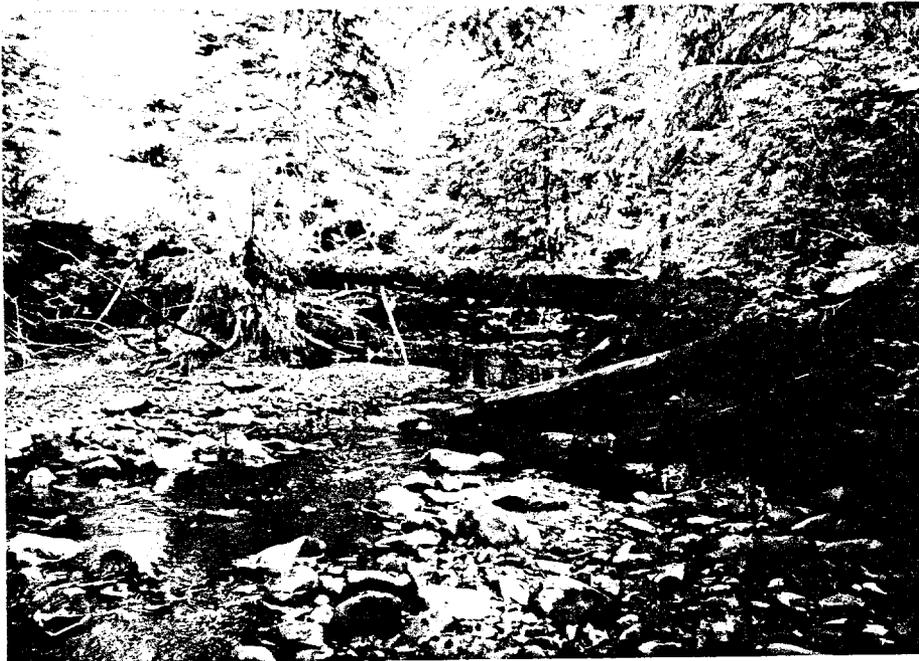
2. Mouth of Whale Pass #1 with blowdown.

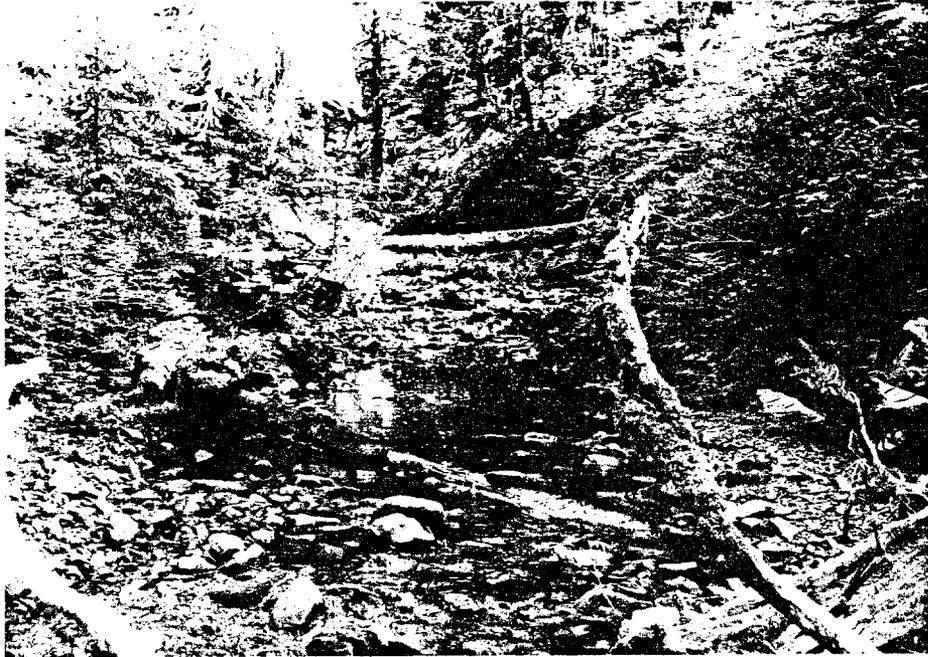
3. Section 2: 40m; Stream flow over boulder/cobble with steep banks and windthrow.
