Appendix I: Juneau

Guide to direct fieldwork for cataloging anadromous water bodies in Southeast Alaska

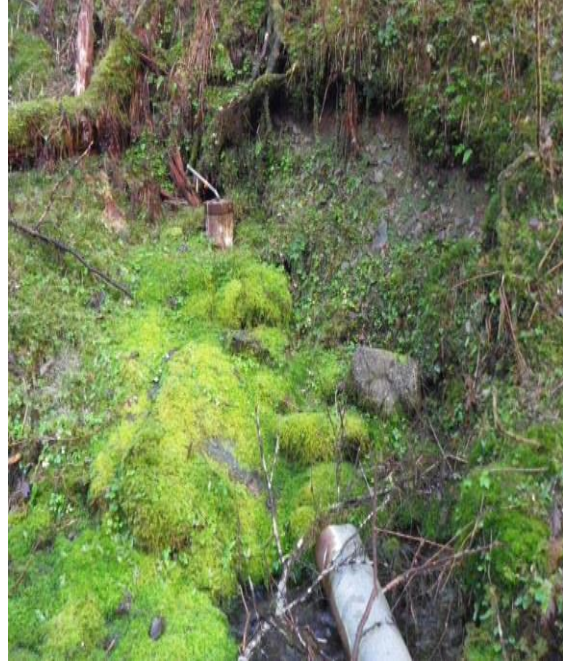
Figure 2.—Water intake at the headwaters.

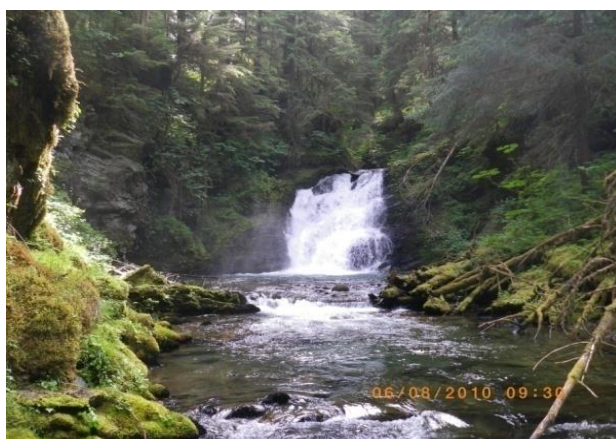
Figure 4.–Second set of falls on Salmon Creek.

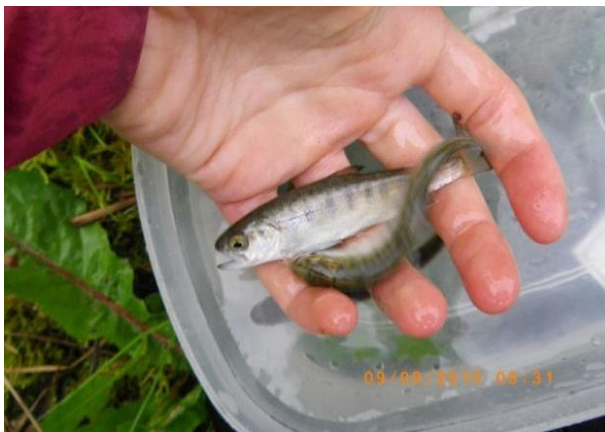
Figure 3.—captured at culvert outlet.

Recommendations: Add stream to the AWC and monitor for riparian regrowth and bank stabilization. Install a fish pipe (Figure 7).

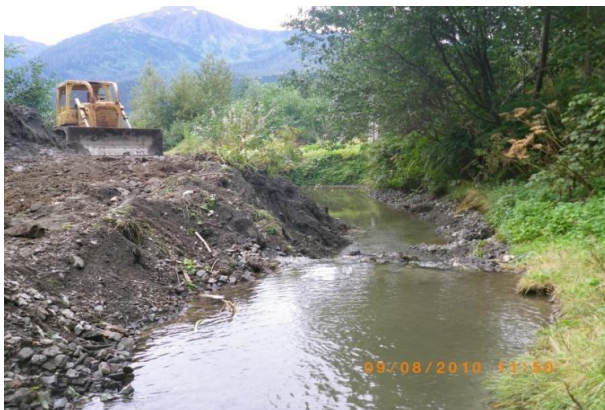
Figure 5.—Steepened gradient in an avalanche runout zone.

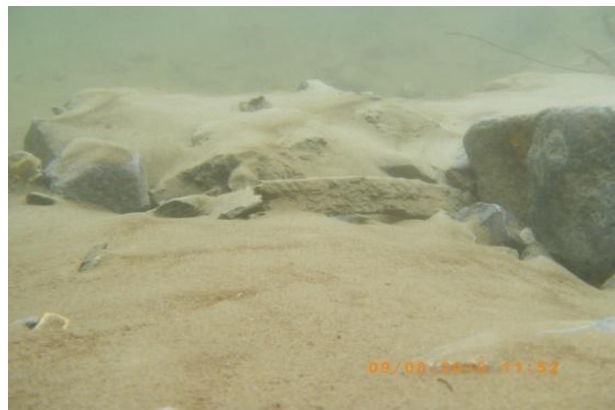
Figure 6.—Sediment from in stream work on substrate.

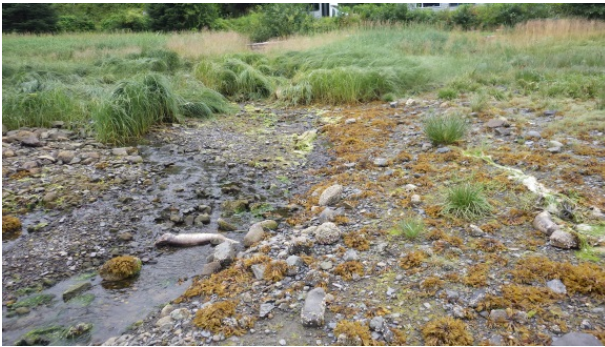
Findings: I visually observed a total of 11 chum salmon carcasses in and on the banks of the intertidal portion of the creek (Table 1, Figures 1, 2).

| Waypoint | Latitude | Longitude | Notes | Sample Effort | Sample Results |
|---|---|---|---|---|---|
| 1 | 58.3042 | -134.4492 | Three chum salmon carcasses | VI | 3 CH |

Figure 1.—Chum salmon carcasses.

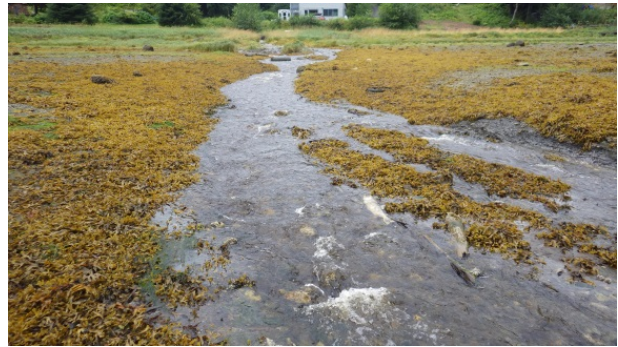
| Waypoint | Latitude | Longitude | Notes | Sample Effort | Sample Results |
|---|---|---|---|---|---|
| 2 | 58.3046 | -134.4490 | Eight chum salmon carcasses | VI | 8 CH |

Figure 2.—Chum salmon carcasses downstream.

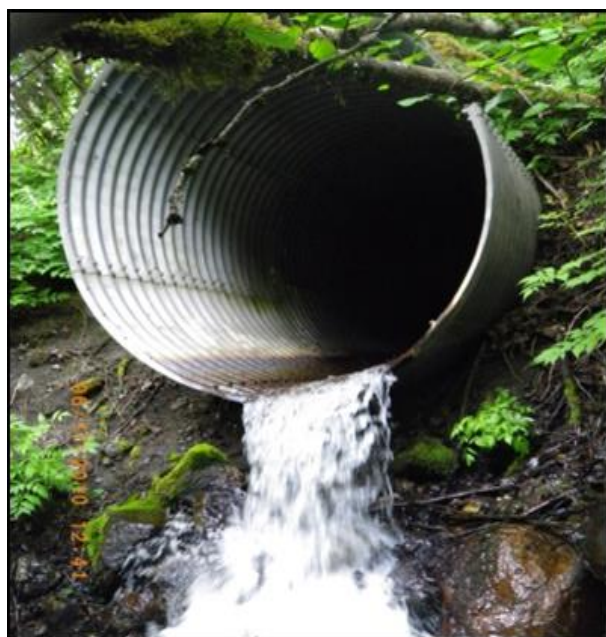
| Waypoint | Latitude | Longitude | Notes | Sample Effort | Sample Results |
|---|---|---|--|---|---|
| 8 | 58.3232 | -134.4819 | Base of perched culvert with large boulders beneath, 2' deep plunge pool. | | |

Figure 1.–Perched culvert on Falls Creek.

Recommendations: Correct the current route in the AWC (Figure 3). Future investigation is needed to confirm anadromous fish use below the culvert.

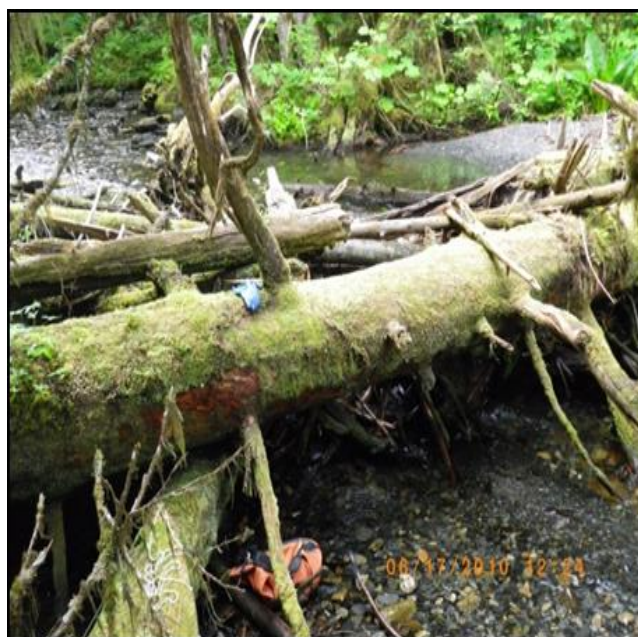
Figure 2.–Elevated streambed and log jam.

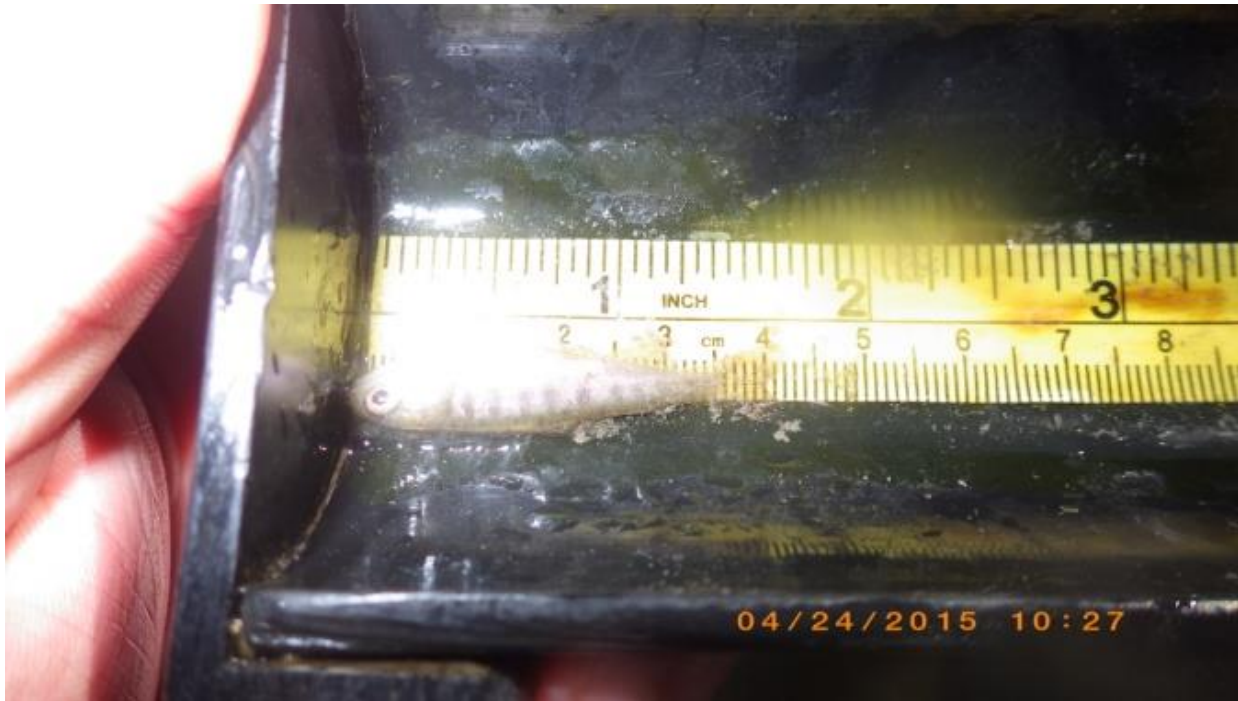
Figure 1.—40mm coho salmon captured in a calm side channel of Herbert River (waypoint 44).

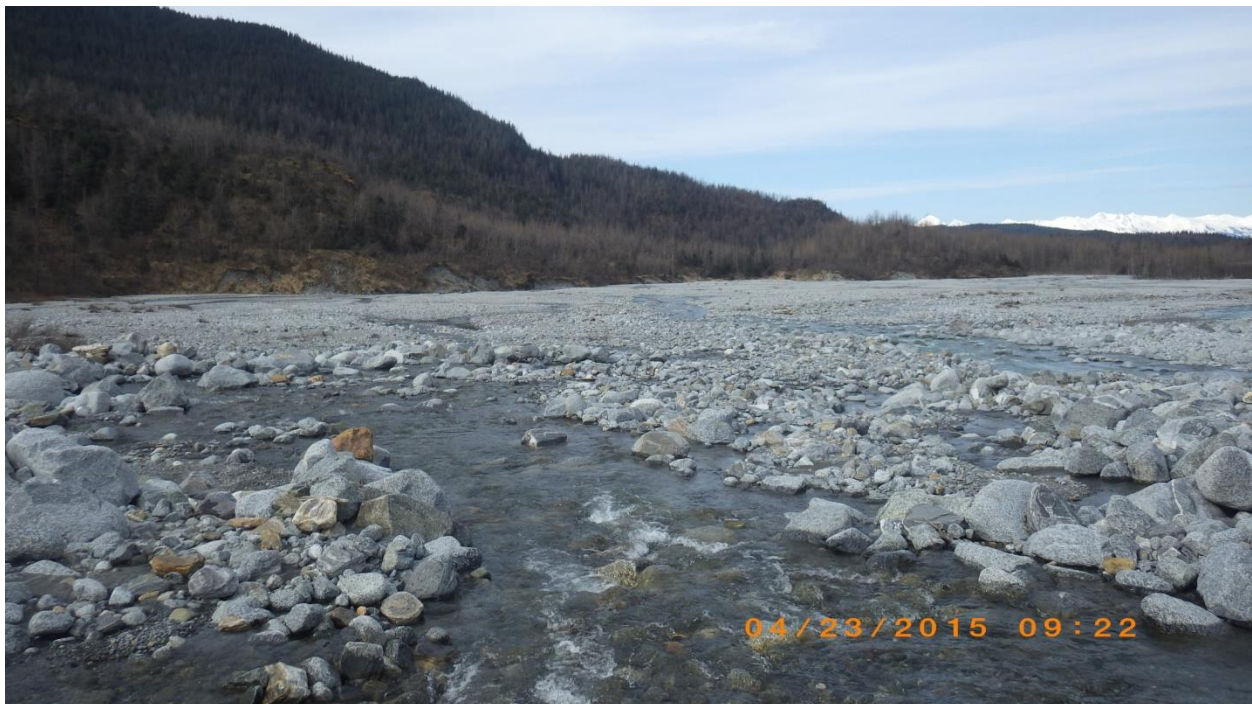
Figure 2.—Herbert River Lake no longer exists. It is currently a braided alluvial fan.

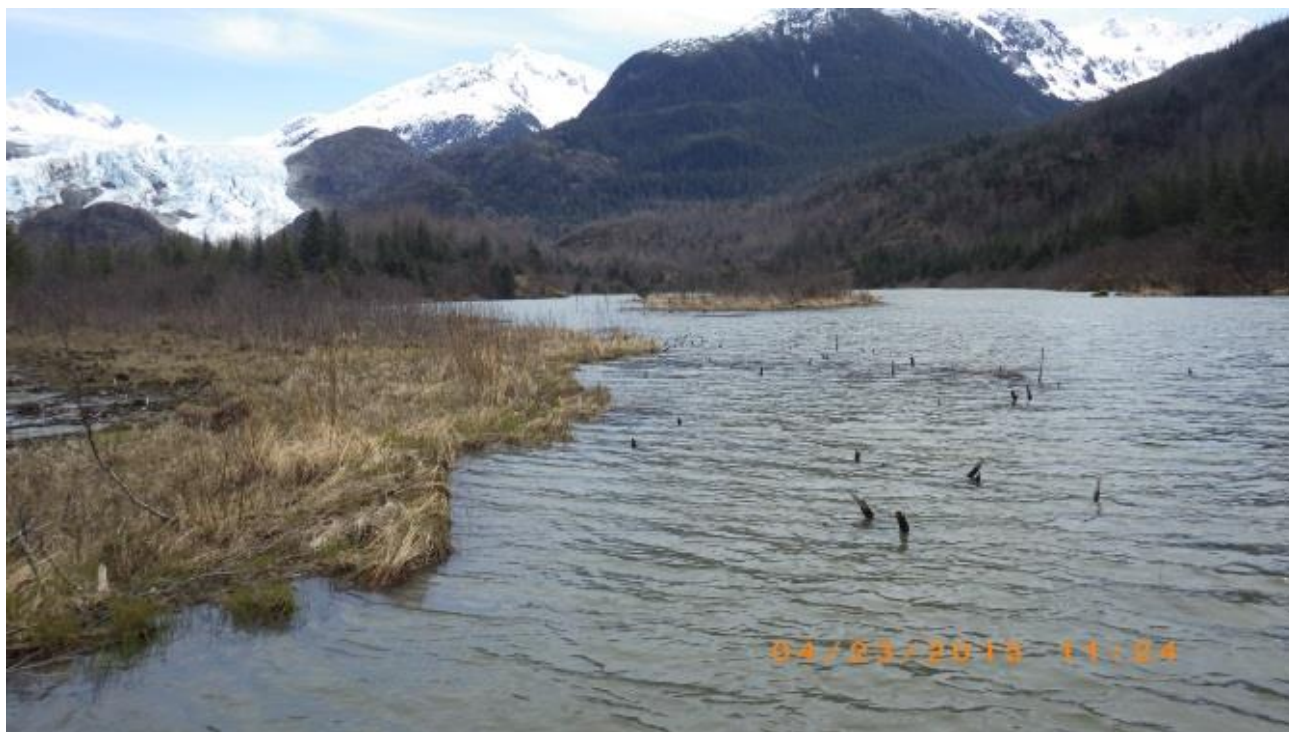
Figure 1.–Herbert River beaver lake.

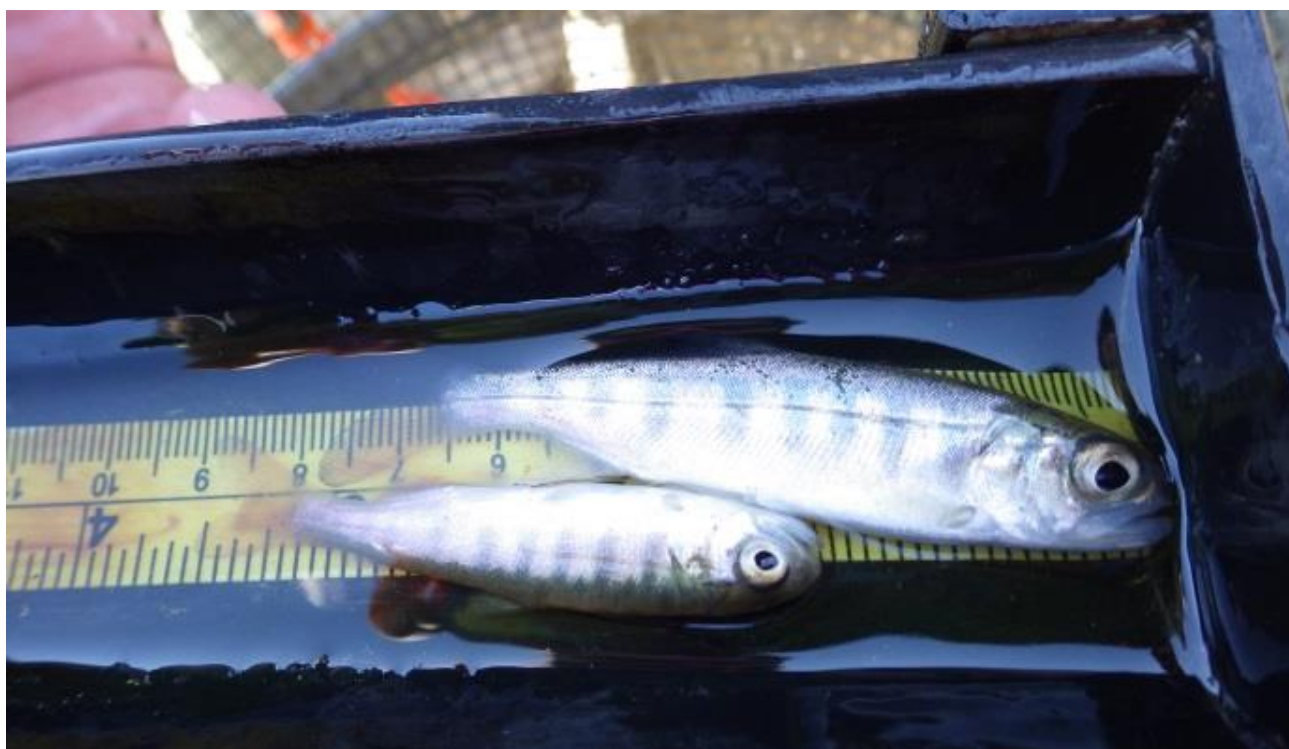
Figure 2.–Coho captured in the beaver lake.

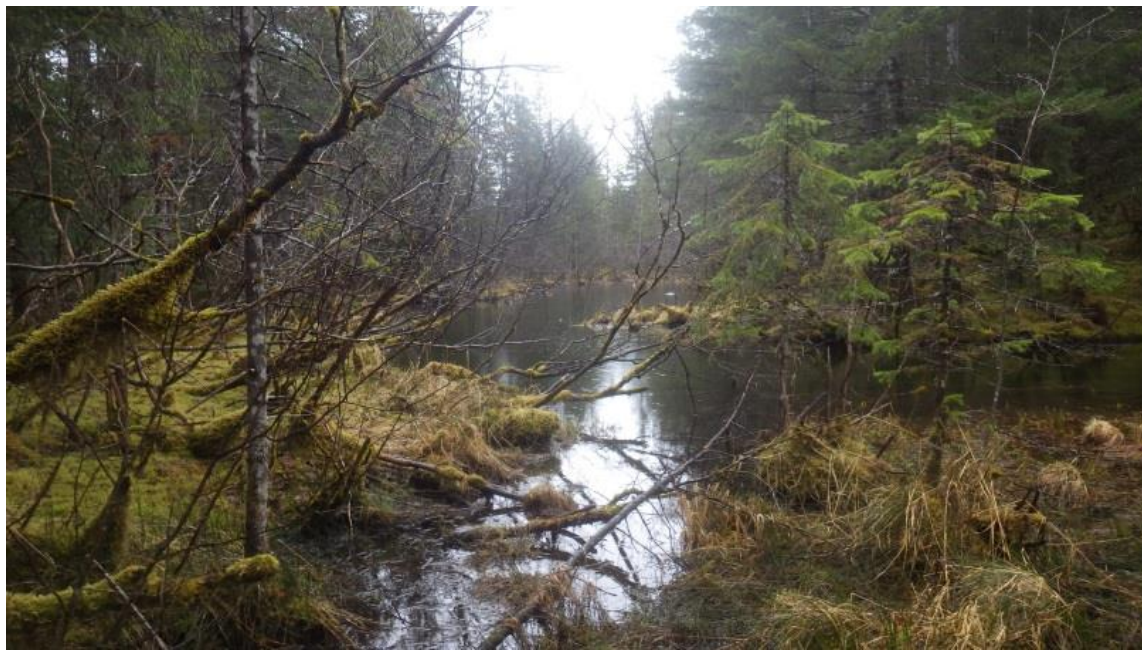
Figure 1.–Beaver complex 1 and upper extent of anadromy, waypoint 11.

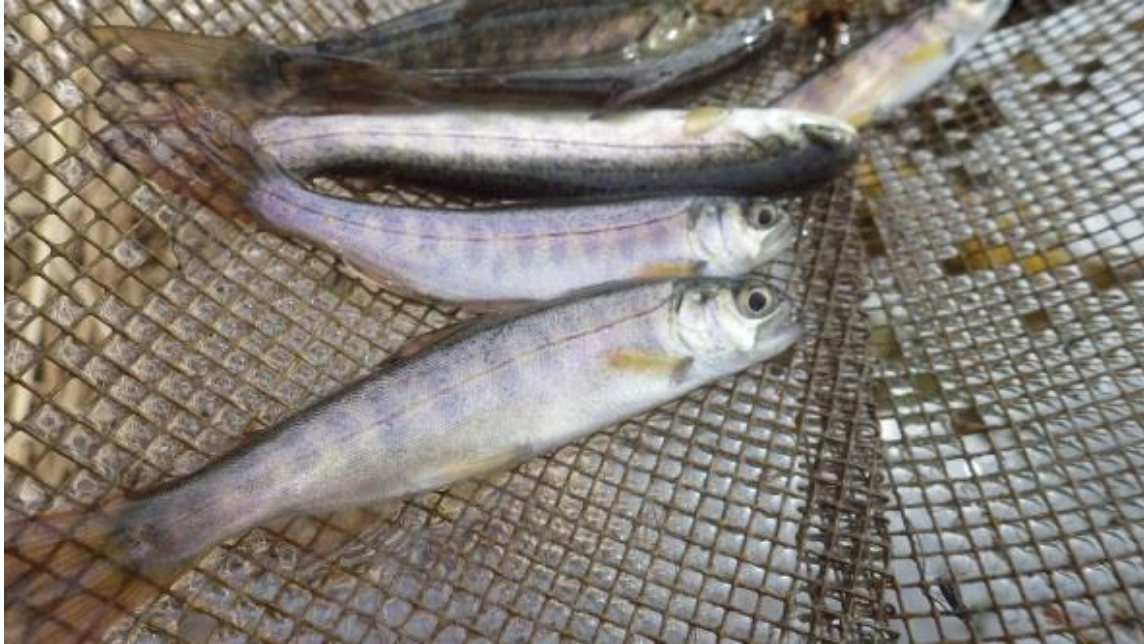
Figure 2.—Coho captured in beaver complex 1.

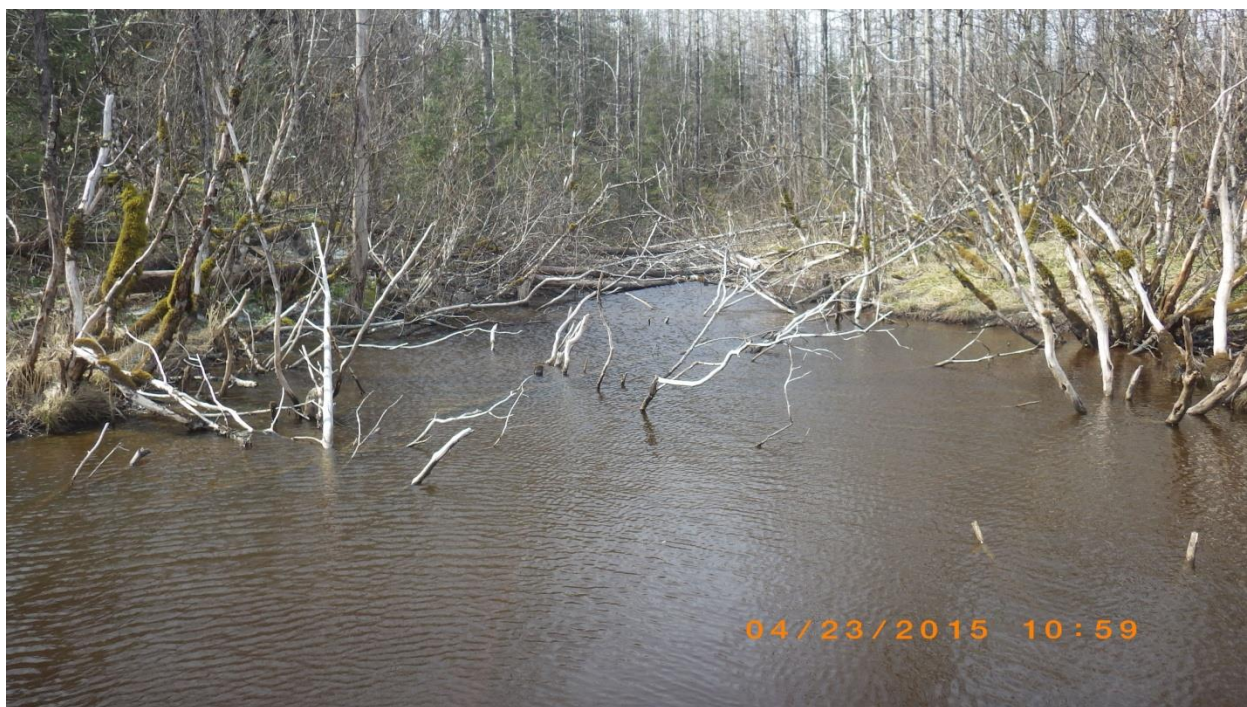
Figure 1.—Beaver complex 2.

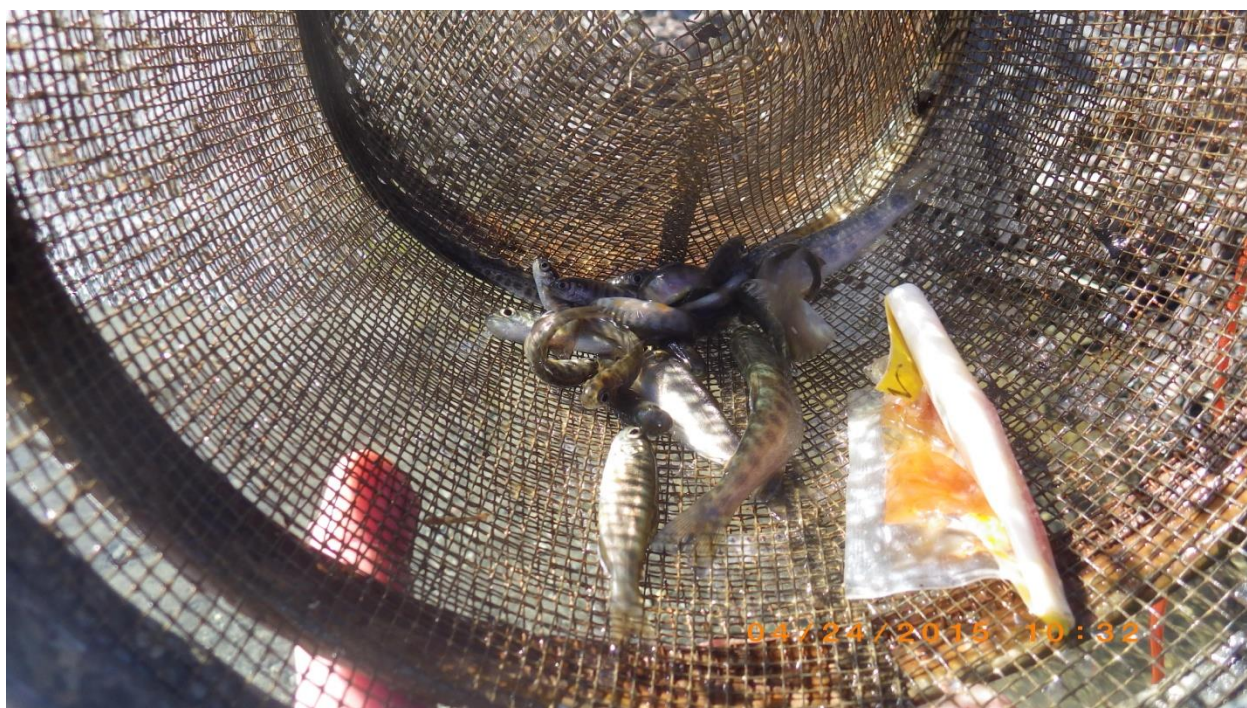
Figure 2.—Coho captured in beaver complex 2.

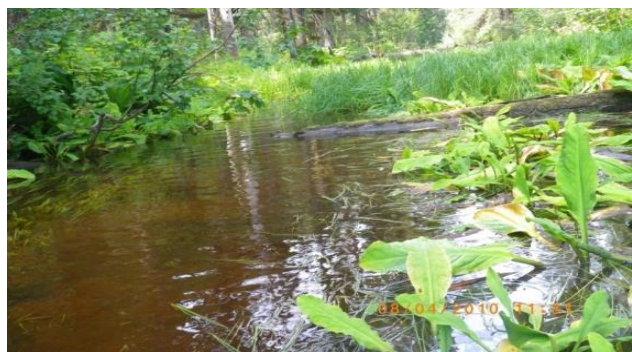
Figure 1.—Windfall tributary.

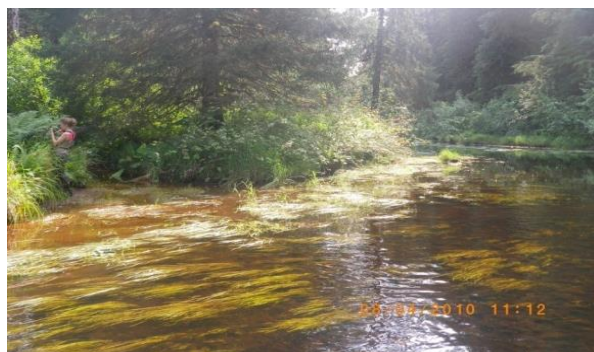
Figure 2.—Mouth of tributary.

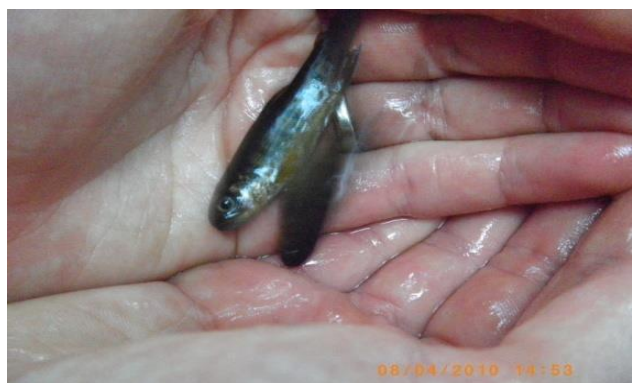
Figure 3.—CO captured in tributary.

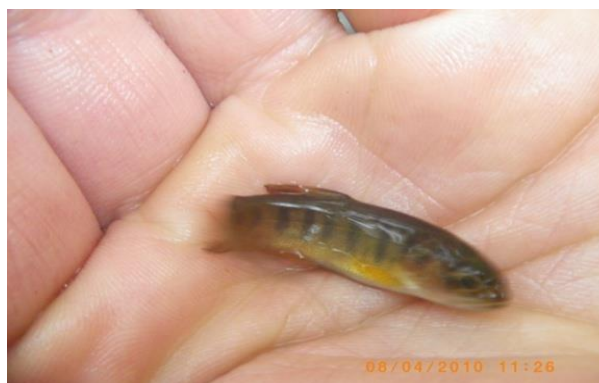
Figure 4.—CO captured in tributary.

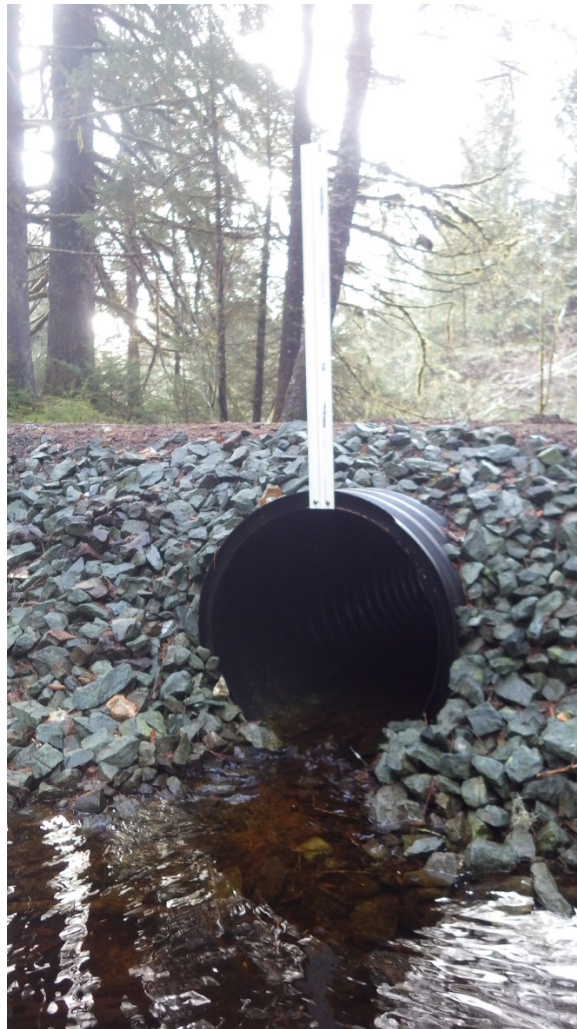
Figure 1.–Culvert at survey start.

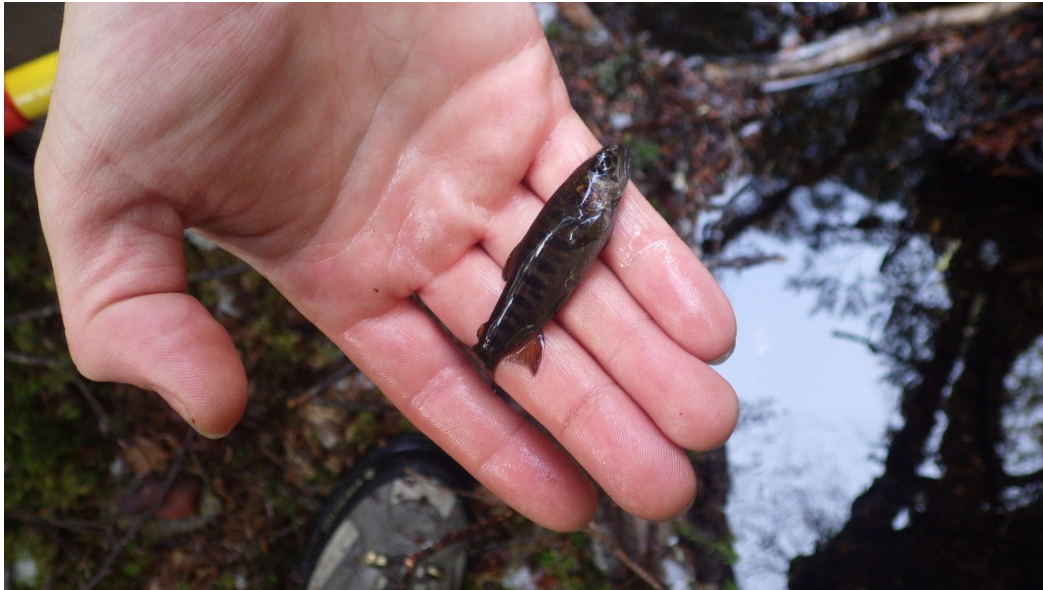
Figure 2.—Coho salmon captured at waypoint 830.

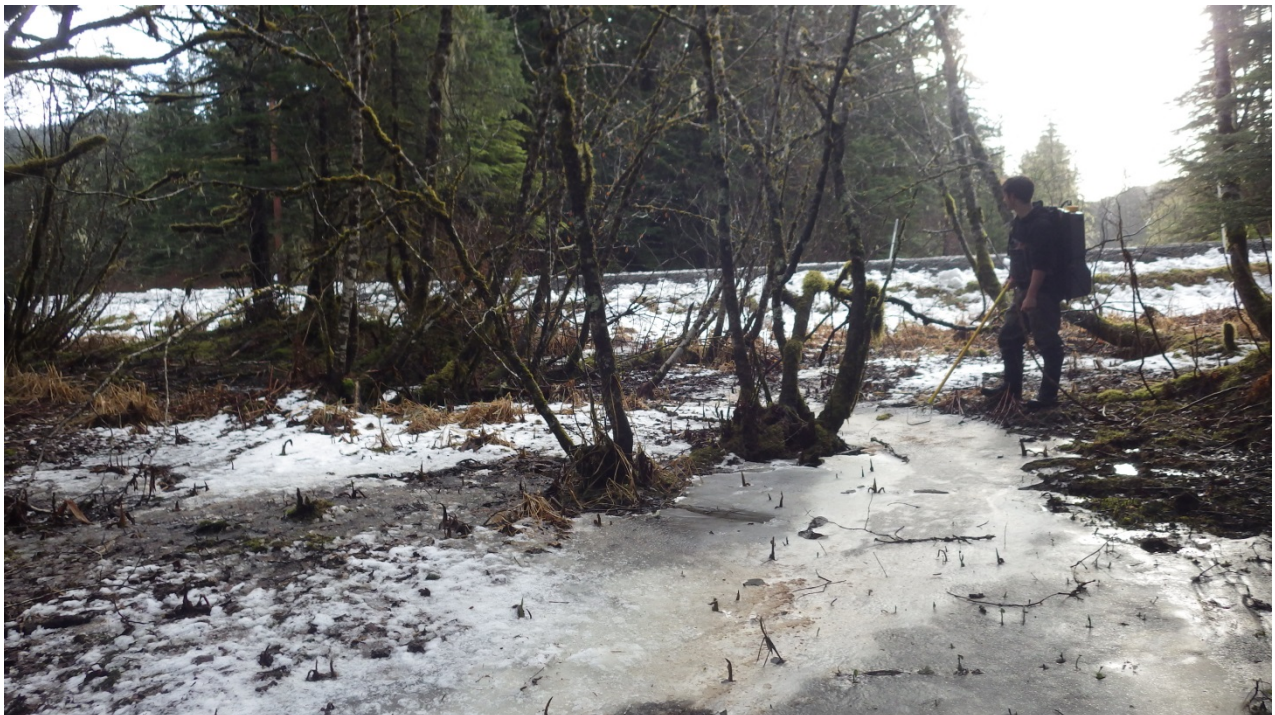
Figure 3.—End survey. Near the road the stream empties a wetland and ceased to have a defined channel.

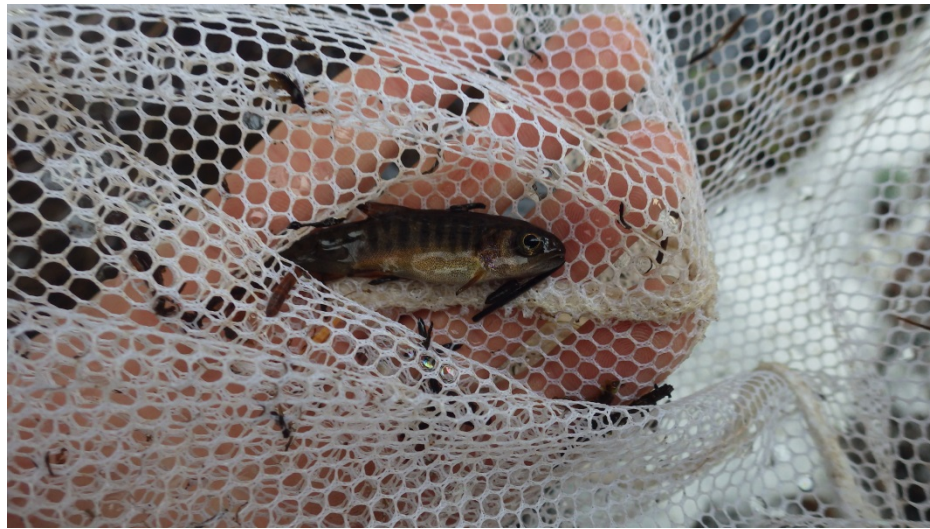
Figure 1.–Coho captured at waypoint 838.

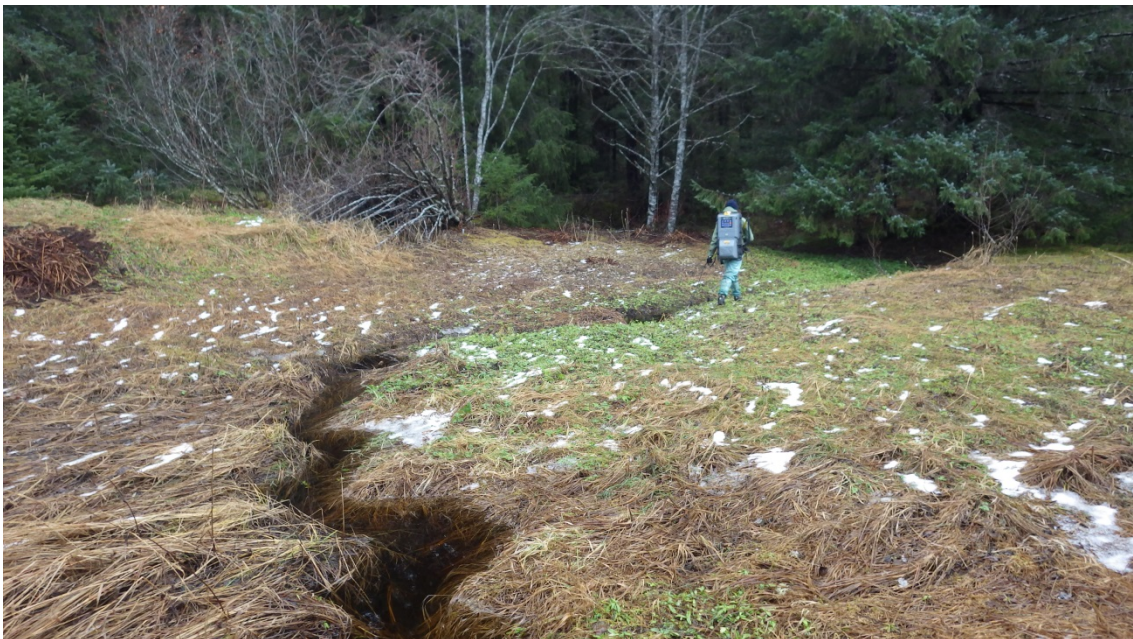
Findings: We surveyed this stream using an electrofisher and a GPS and found coho salmon and stickleback (Table 1; Figure 1). The stream is incised and less than 12 inches wide as it crosses the meadow (Figure 2). We ended the survey where the stream channel became undefined.

Figure 2.–Stream is incised and less than 12 inches wide.

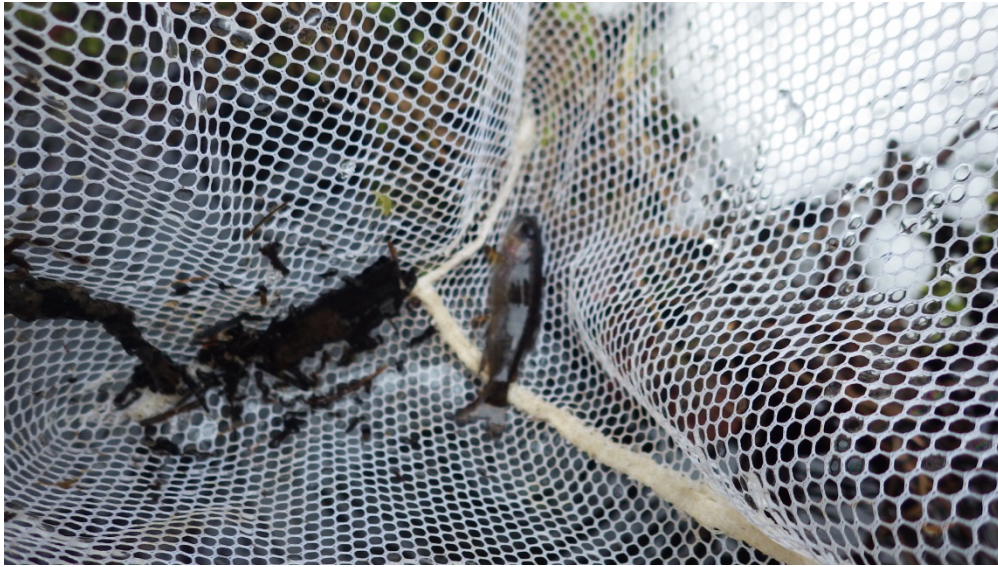
Figure 1.–Coho salmon captured at waypoint 847.

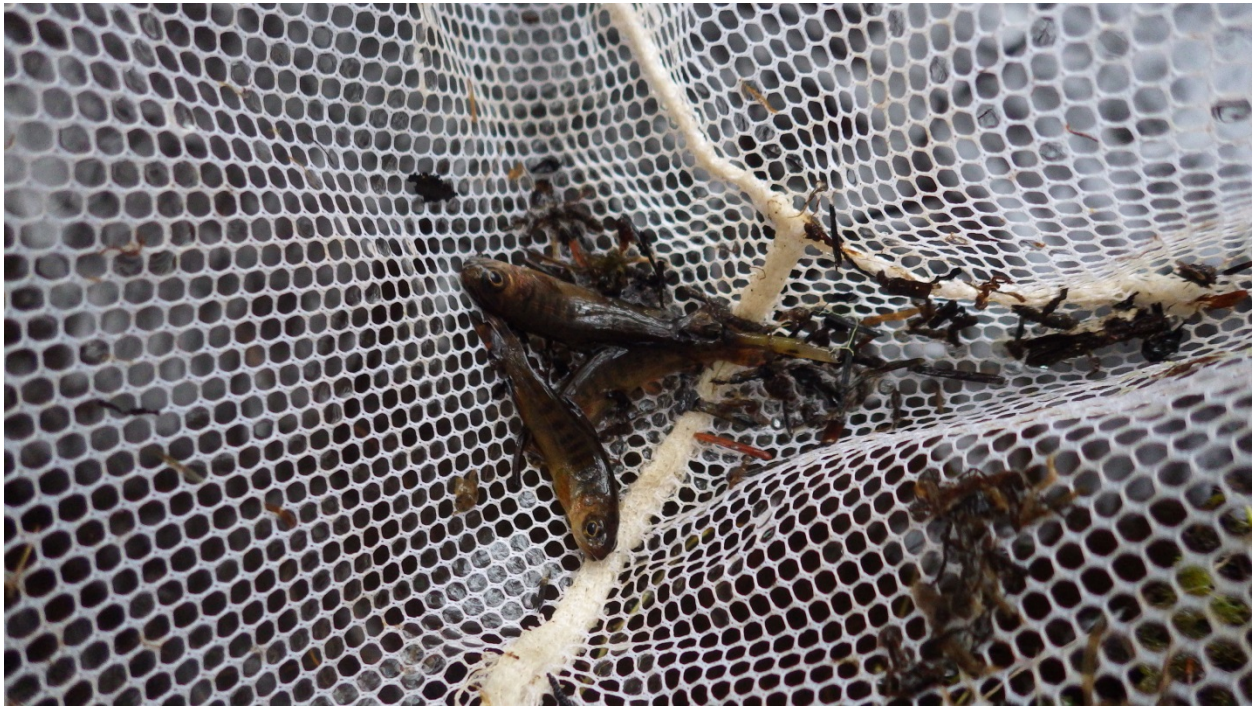
Figure 1.–Coho salmon captured at waypoint 840.

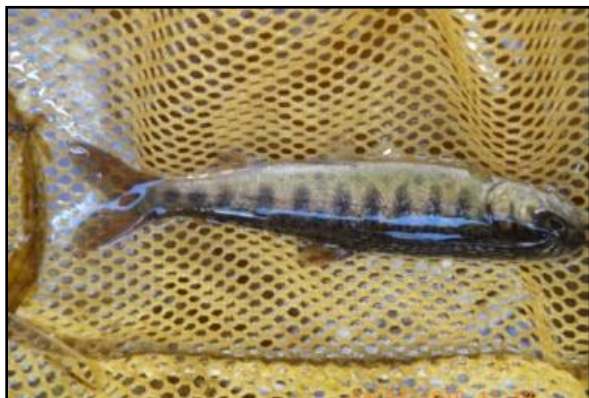
Figure 1.–CO captured in Shrine Creek.

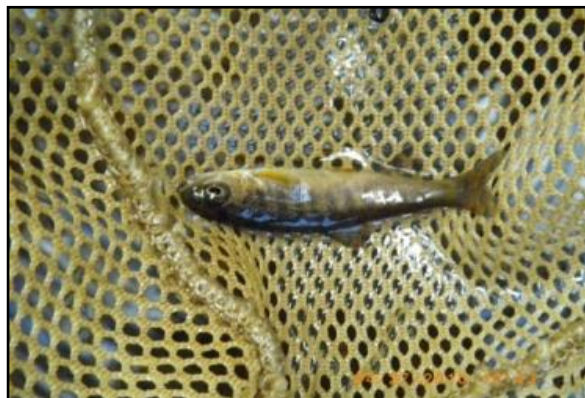
Figure 2.–CO captured.

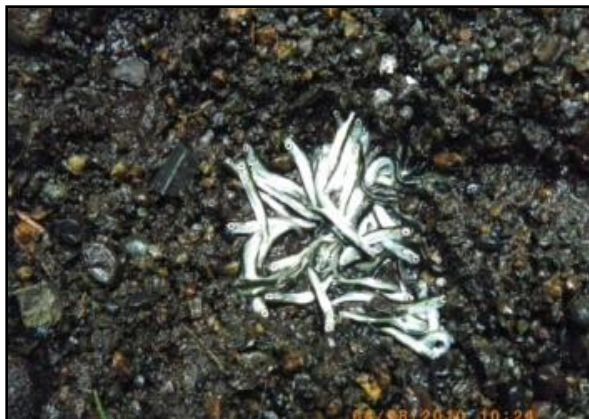
Figure 3.–Pink salmon emerging from dewatered gravel.

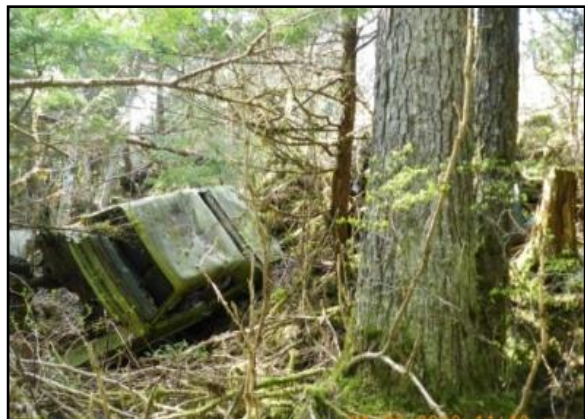
Findings: We surveyed Shrine Creek using a backpack electrofisher and a GPS (Table 1). The upper extent of anadromy extends past the cataloged upper limit. We captured juvenile CO and P salmon and found an old car (Figures 1, 2, 3, and 4). The stream crosses Glacier Highway in a different location then what is shown in AWC.

Figure 4.–Old car dumped in Shrine Creek.

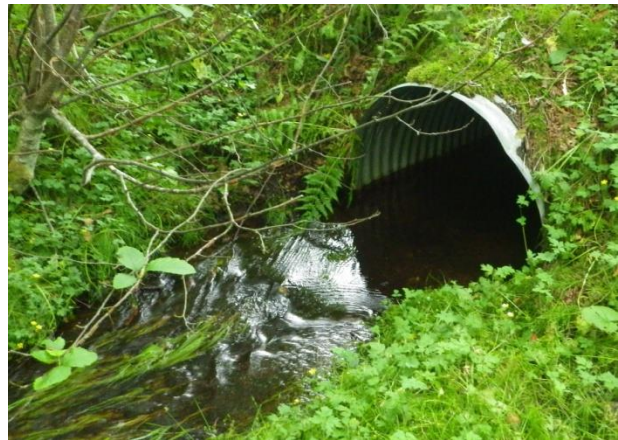
Figure 2.–Culvert currently for cataloged tributary of Campground Creek.

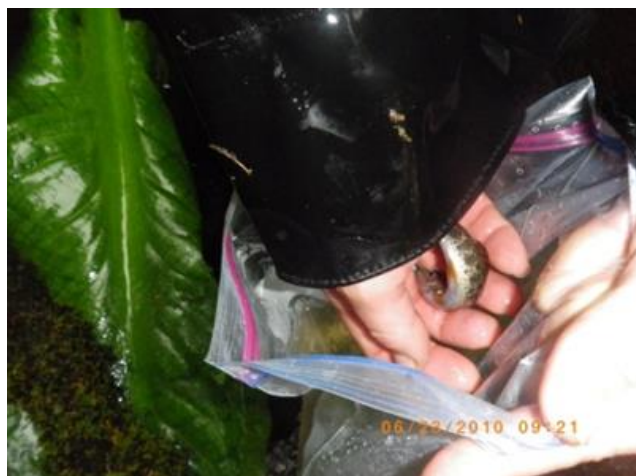
Figure 1.–CT and DV at waypoint 5.

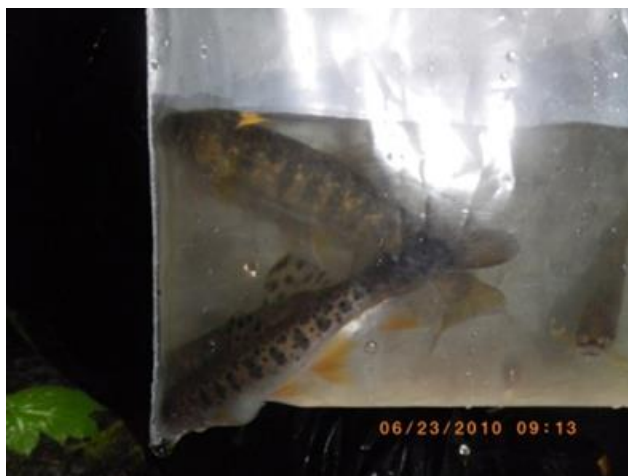
Figure 2.–CT and DV at waypoint 8.

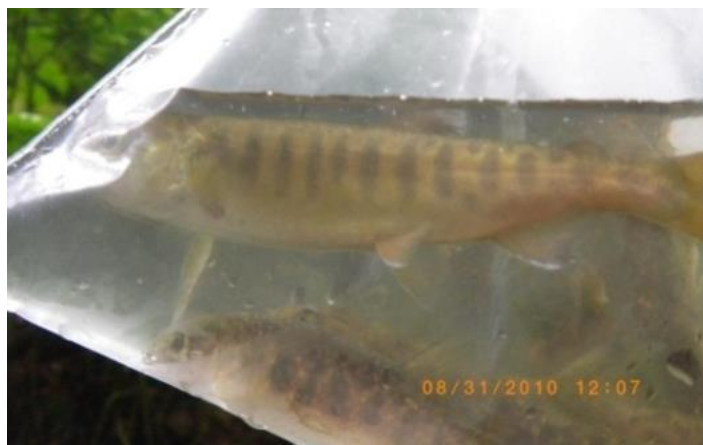
Figure 1.–CO and DV captured in upper reach, August 2010.

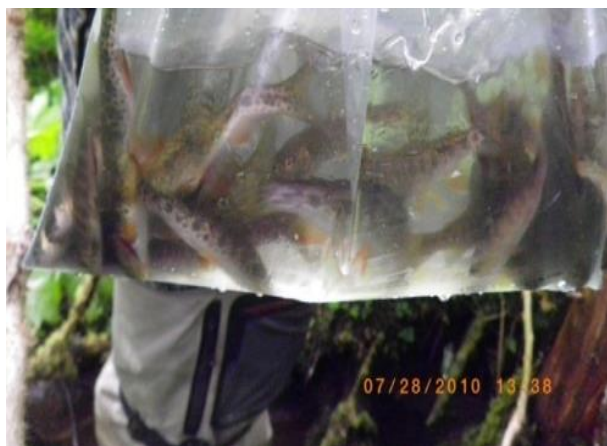
Figure 1.-CO and CT in Lake Two Creek.

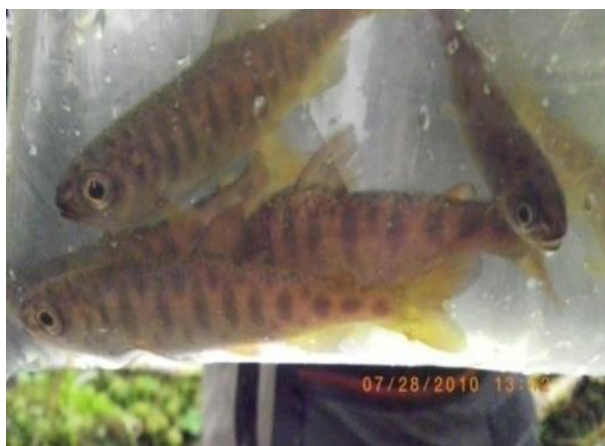
Figure 2.-CO caught in Lake Two Creek.

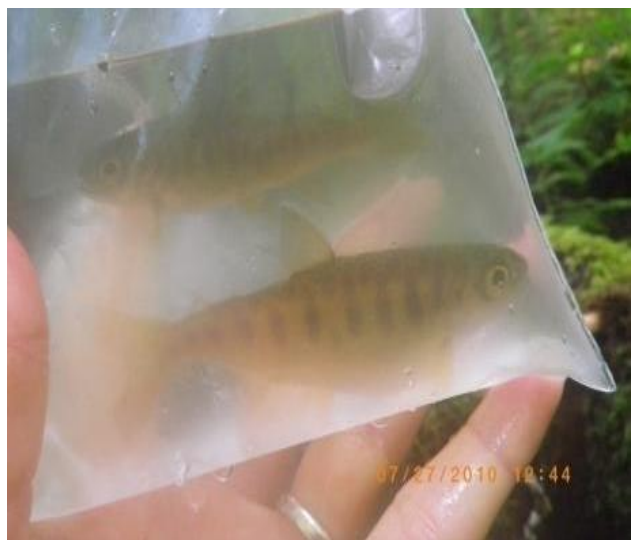
Figure 1.–CO in Lake Creek.

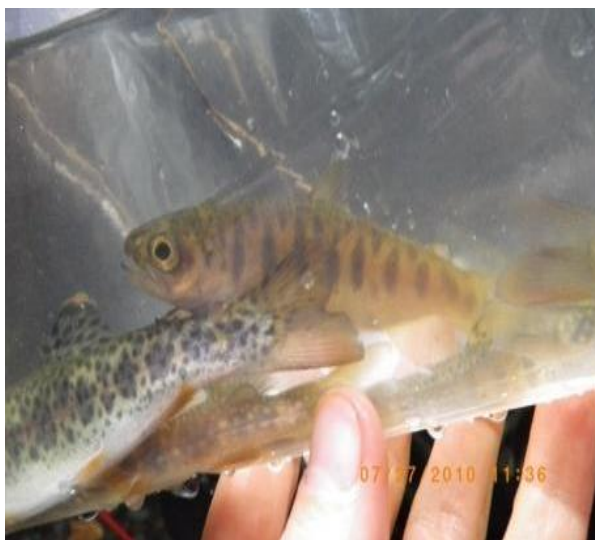
Figure 2.–CT and CO in Lake Creek.

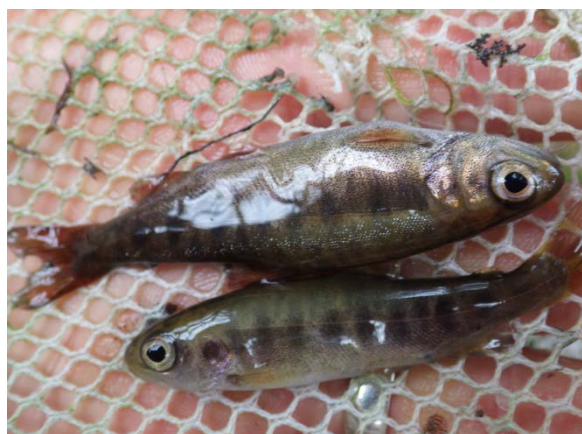
Figure 1.—Juvenile coho salmon.

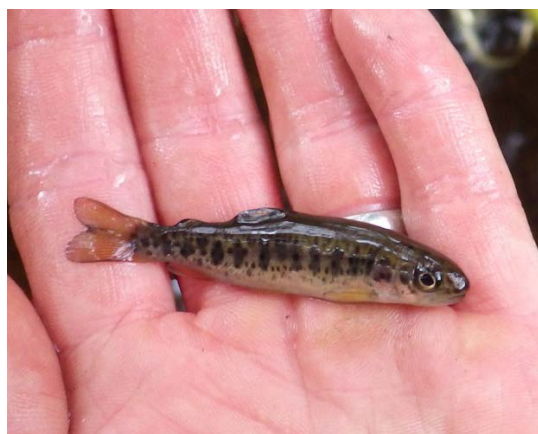
Figure 2.—Juvenile cutthroat trout.

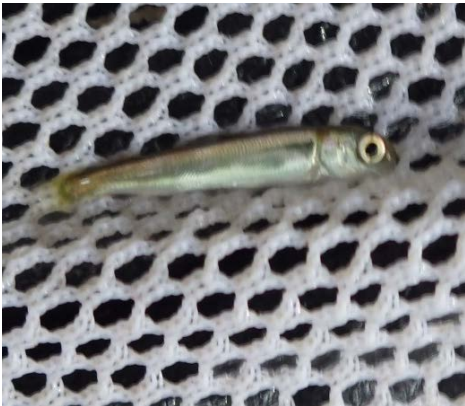
Figure 3.–Pink fry caught above waypoint 12.

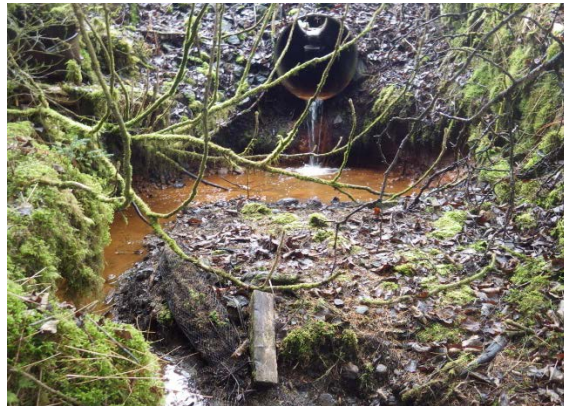
| Waypoint | Latitude | Longitude | Notes | Sample Effort | Sample Results |
|---|---|---|--|---|---|
| 26 | 58.3746 | -134.6236 | Outlet of culvert under LDS church parking area. | EF | 2 DV |

Figure 4.–CMP outlet under LDS parking lot.

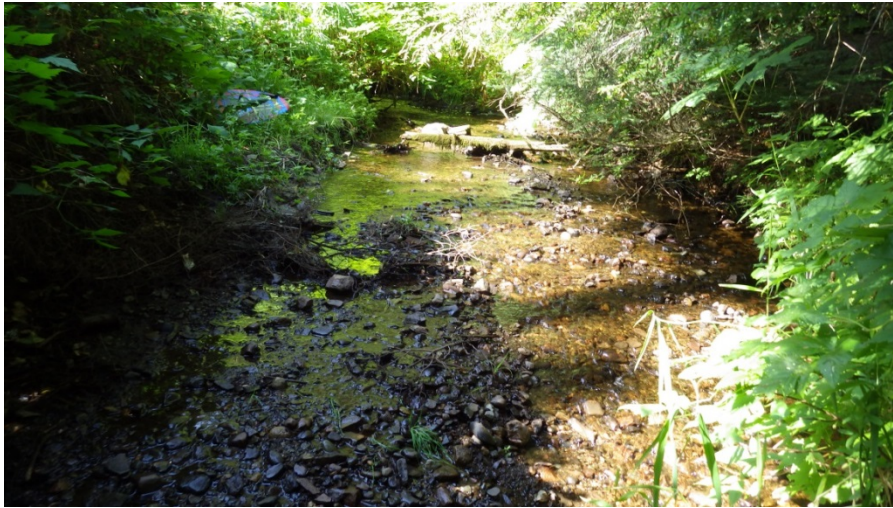
Figure 1.—Looking upstream above Engineers Cutoff Road.

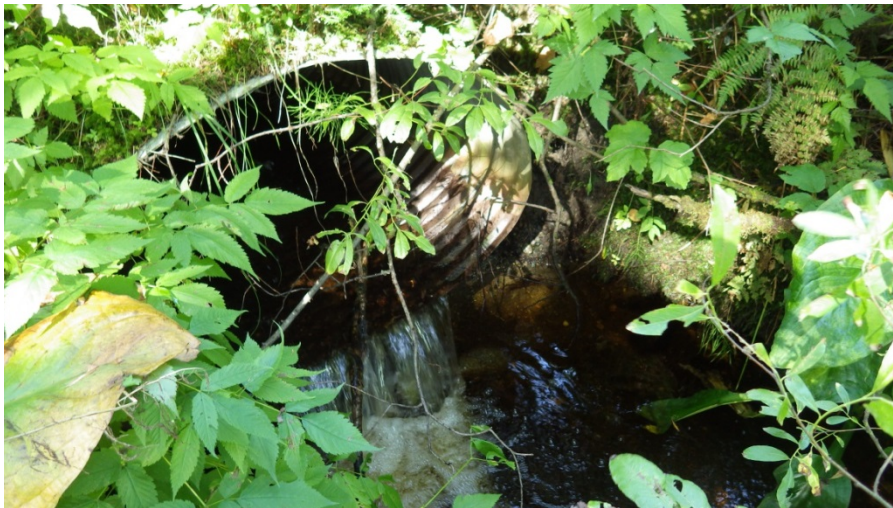
Findings: We surveyed this stream above Engineers Cutoff Road using a backpack electrofisher and a GPS (Table 1). We discontinued electrofishing when chum salmon were observed spawning. Adult salmon can access habitat above the perched culvert (Figures 1, 2). We returned on 3/16/16 to verify fish use above Engineers Cutoff Road. We noted an old dam at waypoint 506 (Figure 3). The route correction below Engineers cutoff is based on aerial imagery and 5-foot contours derived from LIDAR.

Figure 2.—Perch at culvert outlet.

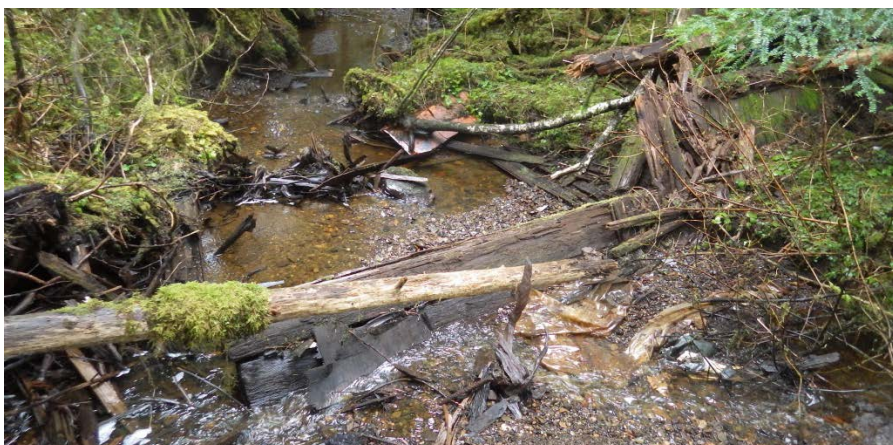
Figure 3.—Old dam located at waypoint 506.

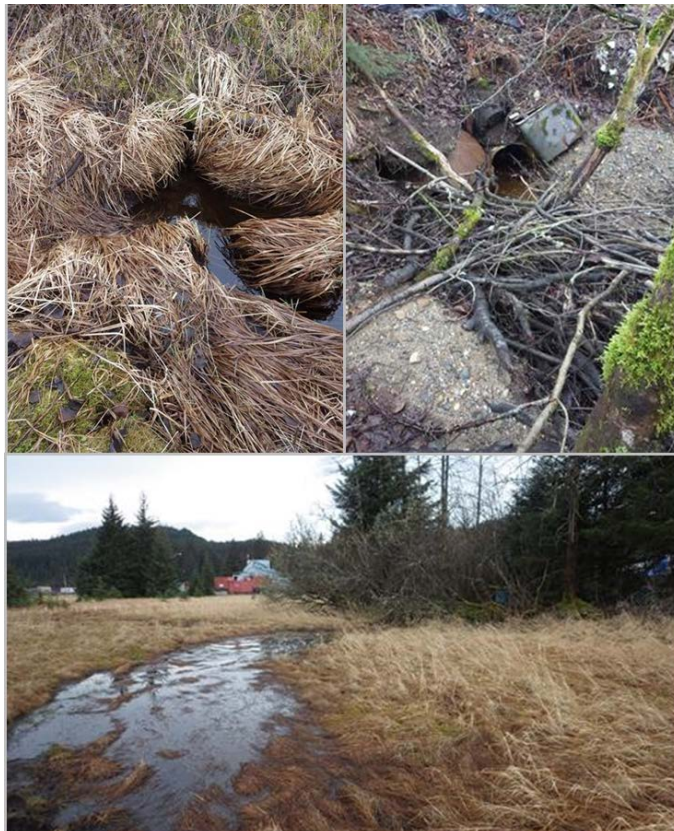
Figure 1.–Culvert inlet (left), outlet (right) and ponded wetland area (bottom).

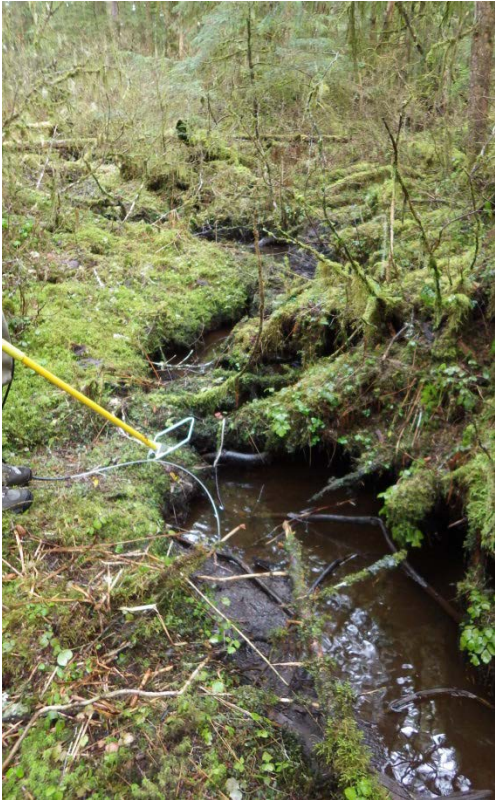
Figure 1.–Stream near waypoint 4.
