Appendix I: Juneau

Guide to direct fieldwork for cataloging anadromous water bodies in Southeast Alaska

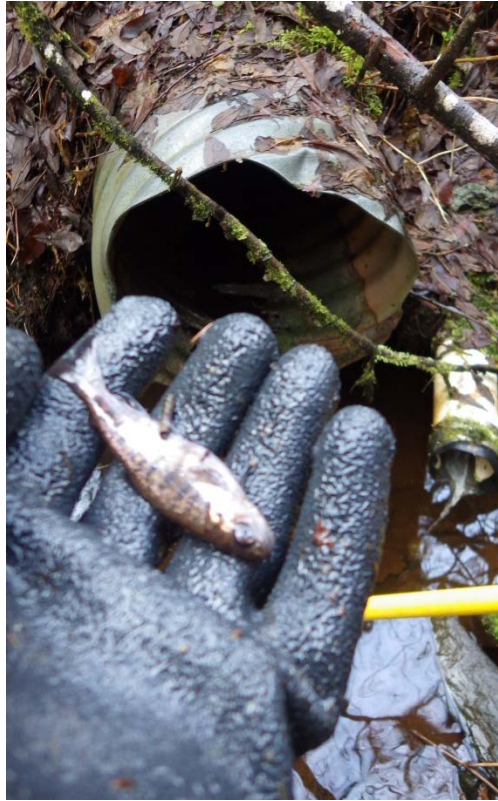
| Waypoint | Latitude | Longitude | Notes | Sample Effort | Sample Results |
|---|---|---|--|---|---|
| 11 | 58.3719 | -134.6229 | Outlet pool. Perched 18" diameter CMP. End survey. | EF | 3 CO |

Figure 2.–Ended survey at waypoint 11.

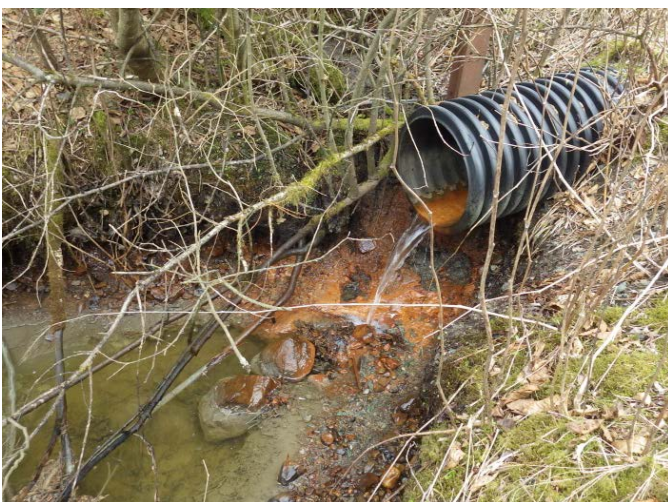
Figure 1.–Barrier culvert at waypoint 1.

Recommendations: Update the Anadromous Waters Catalog with the field verified route (Figures 1, 2).

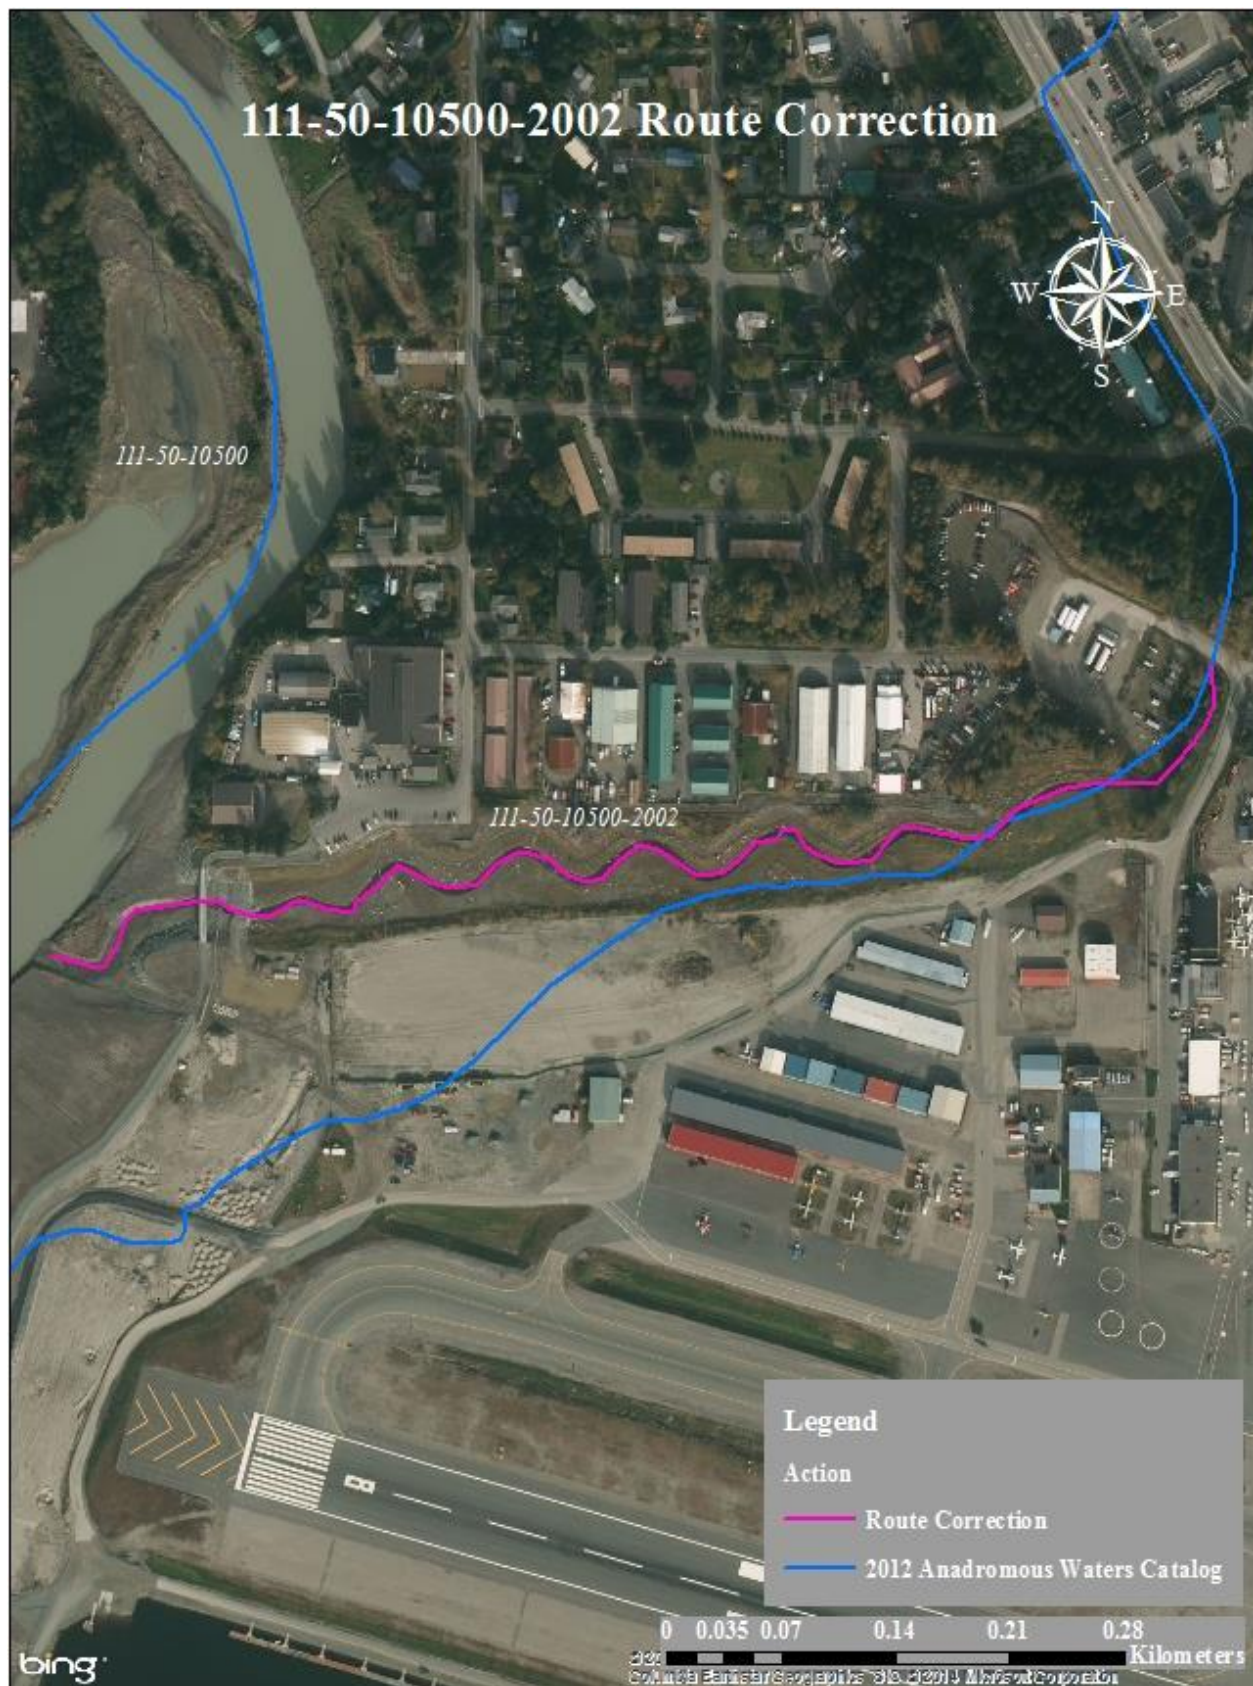
Figure 1.—111-50-10500-2002 route correction map. Lower reach of Duck Creek below Cessna Drive.

Recommendations: Correct route to reflect realignment constructed in 2010 (Figure 1).

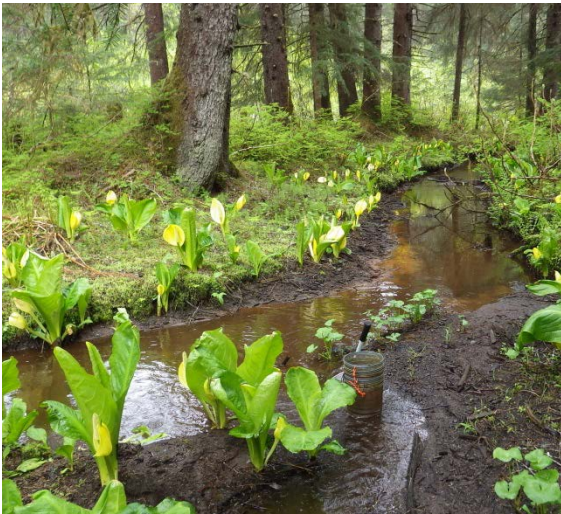
Figure 1.–Stream at WP 108.

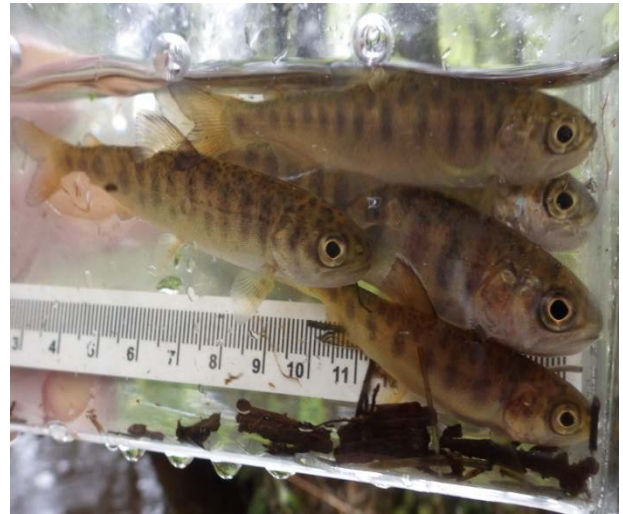
Figure 2.–Coho salmon captured at WP 108.

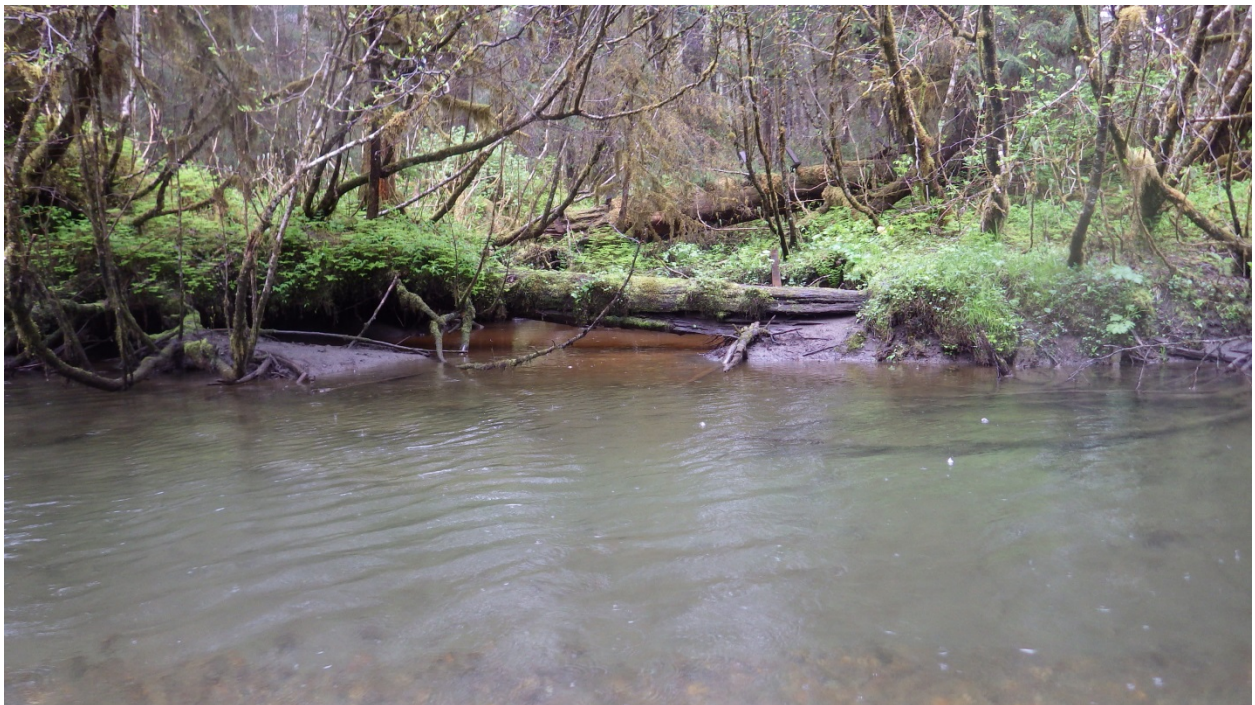
Figure 3.–Confluence with Montana Creek WP 125.

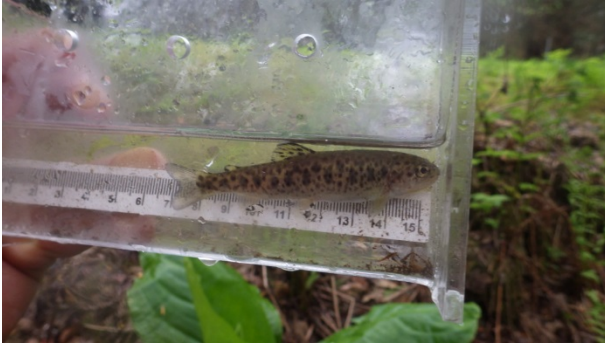
Figure 1.–Cutthroat trout captured at WP 80.

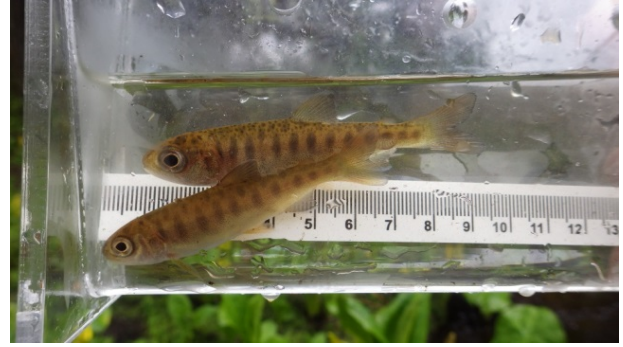
Figure 2.–Coho salmon captured at WP 107.

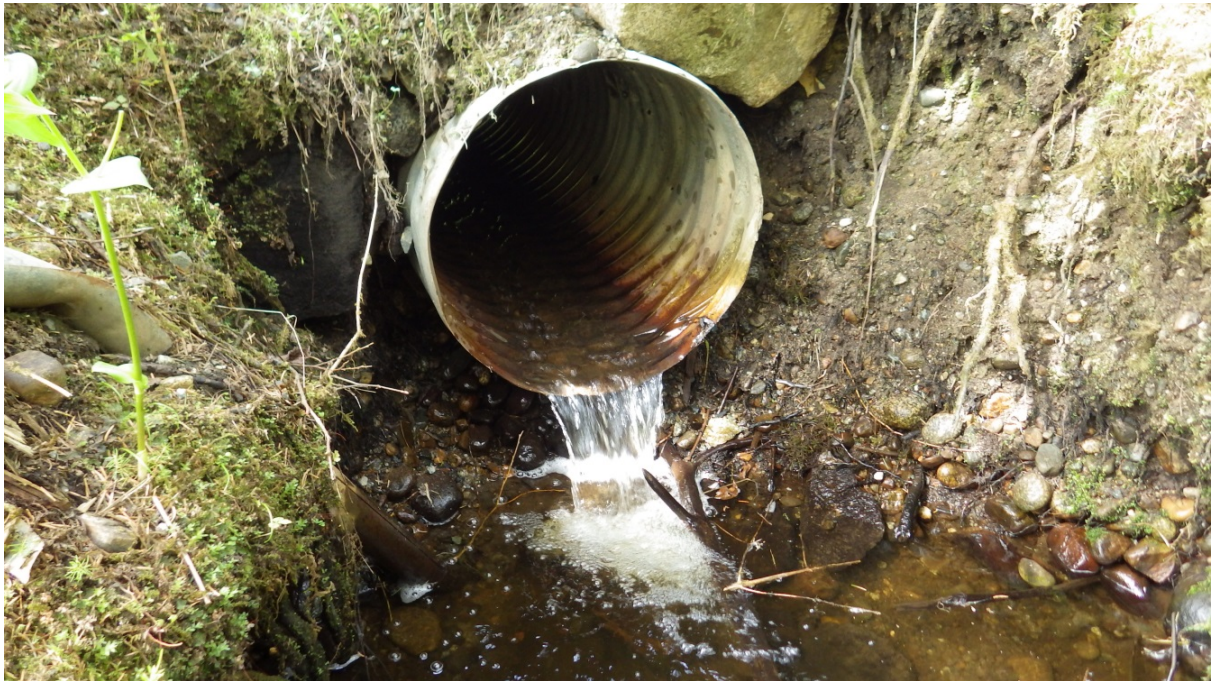
Findings: We surveyed this stream using minnow traps, backpack electrofisher and a GPS. We found juvenile coho salmon and cutthroat trout. The creek ends berm that restricts flow, but no coho salmon were captured above a perched culvert at WP 88 (Table 1, Figures 1-4).

| Waypoint | Latitude | Longitude | Notes | Sample Effort | Sample Results |
|---|---|---|---|---|---|
| 79 | 58.3943 | -134.6128 | Downstream end of Blackbear Rd 24" culvert. The culvert is perched about one foot above the stream with a one foot pool. Rust on the pipe indicates that the culvert is close to high water mark. Two clogged culverts were to the left of it. Trap was pulled at 11:50 on 5/18/2017. CT were 60-80 mm. | MT | 6 CT |

Figure 3.–Perched culvert at Black Bear Road.

Recommendations: Add this stream to the Anadromous Waters Catalog for rearing coho salmon.

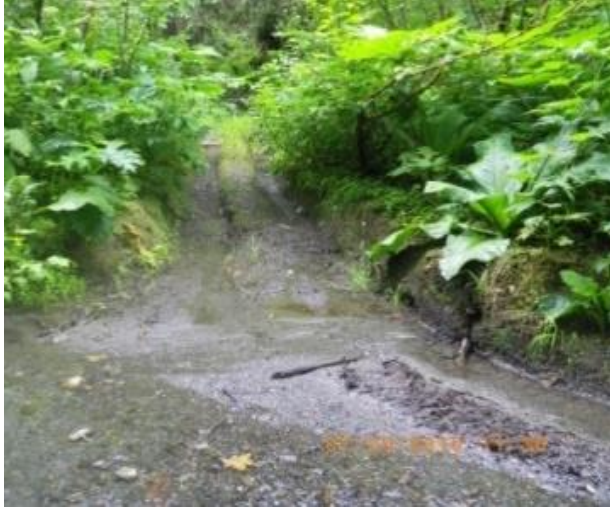
Findings: We surveyed this tributary to McGinnis Creek using a handnet and a GPS (Table 1). There were several ATV crossings that had filled with water and in one instance we observed fish in these tracked areas (Figures 1, 2). We captured rearing coho salmon and cutthroat trout (Figures 3, 4). This stream extends past the cataloged upper limit.

Figure 1.—ATV trails through bank and riparian disturbance in 111-50-10500-2003-3054-4014.

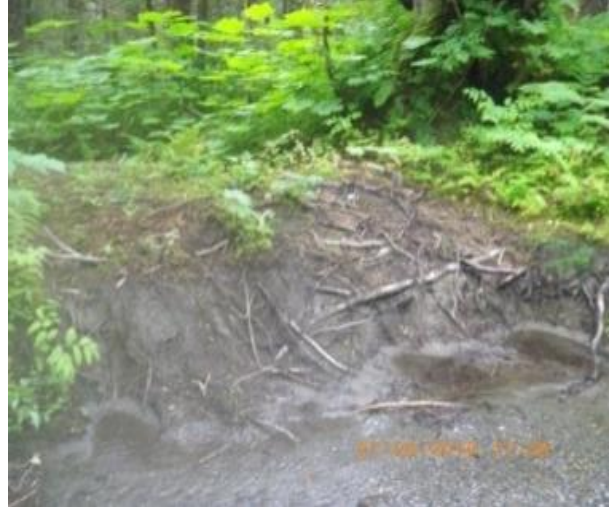
Figure 2.—Bank and riparian disturbance in 111-50-10500-2003-3054-4014.

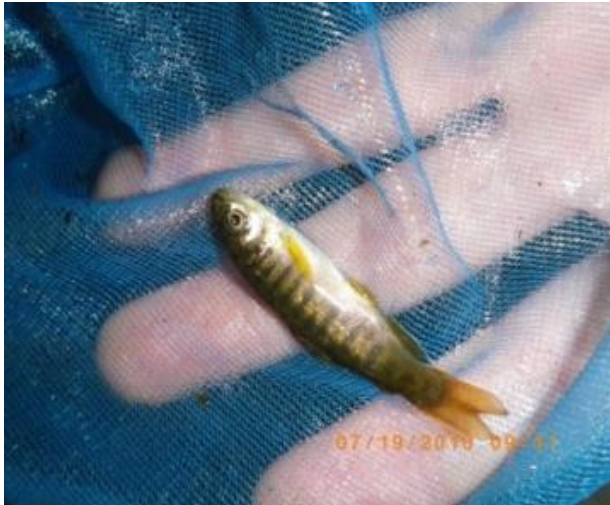
Figure 3.—CO in bank and riparian disturbance in 111-50-10500-2003-3054-4014.

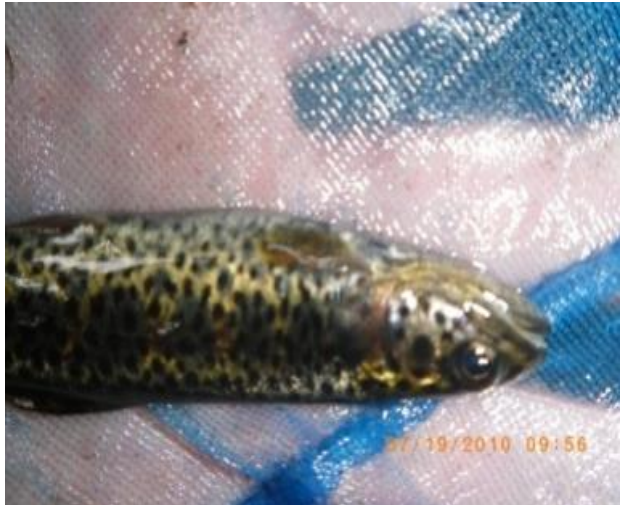
Figure 4.—CT in bank and riparian disturbance in 111-50-10500-2003-3054-4014.

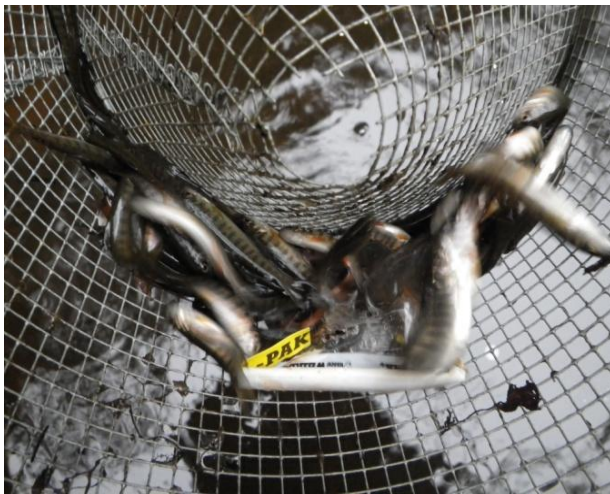
Figure 3.–Trap full of coho salmon from below culvert on tributary.

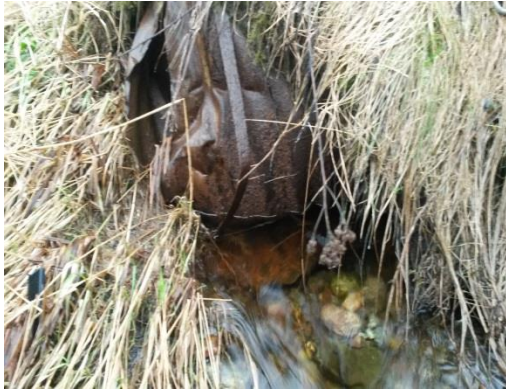
Figure 1.–Outlet of culvert under Old Dairy Road.

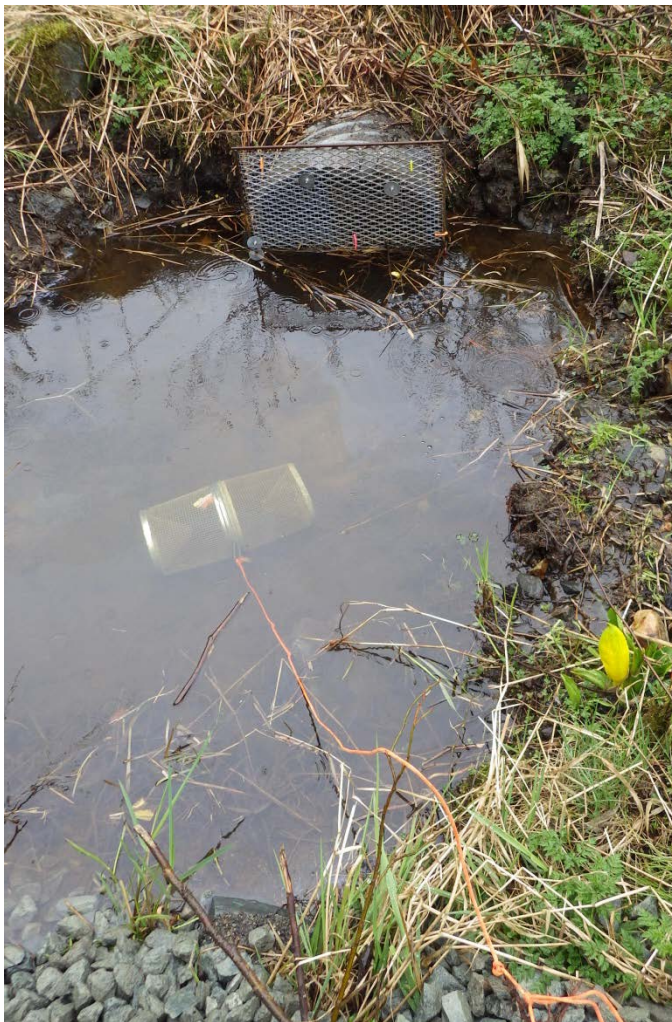
| Waypoint | Latitude | Longitude | Notes | Sample Effort | Sample Results |
|---|---|---|---|---|---|
| 17 | 58.3590 | -134.5331 | Inlet of culvert covered by screen. | | |

Figure 1.–Culvert with fish exclusion screen.

Recommendations: Remove the portion of the stream above waypoint 17 (Table 1.)

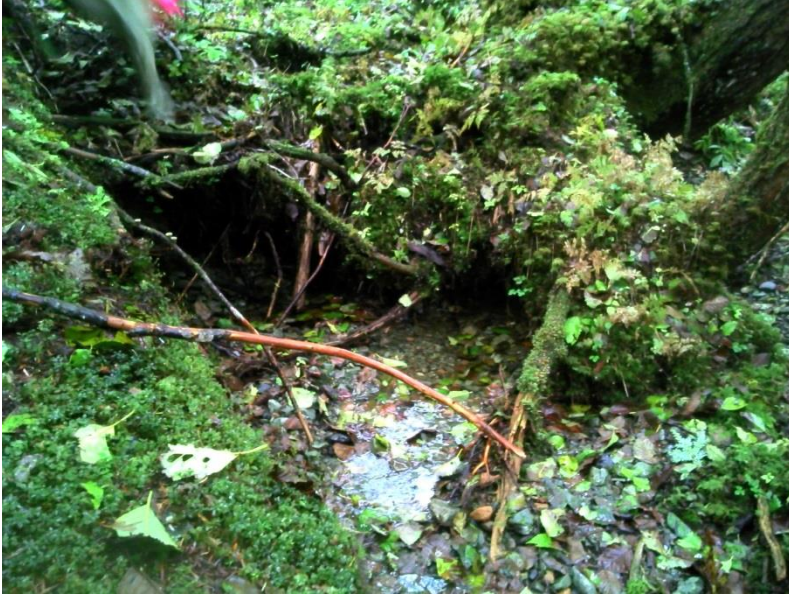
| Waypoint | Latitude | Longitude | Notes | Sample Effort | Sample Results |
|---|---|---|---|---|---|
| 961 | 58.2814 | -134.6497 | The water is coming out of gravel and clay substrate here. | | |

Figure 1.—Water seeping out of gravel and clay substrate.

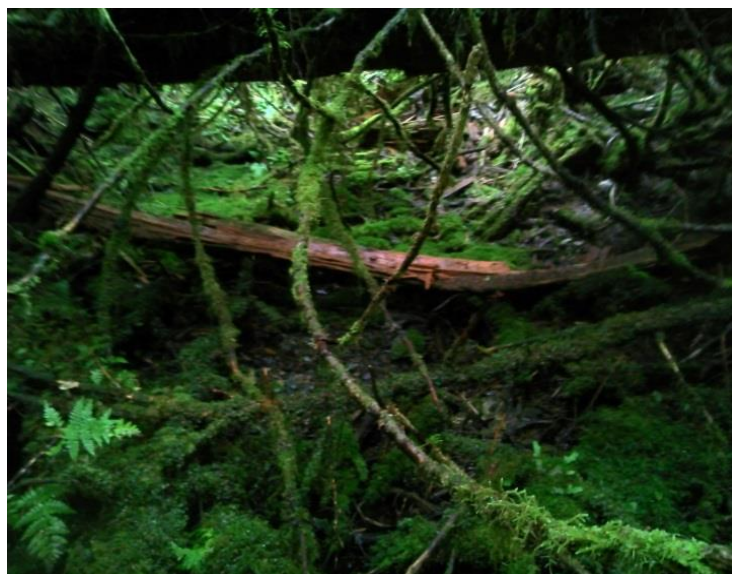
| Waypoint | Latitude | Longitude | Notes | Sample Effort | Sample Results |
|---|---|---|---|---|---|
| 852 | 58.2786 | -134.6448 | Top of tributary. Water is seeping out of the ground. | | |

Figure 1.—Headwater where water is seeping out of the ground.

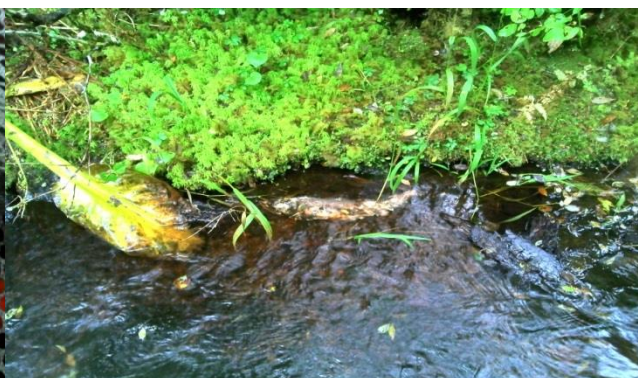
Figure 2.—Pink salmon carcass.

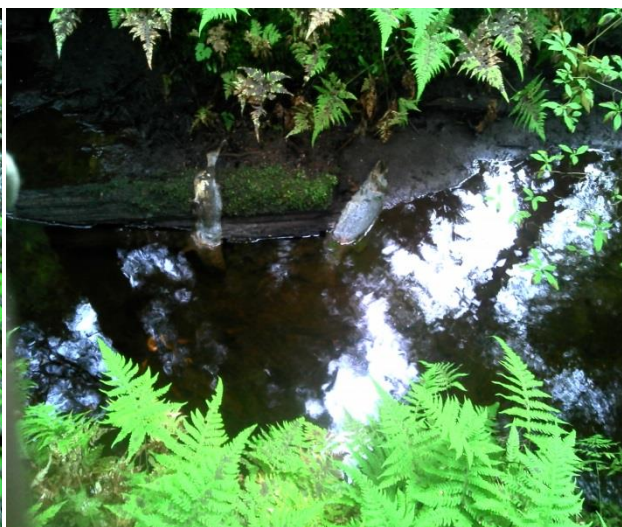
Figure 2.–Pink salmon carcasses on stream bank.

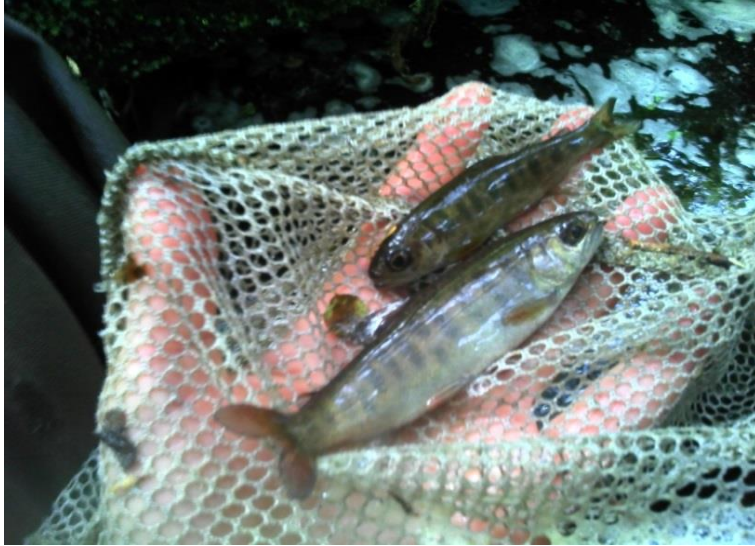
Figure 1.—Coho salmon caught in 111-50-10750-2042-3020.

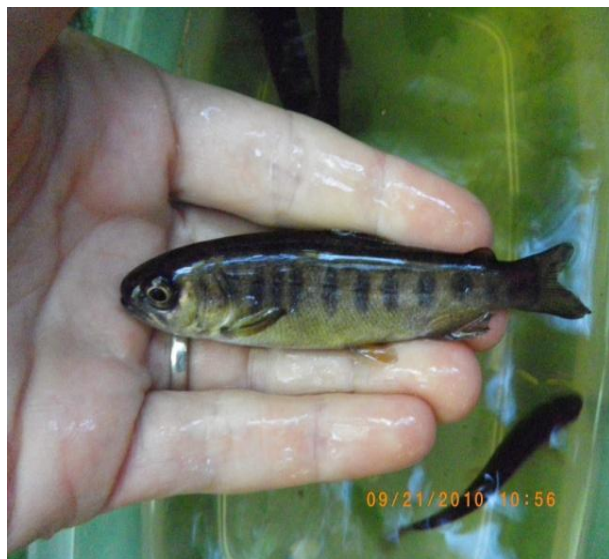
| Waypoint | Latitude | Longitude | Notes | Sample Effort | Sample Results |
|---|---|---|---|---|---|
| 15 | 58.6178 | -134.9340 | Trap at 90 degree corner right next to road. | MT | 4 CO |

Figure 1.—Coho salmon captured at WPT 15.

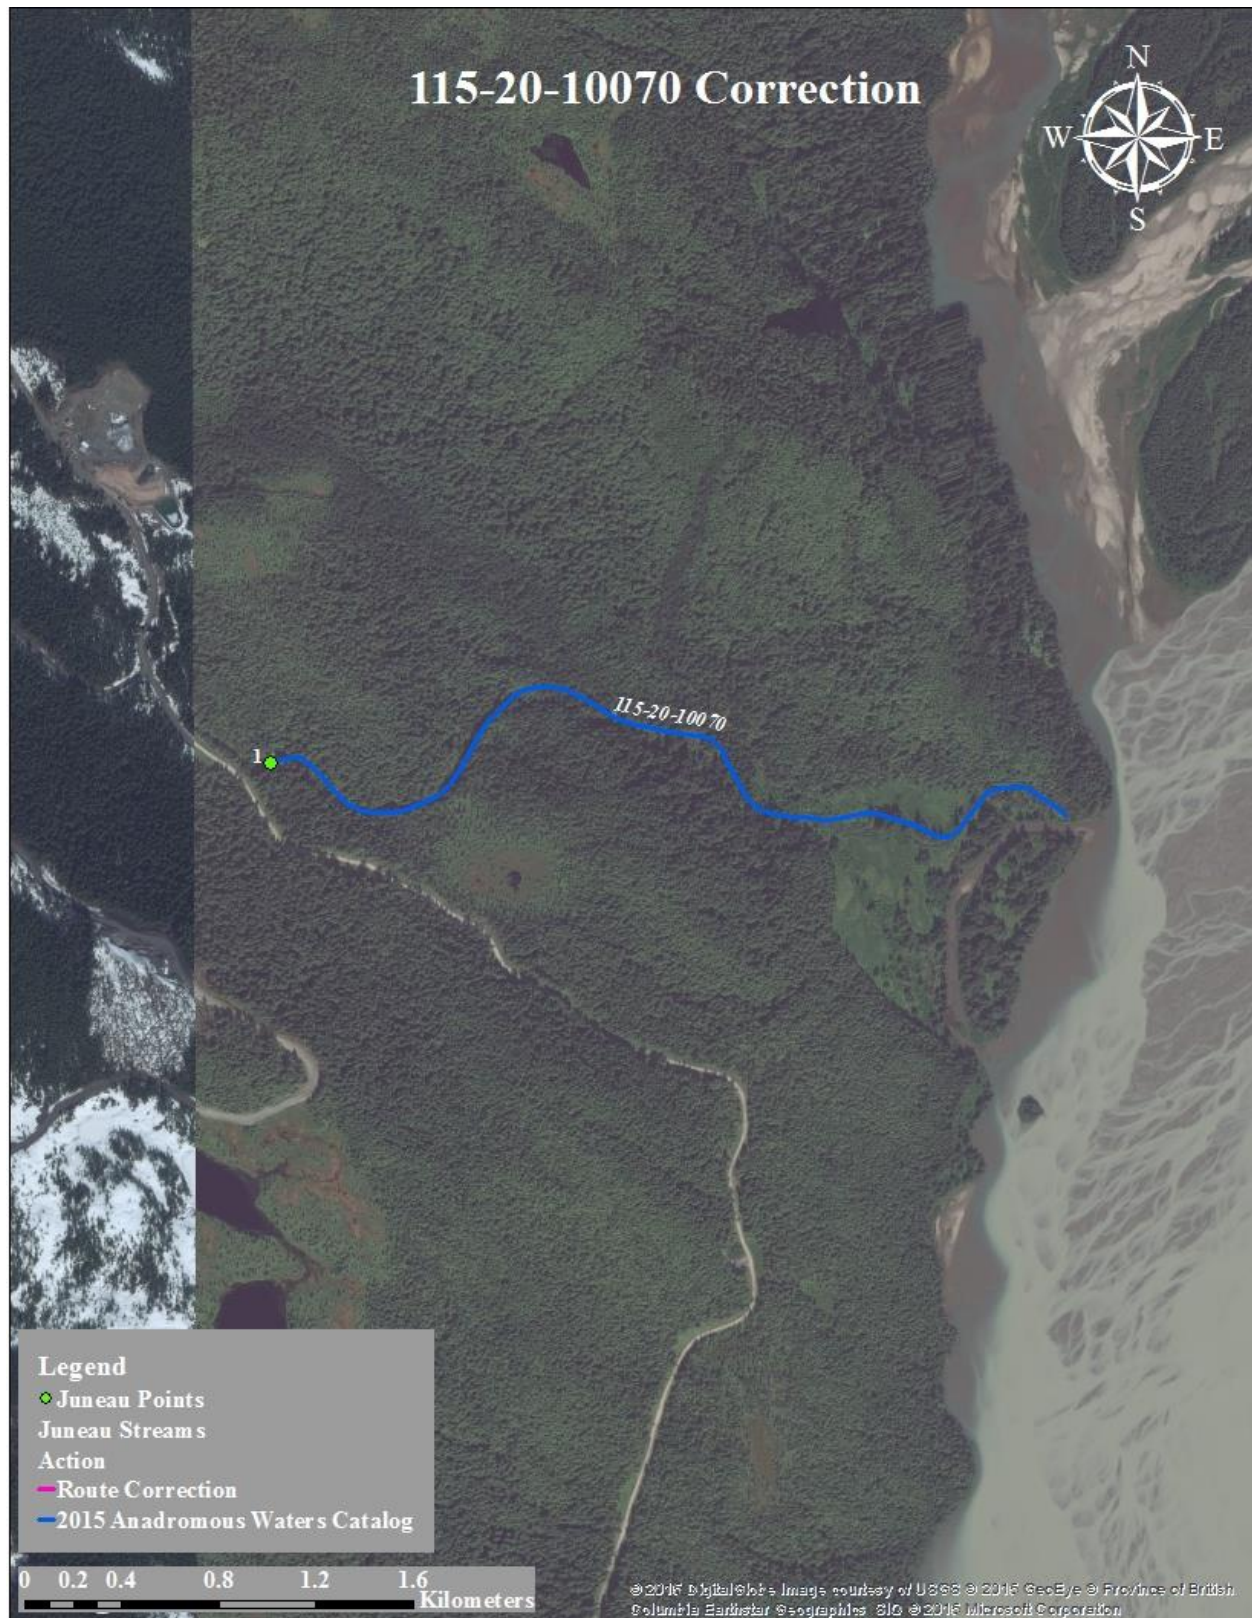
Figure 1.—115-20-10070 correction map.

Findings: From 2005-2008 adult pink, chum, and coho salmon were observed spawning in Johnson Creek. Pink, chum, and coho salmon fry were also captured in fyke traps in the spring of 2005-2008 (Table 1)

Recommendations: Add coho salmon spawning and rearing. Add pink and chum salmon spawning.

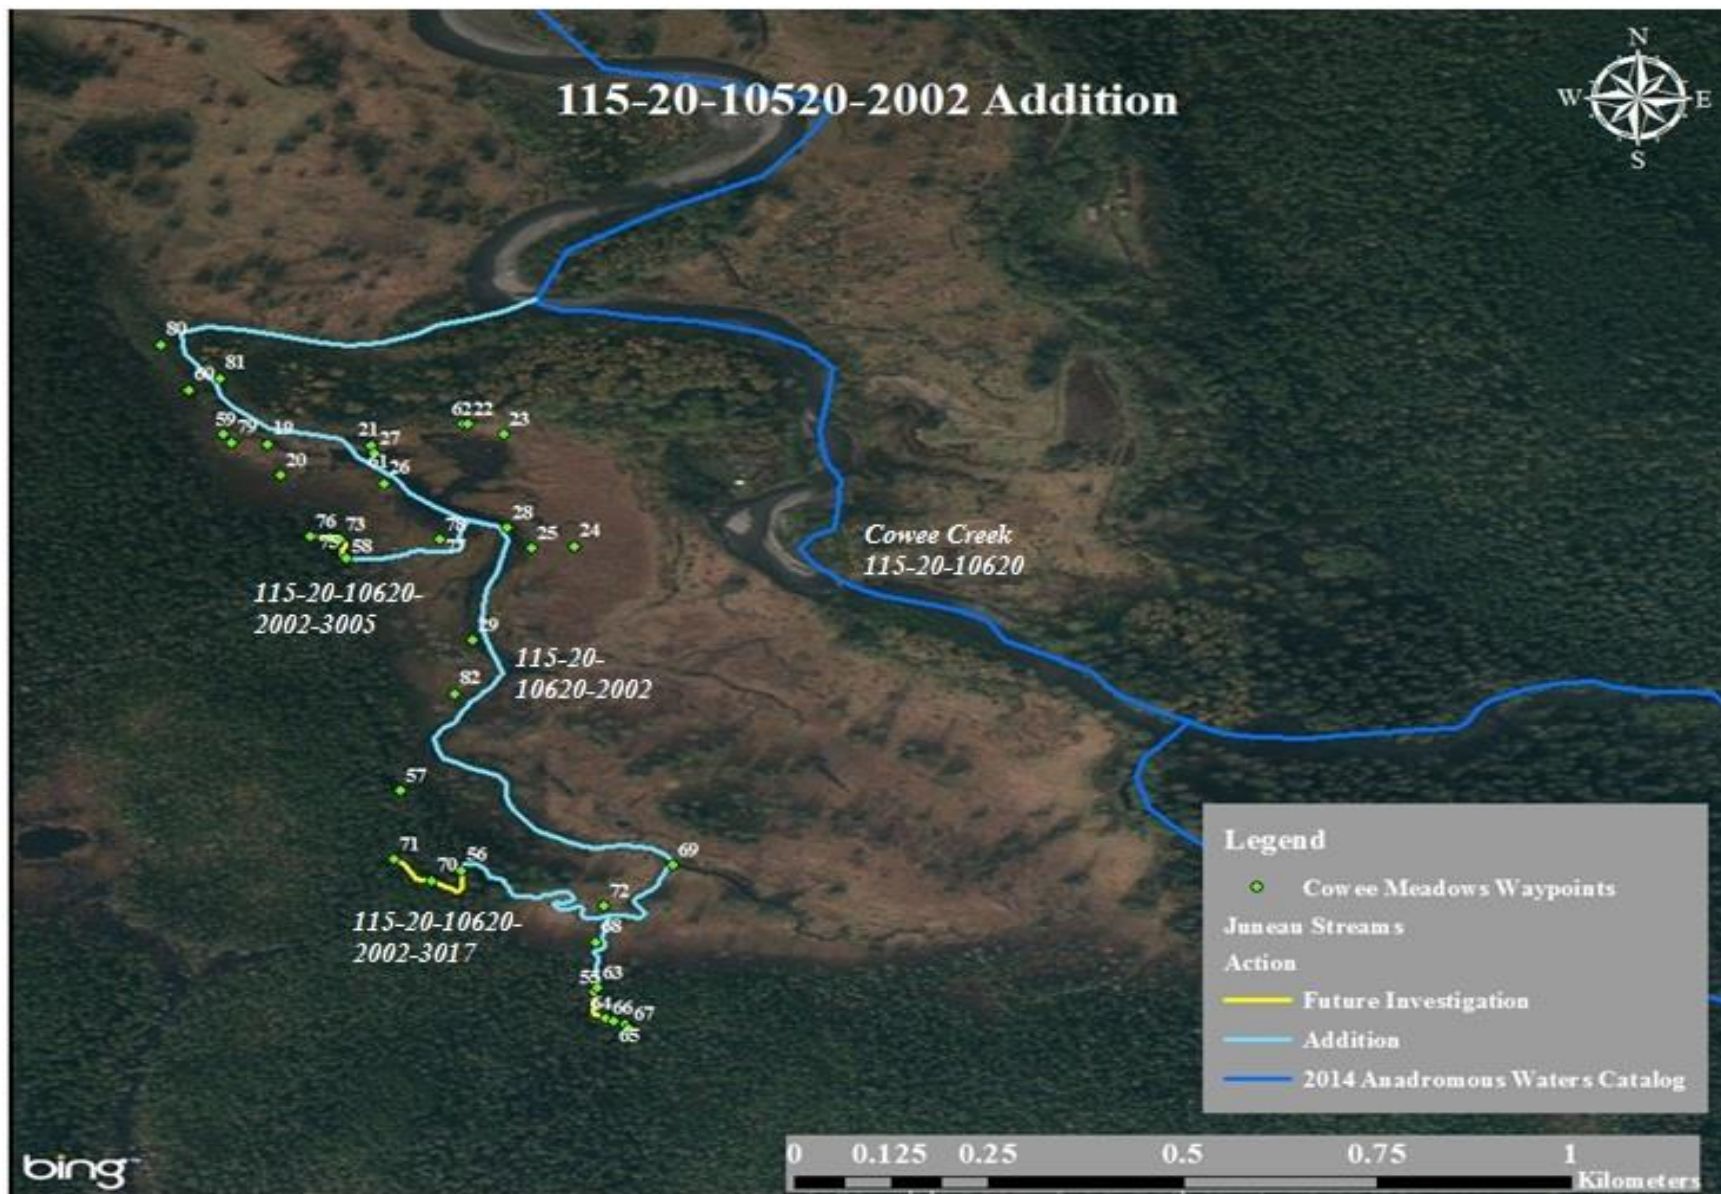
Figure 4.—115-20-10620-2002 addition map.

Findings: We surveyed this stream using minnow traps, handnet and GPS (Table 1). This large network of beaver ponds and channels supports rearing juvenile coho salmon, cutthroat trout, threespine stickleback, and Dolly Varden char (Figures 1, 2, 3). The numerous beaver dams do not appear to function as barriers to fish passage as we found coho salmon fry above many dams.

Recommendations: Add this stream course to the AWC (Figure 4).

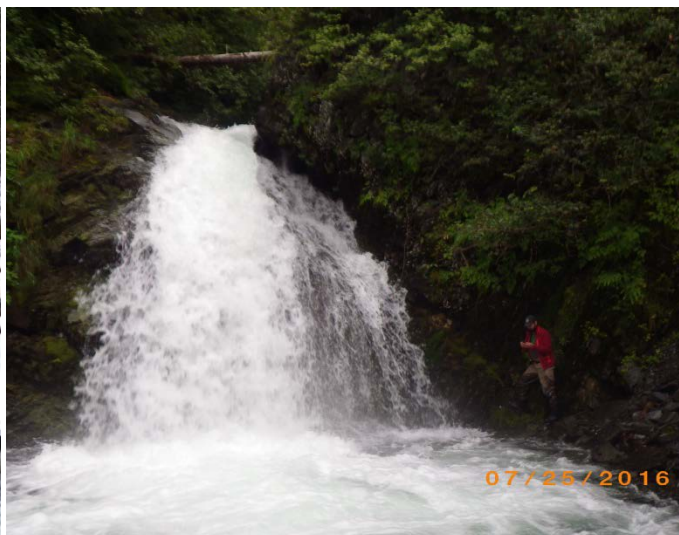
Figure 1.—Sherman Creek on April 2012. Falls can be seen in the background.

Figure 2.—Close-up photo of same falls in 2016.

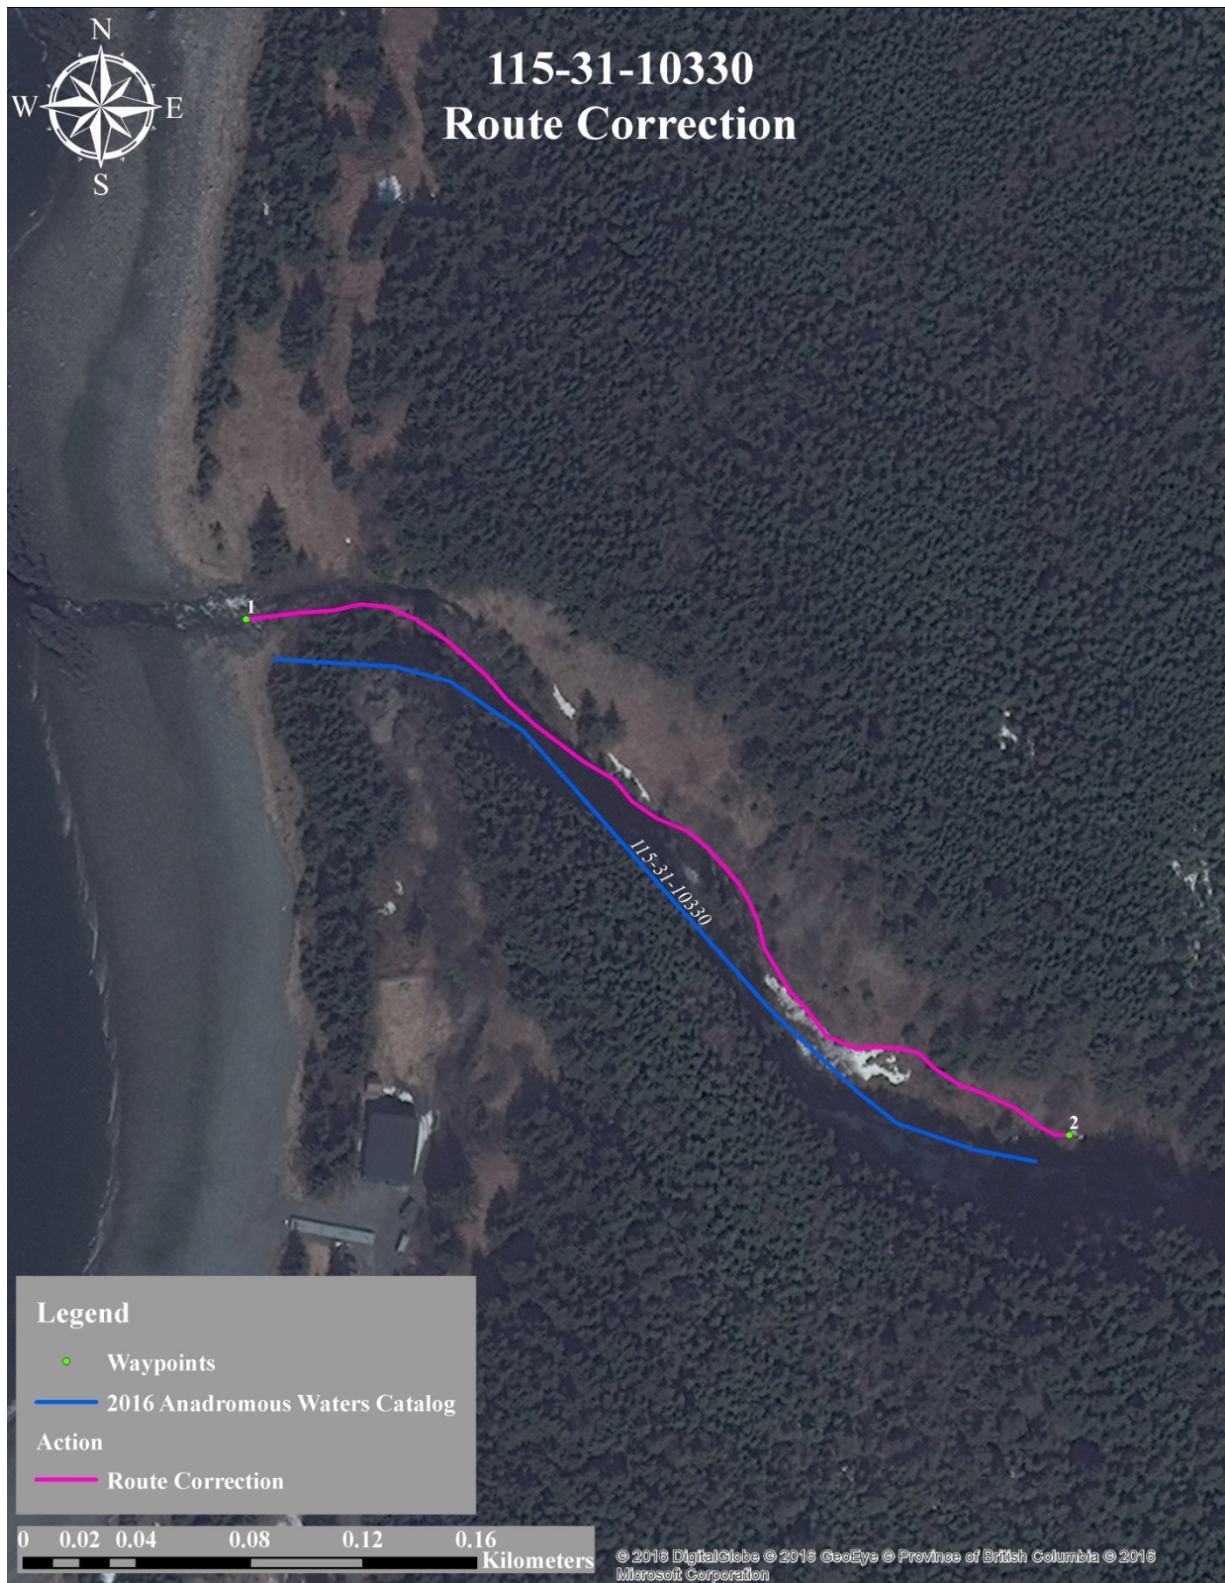
115-31-10330

| Waypoint | Latitude | Longitude | Notes | Sample Effort | Sample Results |
|---|---|---|---|---|---|
| 1 | 58.8668 | -135.1369 | Anadromous fish barrier. | | |

Figure 2.—115-31-10330 route correction map.

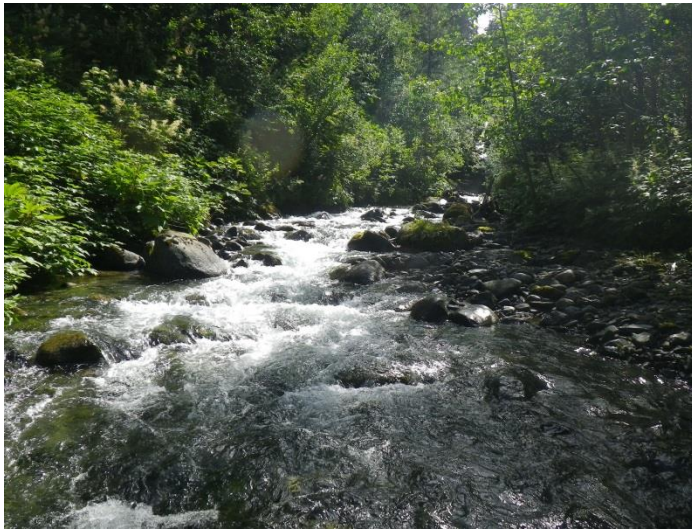
Figure 1.—Looking upstream on Sherman Creek.

Recommendations: Delete coho salmon from the species list in Sherman Creek.
